Mariusz Ziejewski, Ph.D., Inż.

RE: Matthew and Marcia Seebachan

Pursuant to your request, I am setting forth my biomechanical opinions regarding the motor vehicle incident on December 21, 2013 involving Matthew and Marcia Seebachan. I am also providing a summary synopsis of my background and qualifications to render my opinions.

To perform a biomechanical analysis of the incident involving Matthew and Marcia Seebachan on December 21, 2013.

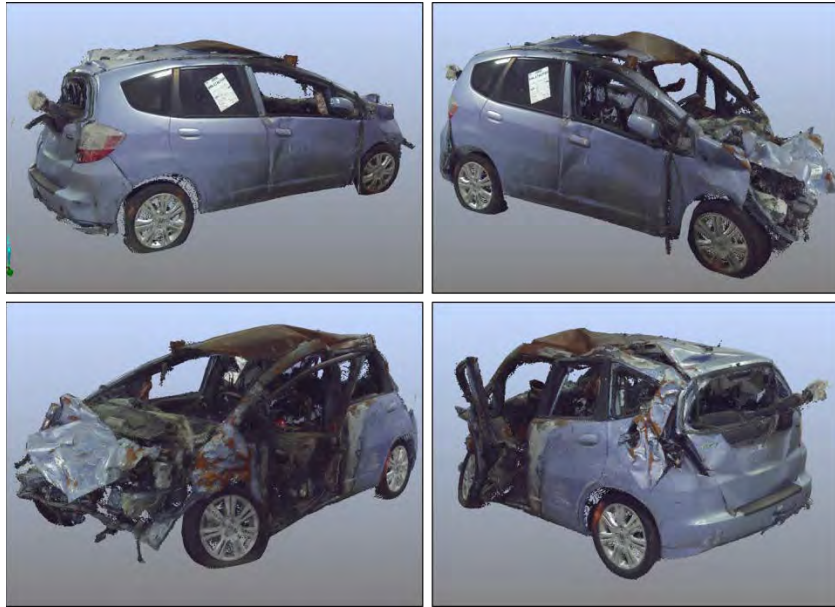
Figure 7 – FARO Laser Image for the 2010 Honda Fit

The damage assessment for the Honda Fit was carried out using two different approaches: laser based measurements and basic measuring tools. Selected images from the 3D FARO Laser System are shown in Figure 7. Example photographs taken during my inspection, with exterior measurements suitable for photogrammetric analysis are shown in Figure 8.

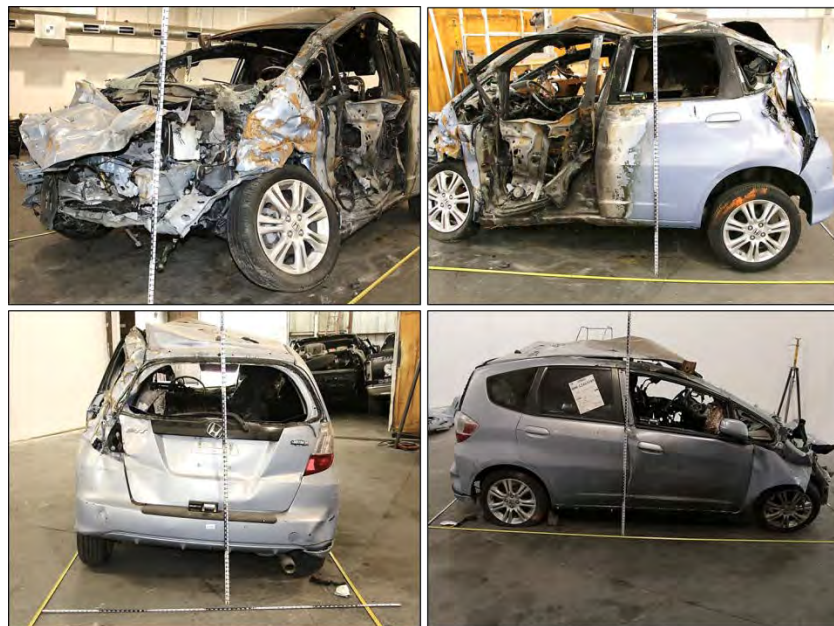
Figure 8 – Exterior Damage of Subject Honda Fit

My inspection of the subject vehicle revealed extensive damage consistent with a small overlap frontal impact. From a trauma biomechanics perspective, in this case, the most relevant area of damage included but was not limited to the front, the roof, the driver's side cant rail, lower frame and the interior of the vehicle. Based on the nature and extent of the Honda Fit's damage, it is obvious the structural components were subjected to compressive forces exhibited by dynamic progressive buckling characteristics. The subject of dynamic progressive buckling has been extensively studied. There is a broad base of peer reviewed publications. For example:

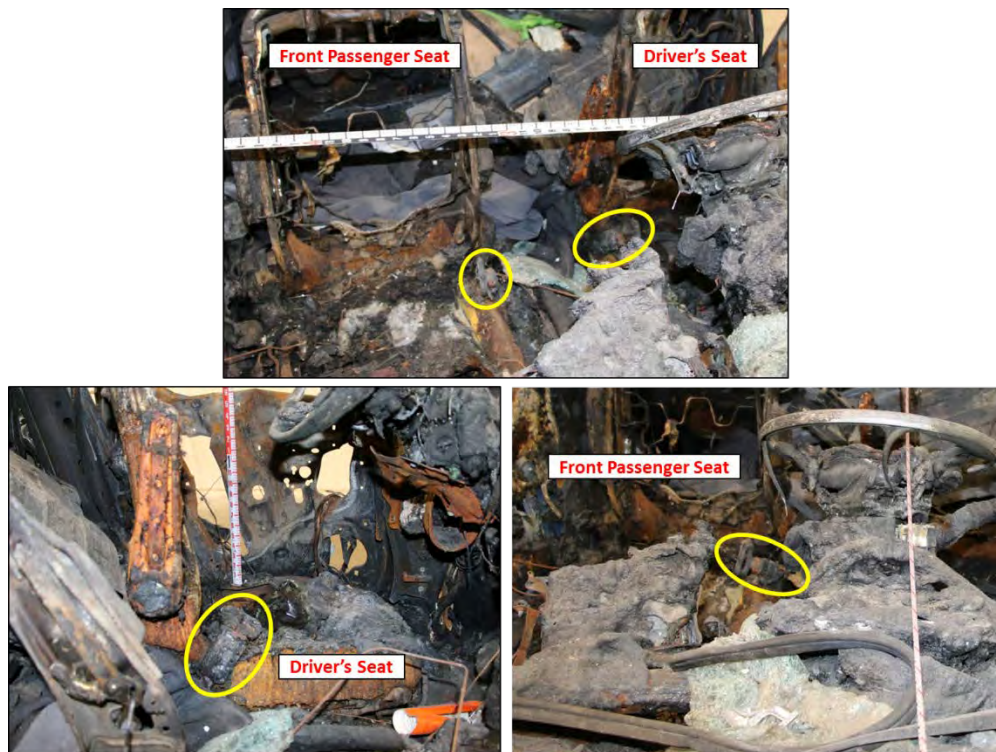
Figure 9 – Latch Plate Engagement and Fusion

Physical evidence of the latch plate fused to the buckle can be seen on both the driver’s side and the front passenger side (Figure 9). Remnants of deployed front airbags are still identifiable on the steering wheel and passenger side dash (Figure 10).

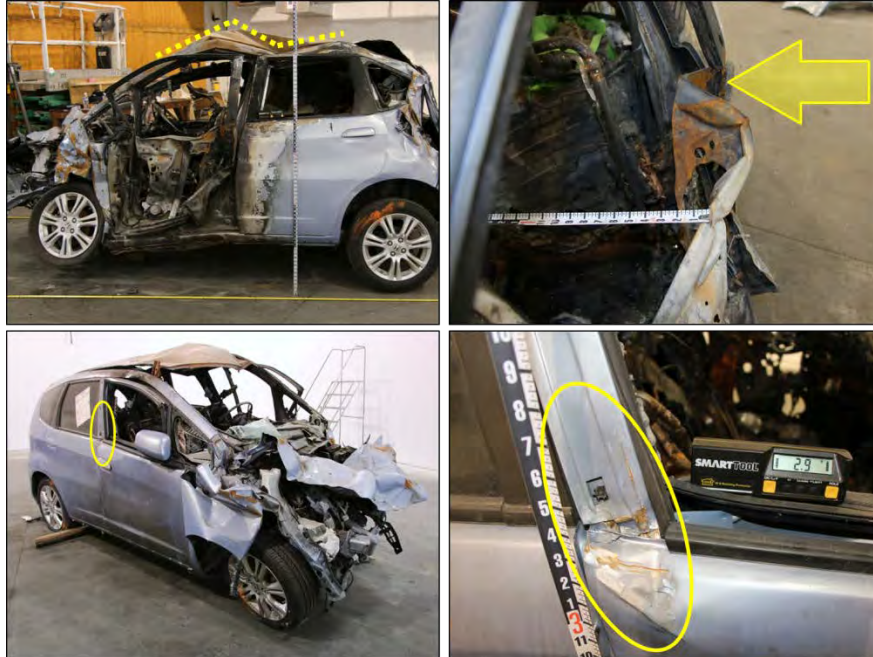
Figure 11 – Roof and Door Deformation

As stated in Mr. Hannemann’s report (pp 7-10), the failure of the cant rails due to lack of proper welding by John Eagle Collision compromised the entire frame of the subject 2010 Honda Fit;

- “Z” buckling of the roof and cant rail caused deformation of the driver side and passenger side doors, subsequently jamming them shut and preventing any egress of the occupants without assistance (Figure 11).
- Lower frame rails were not able to manage the impact energy and became detached from the main vehicle structure (Figure 12).
- The left lower frame rail came in contact with the fuel tank causing fuel to escape.
- There was a missing fuel tank cover at the time of inspection.
