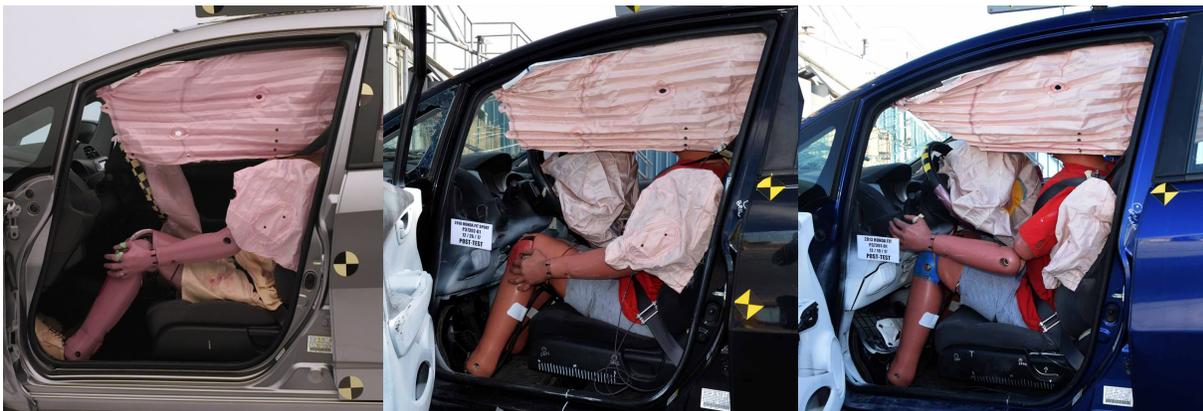
Figure 3. Door closure, IIHS 2009 Honda Fit (left); 2010 Fit OEM (middle) and 2013 Fit equipped with aftermarket parts (right)

Structurally, the results of the control (2010 Fit) and aftermarket parts (2013 Fit) tests look roughly similar to the 2009 Honda Fit test IIHS performed in 2008 as shown in Figure 3. The IIHS test was an audit of Honda’s own test of the Fit submitted to the Institute as part of the ratings verification process. Consequently, there are three tests of unmodified Fit cars to compare with the Karco tests of a car repaired with non-OEM repair parts.

Table 1 shows the intrusion measures from Honda Fit tests performed by Karco, IIHS and Honda. The test of the 2013 Fit resulted in more intrusion of the left and center toepan and brake pedal than any of the tests of unmodified cars. Despite these differences, the measurements from all four tests represent structural performance that would be rated good according to IIHS protocol.

It is possible that replacing the bumper reinforcement, radiator support and left front wheel with non-OEM alternatives in the test of the 2013 Fit resulted in somewhat more toe pan intrusion and a slight degradation of protection for the driver's left knee/thigh/hip and right foot/ankle. These were the only measurements reported by Tracy and Karco that varied from the baseline results by more than would be expected in exactly repeated crash tests. Even though these and other measures indicate a somewhat increased risk of injury compared with the test of an unmodified Honda Fit, the overall rating for the cars in both tests would be good according to IIHS protocol and consistent with our own test.

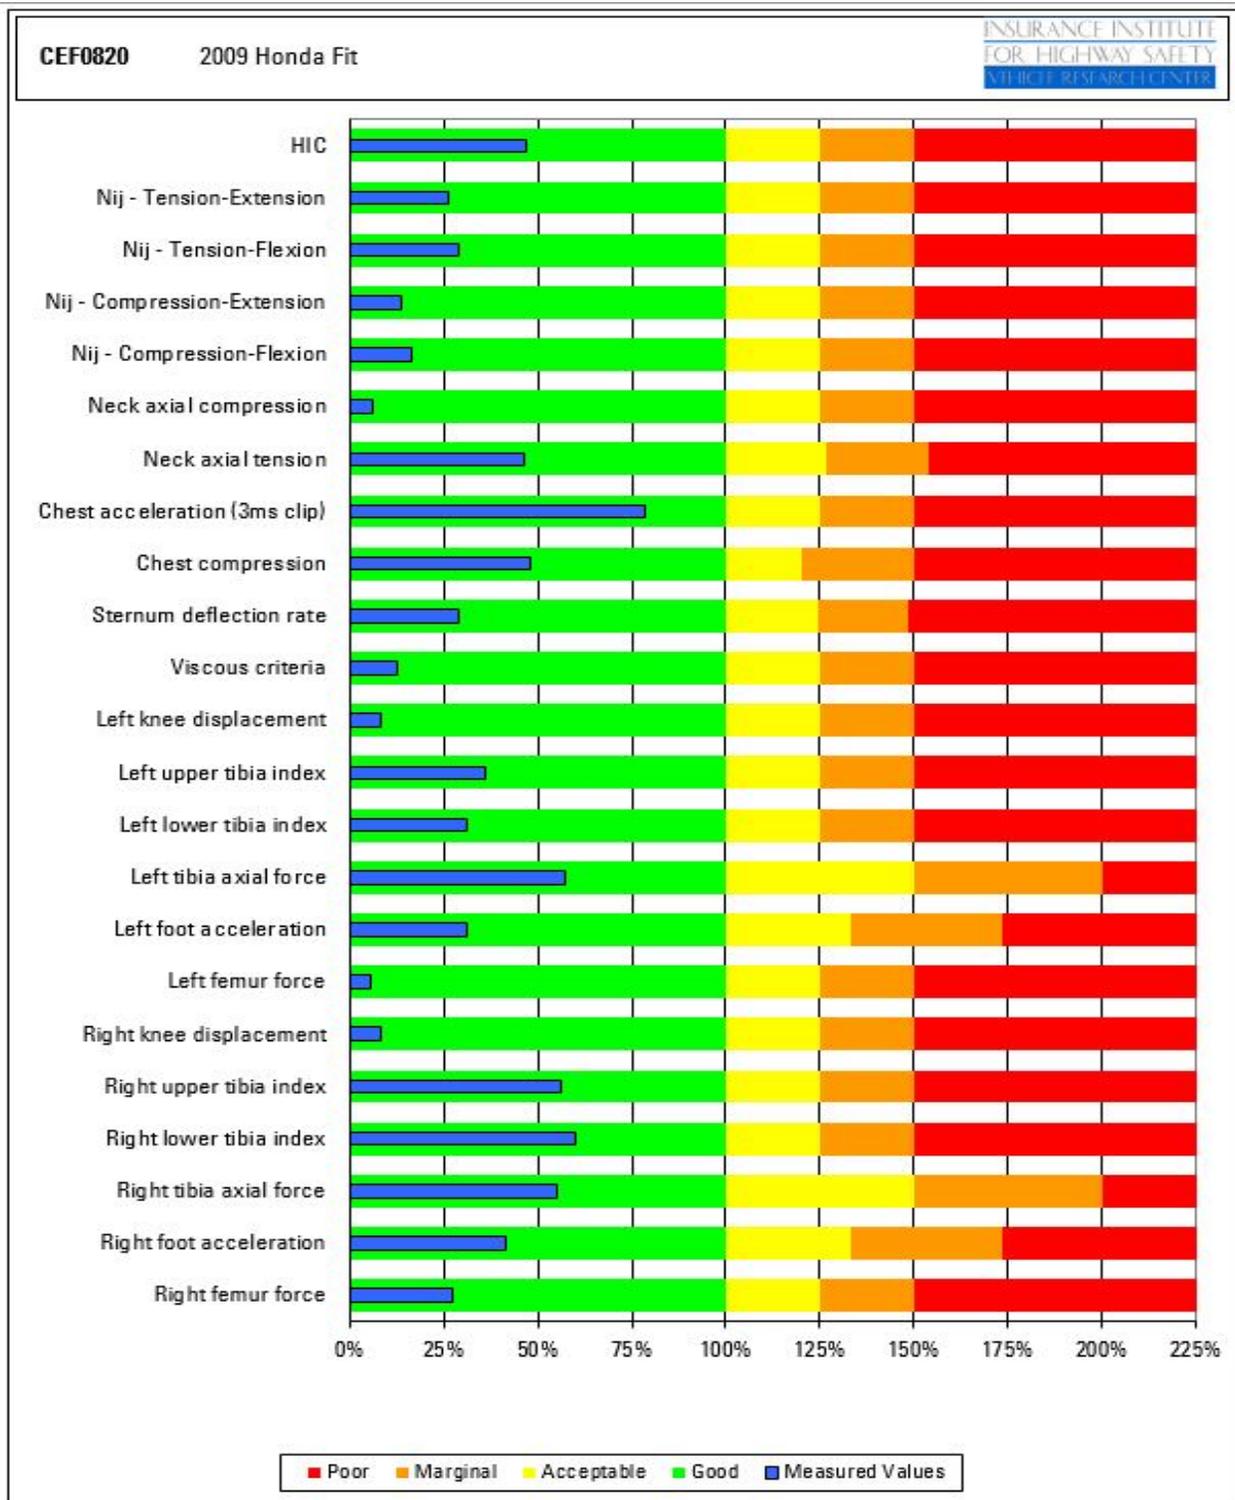
Figure A1. IIHS 2009 Honda Fit – Test CEF0820

Similarly, the compression forces recorded on the left femur in all four tests also are well below the level (7,300 N) at which the IIHS protocol would downgrade its assessment of protection for the knee, thigh and hip because serious injuries, including fractures, wouldn't be expected below this level. In fact, a force of 10,000 N is a passing grade for regulatory frontal crash tests. Charts in the Karco test reports show that all the injury measures used by IIHS for

injury risk evaluation are below the threshold for a downgrade from a good to an acceptable rating. These, as well as the corresponding chart from the Institute's test, are appended to this Advisory (see Appendix).
