FATAL CMV SCHOOL BUS RAILROAD MAB SUPPLEMENT ACTIVE SCHOOL ZONE

**University Park
Police Department
Traffic CRASH Reconstruction Investigation**

Case #: 17-00026 Incident : Motor Vehicle CRASH (SUPPLEMENT 1/20/17)

Crush Energy Analysis Report

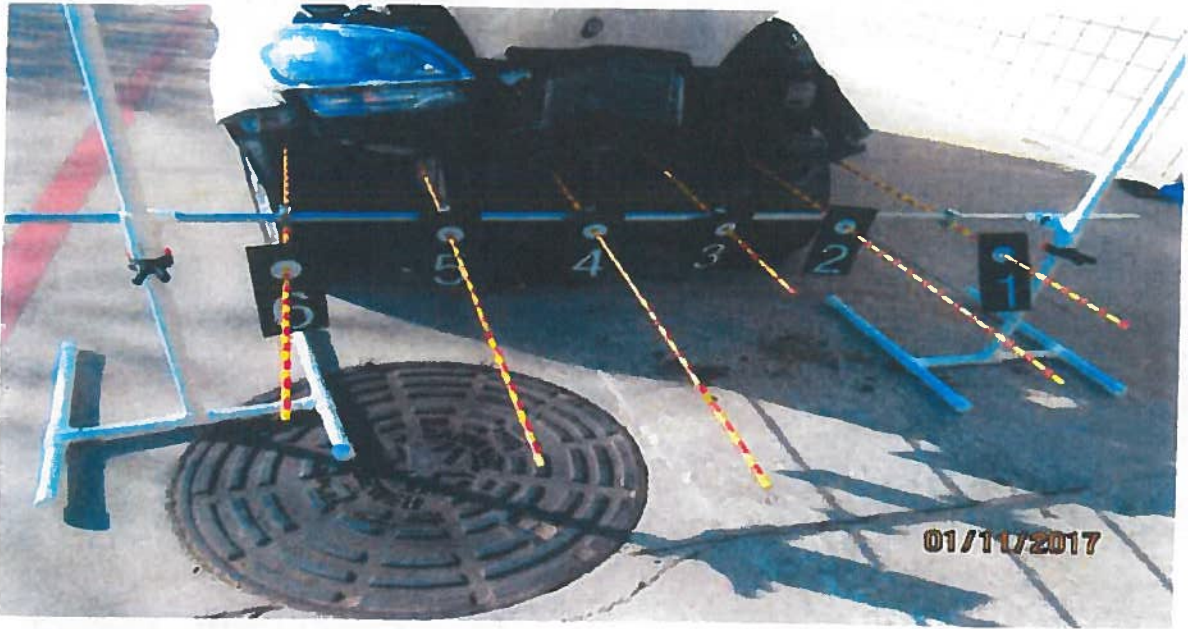
CRUSH JIG Photograph with rods extended to max crush at the C measurements

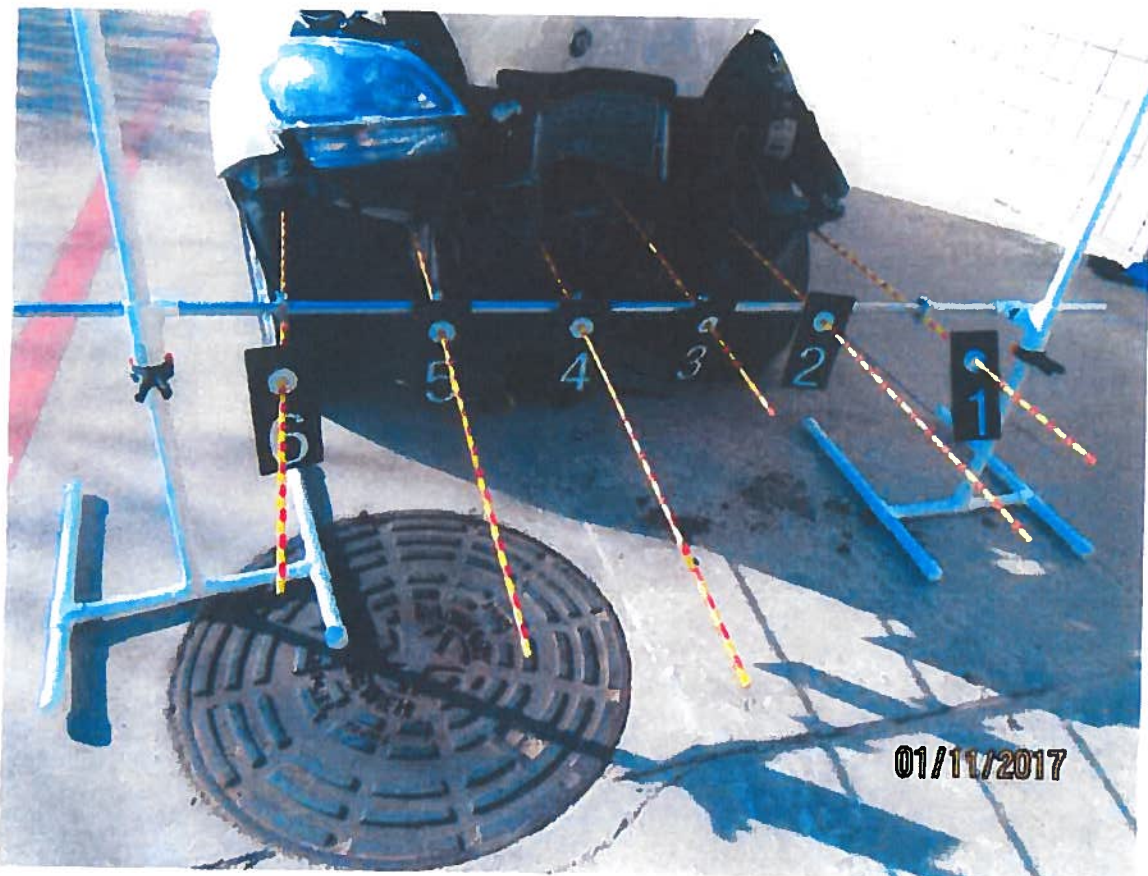
On 01/11/2017, Officers Jackson was contacted by University Park PD Officer Jason Baxter in reference to a request for crush analysis on a vehicle involved in a crash in Highland Park, Texas. The vehicle was brought to the rear parking lot of Mesquite PD by a wrecker driver. The vehicle is pictured below:

The width of the damage ("W"/"L") was approximately 56 inches and the C measurements were taken at 11.2 inch intervals. The C measurements were taken driver-side to passenger-side (C1 – C6). Six C measurements were taken because the frontal plane was pulled inward. The crush jig was set up 11 feet 3 inches from the rear axle. The C3 measurement was the deepest crush and it did not need to be moved. The midpoint of the damage was approximately -6 inches (toward driver side). The visual PDOF was about 5 degrees. The measurements were taken at bumper level (bumper removed by Officer Jackson to measure the crush) at approximately 22" above ground level. The curb weight of the vehicle (published data/Edmunds) was 2,690 lbs. with a driver weight of about 170 lbs, for a total weight of about 2,860 lbs. There were additional items in the vehicle, so the weight used for this analysis will be 3,100 lbs. Note that any addition of weight will reduce the speed estimate. The rear overhang (per ARAS 360 specs) is 28.74 inches. The overall vehicle length was 162 inches. If you subtract the rear overhang from the overall length, that calculates to 133.26 inches or 11.1 feet. The following crush measurements were obtained:

Conclusion: Based upon the crush damage, the Kia was traveling at about 46 mph when it collided with the tree.
