Vehicle as examined

Vehicle Data

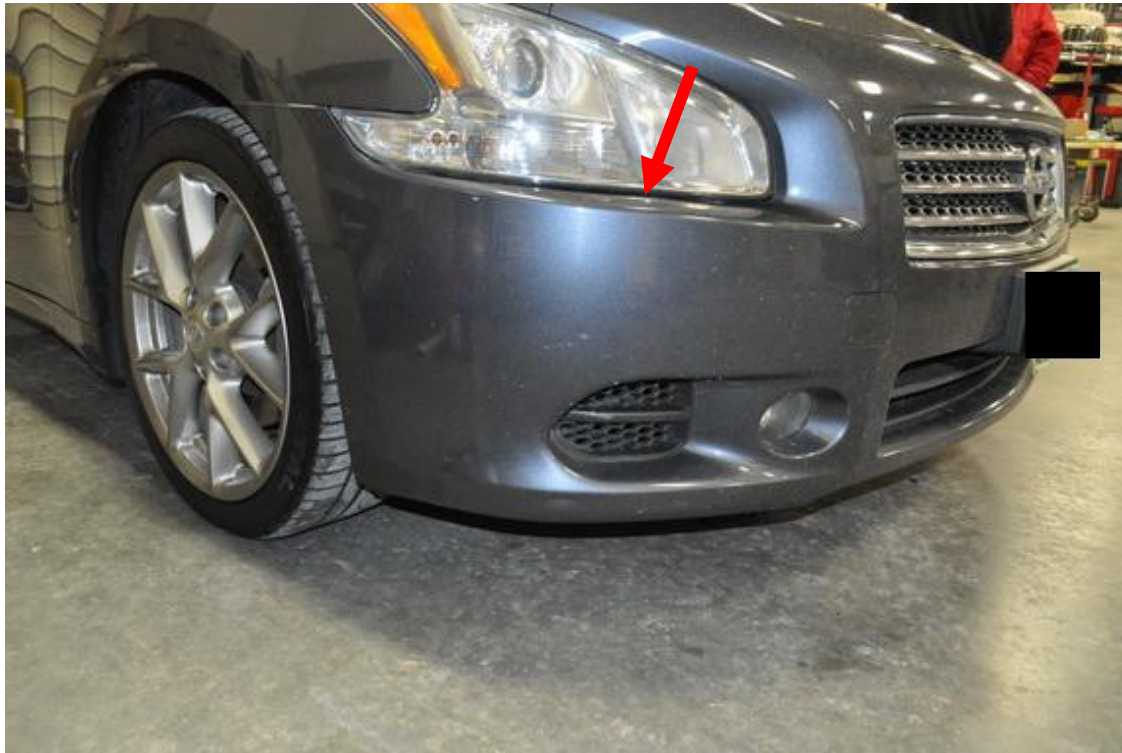
Excessive positive gap right headlamp to front fascia (red arrows).

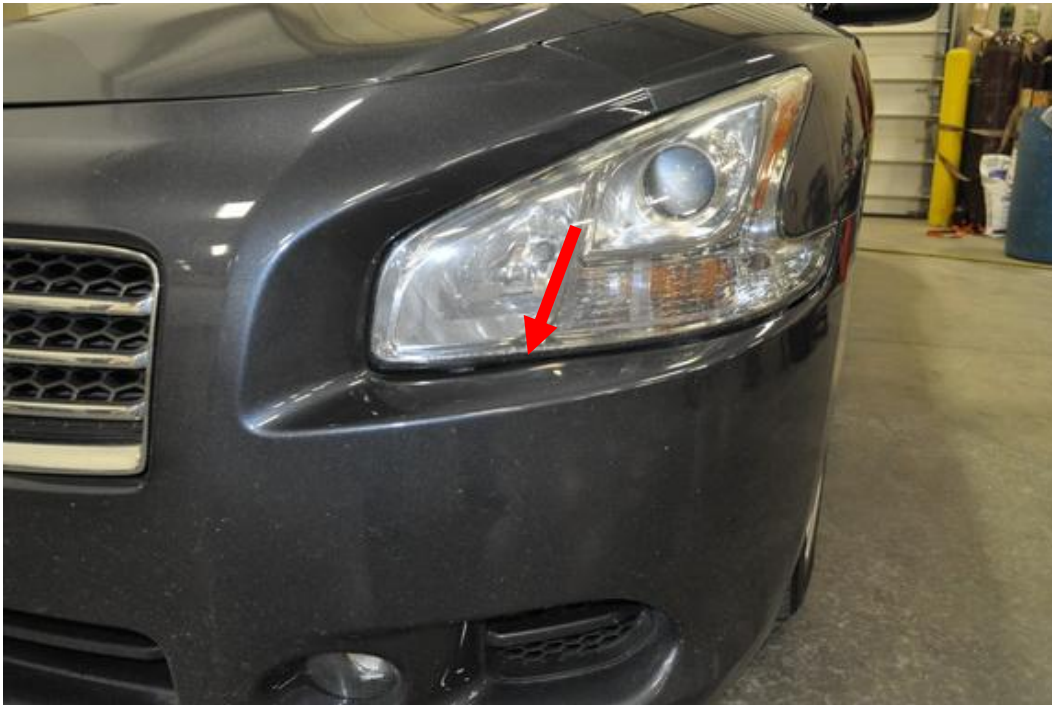
Excessive positive gap left headlamp
to front fascia (red arrows).

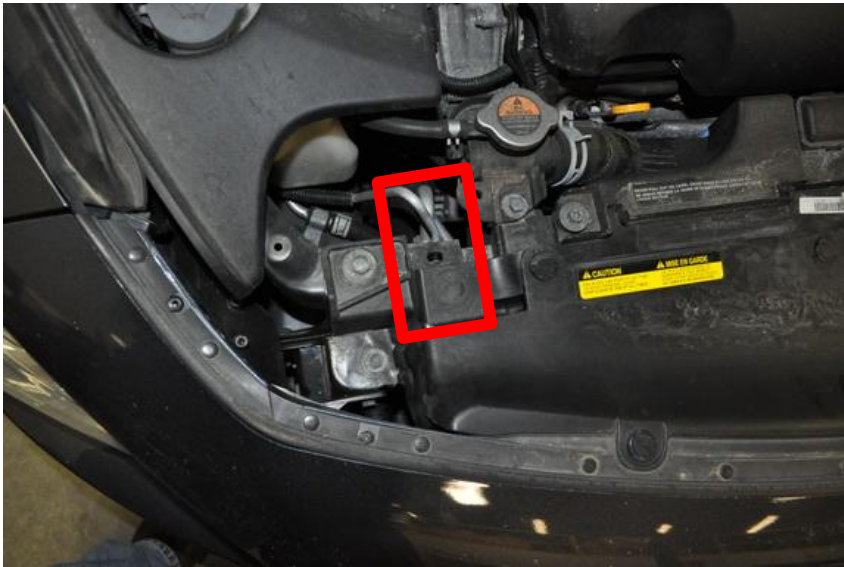
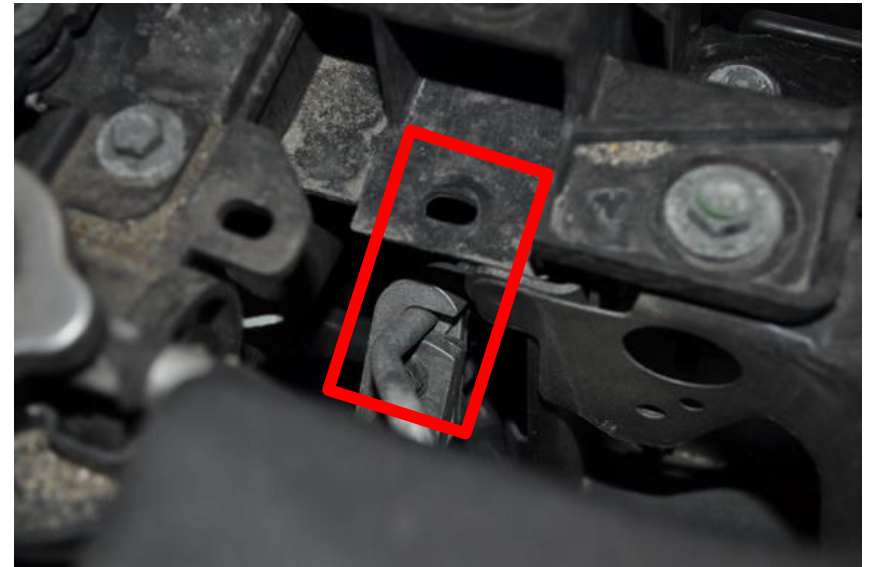
Missing mounting bolt, fiber reinforced radiator core support to air conditioning lines bracket (red boxes).

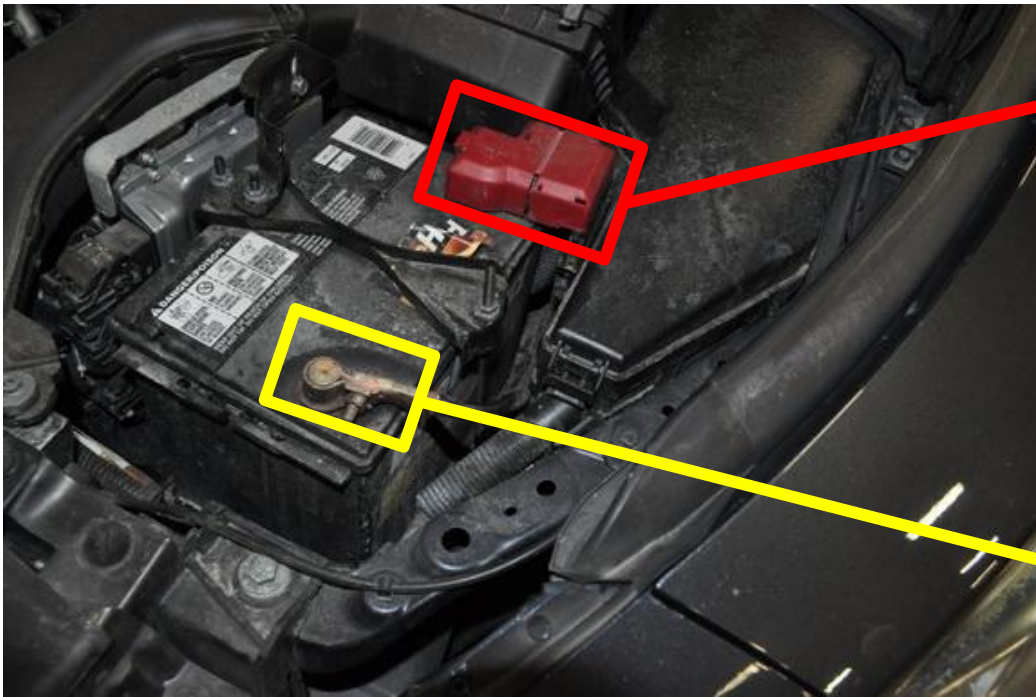
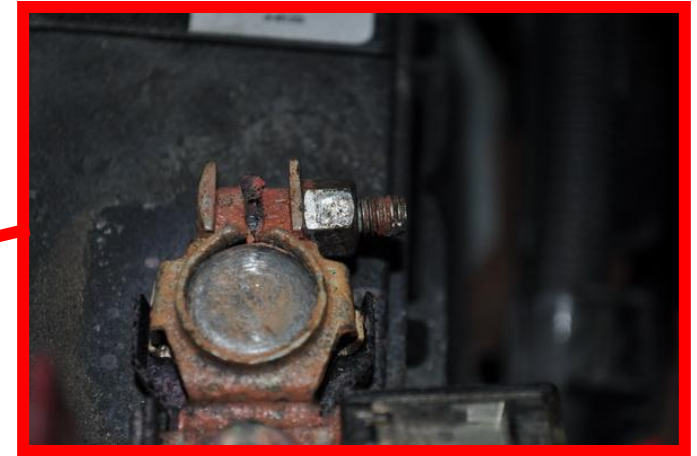
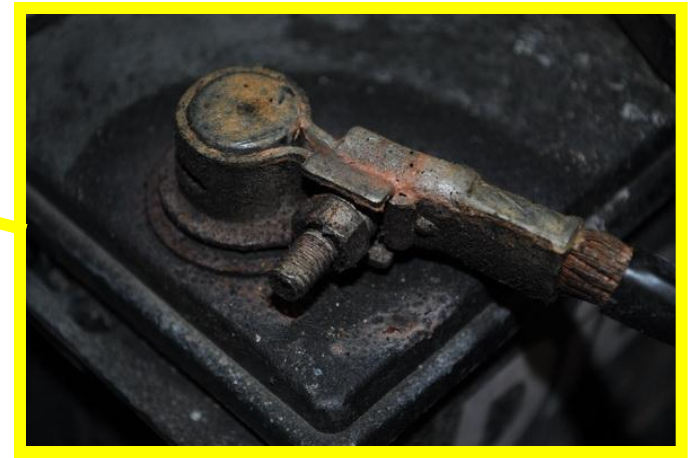
Positive and negative cable mounting nuts, no evidence of tool type impact markings.

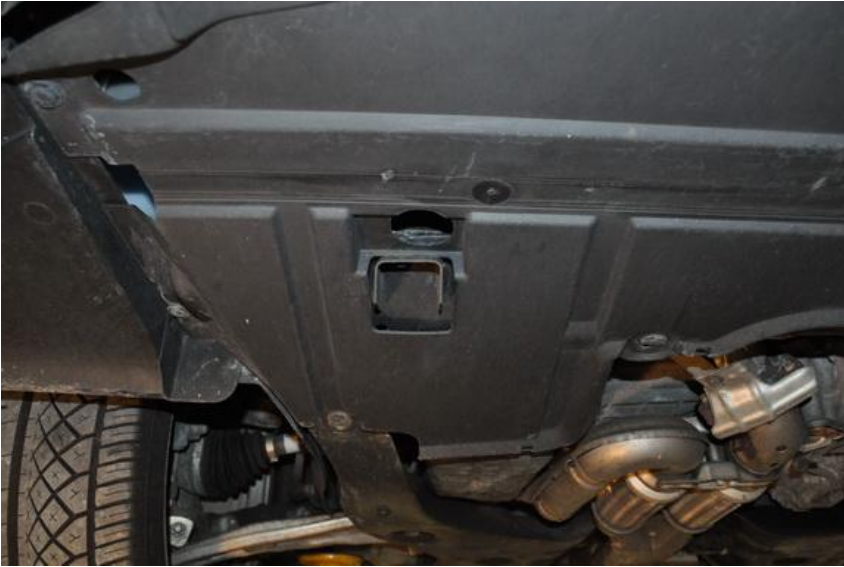
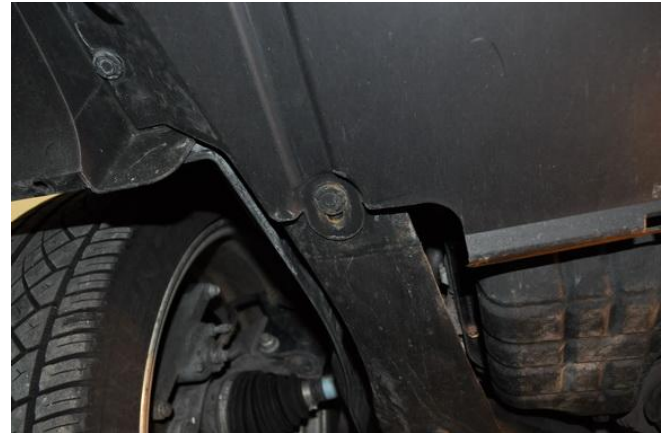
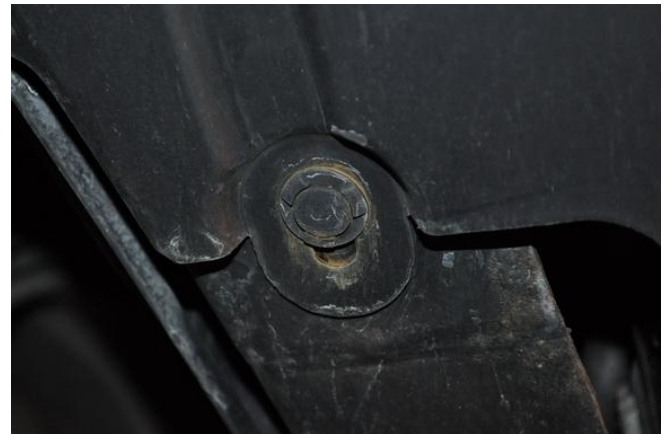
Right lower front splash shield, worn mounting retaining clip.

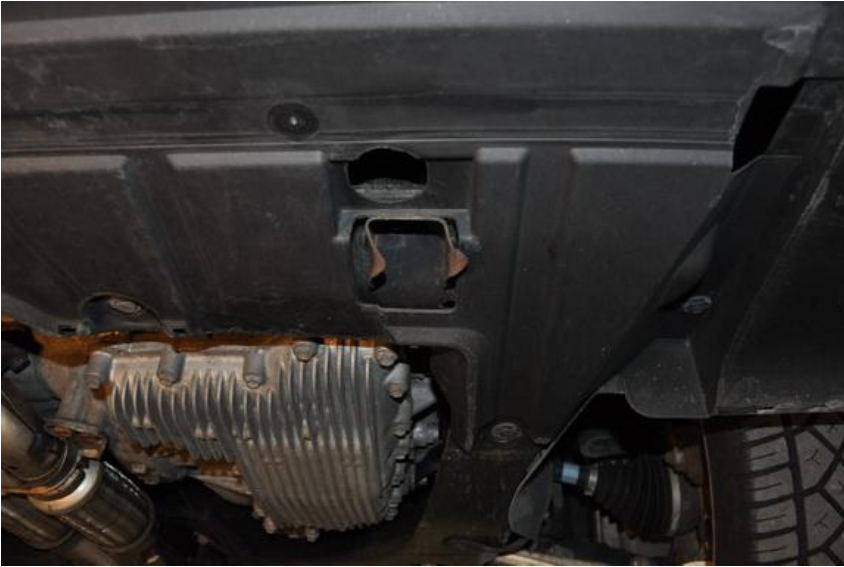
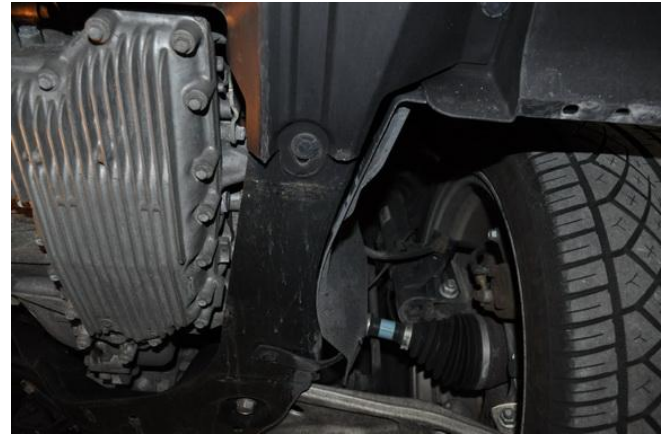
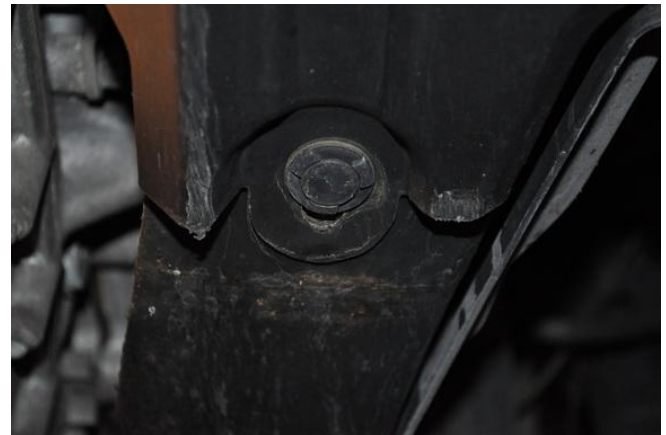
Left lower front splash shield, worn mounting retaining clip.

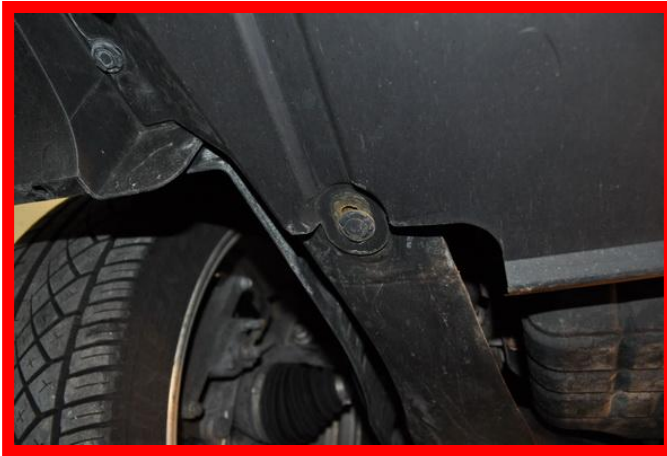
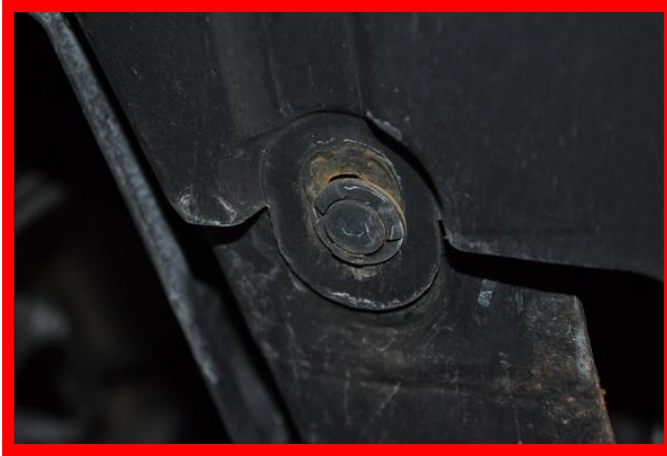
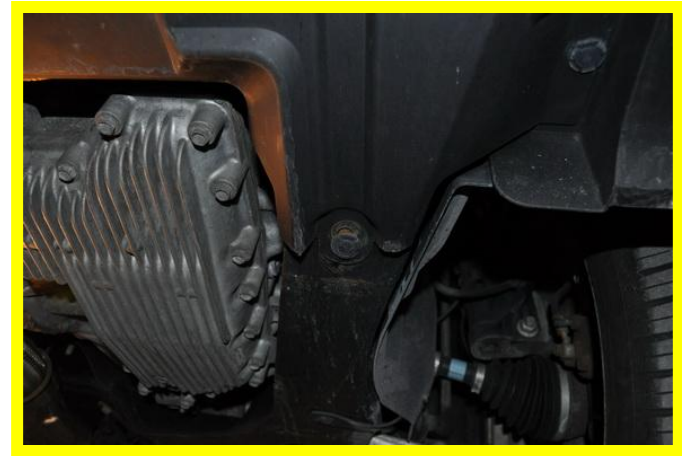
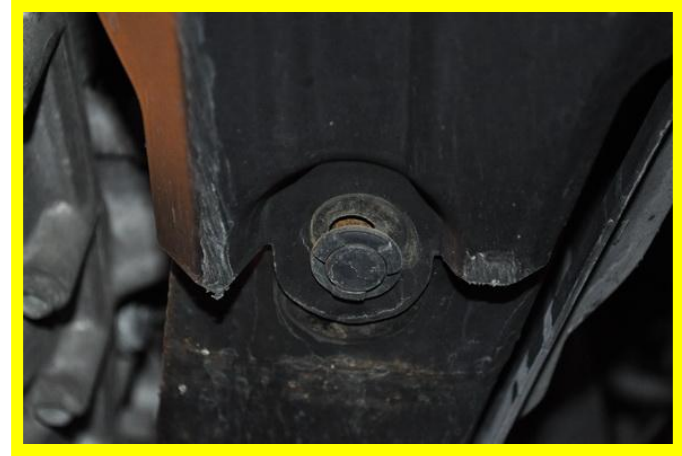
Right (red boxes) and left (yellow boxes) mounting retaining clips, excessive movement of 10mm – 12mm

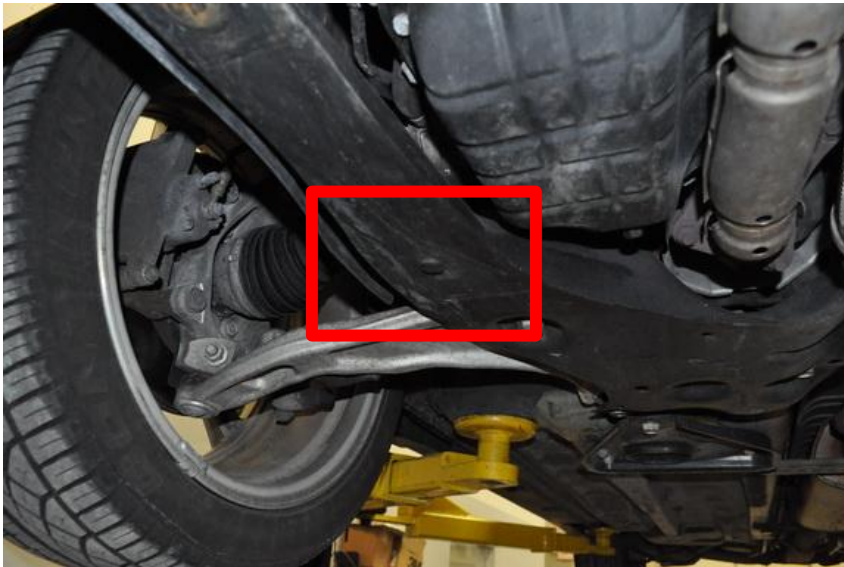
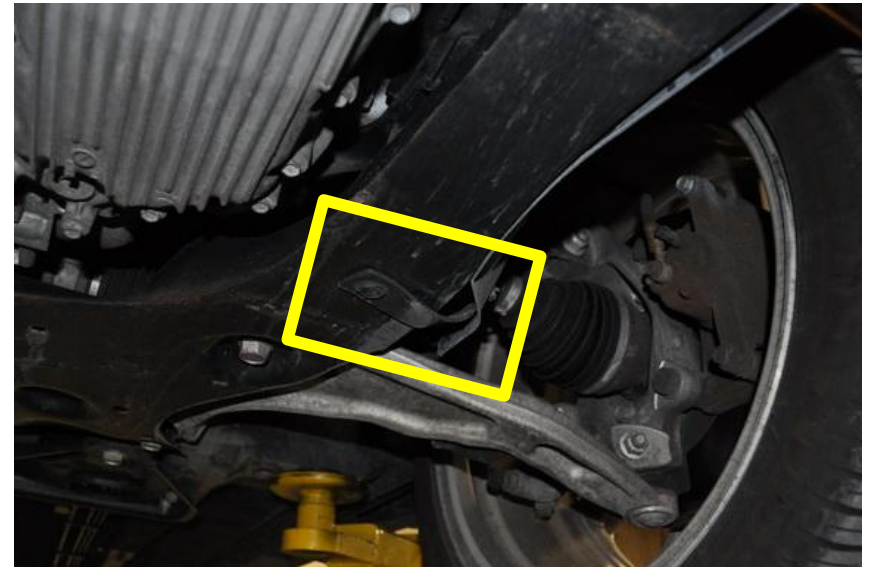
Right (red boxes) and left (yellow boxes)
mounting strap, splash shield to cradle.
Right side strap separated and missing.

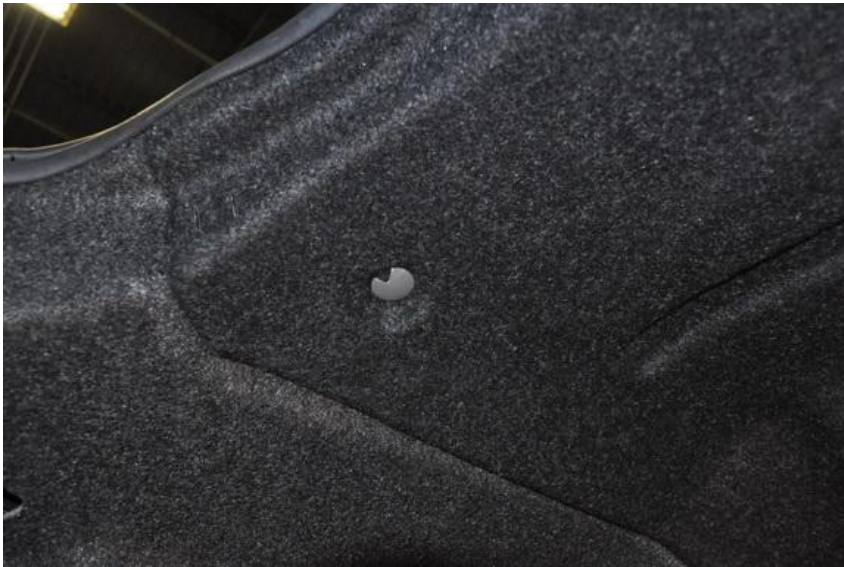
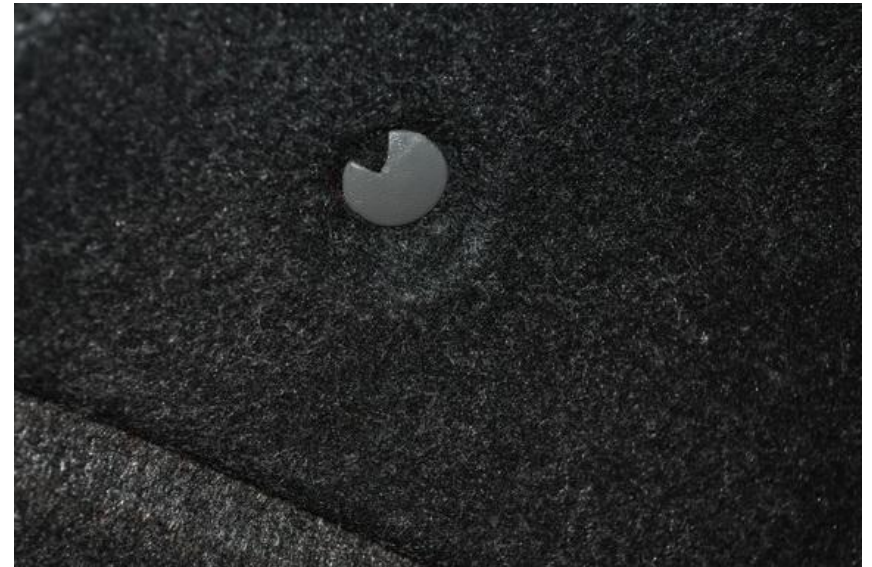
Left upper clip, multiple ductile fractures to clip head with missing portions.

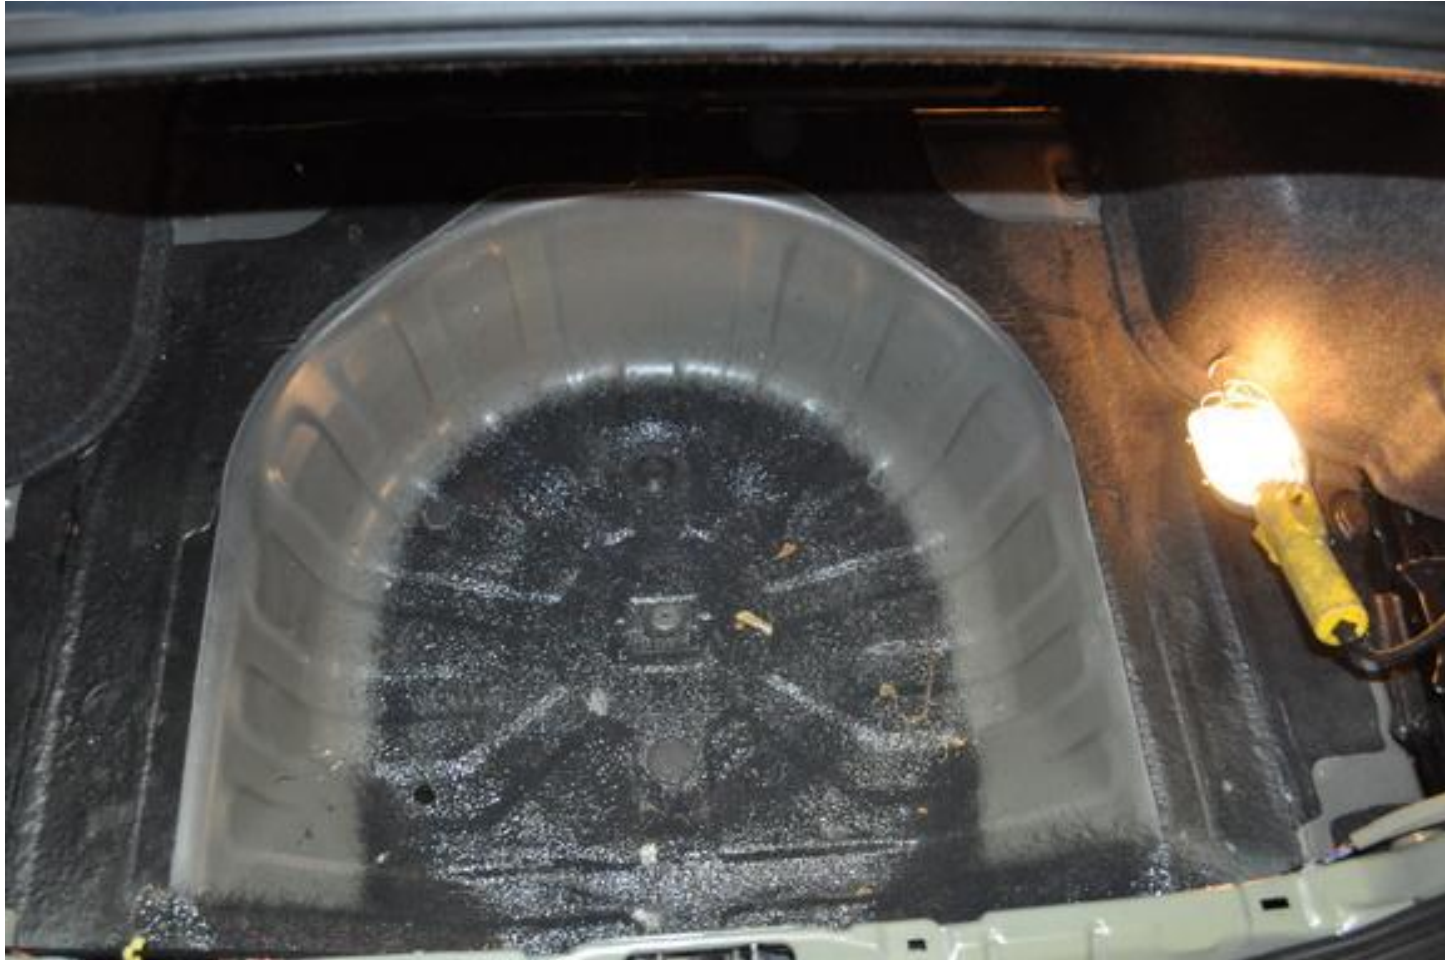
Non-Nissan sprayable seam sealer applied to spare tire well, instead of sound dampening pads.

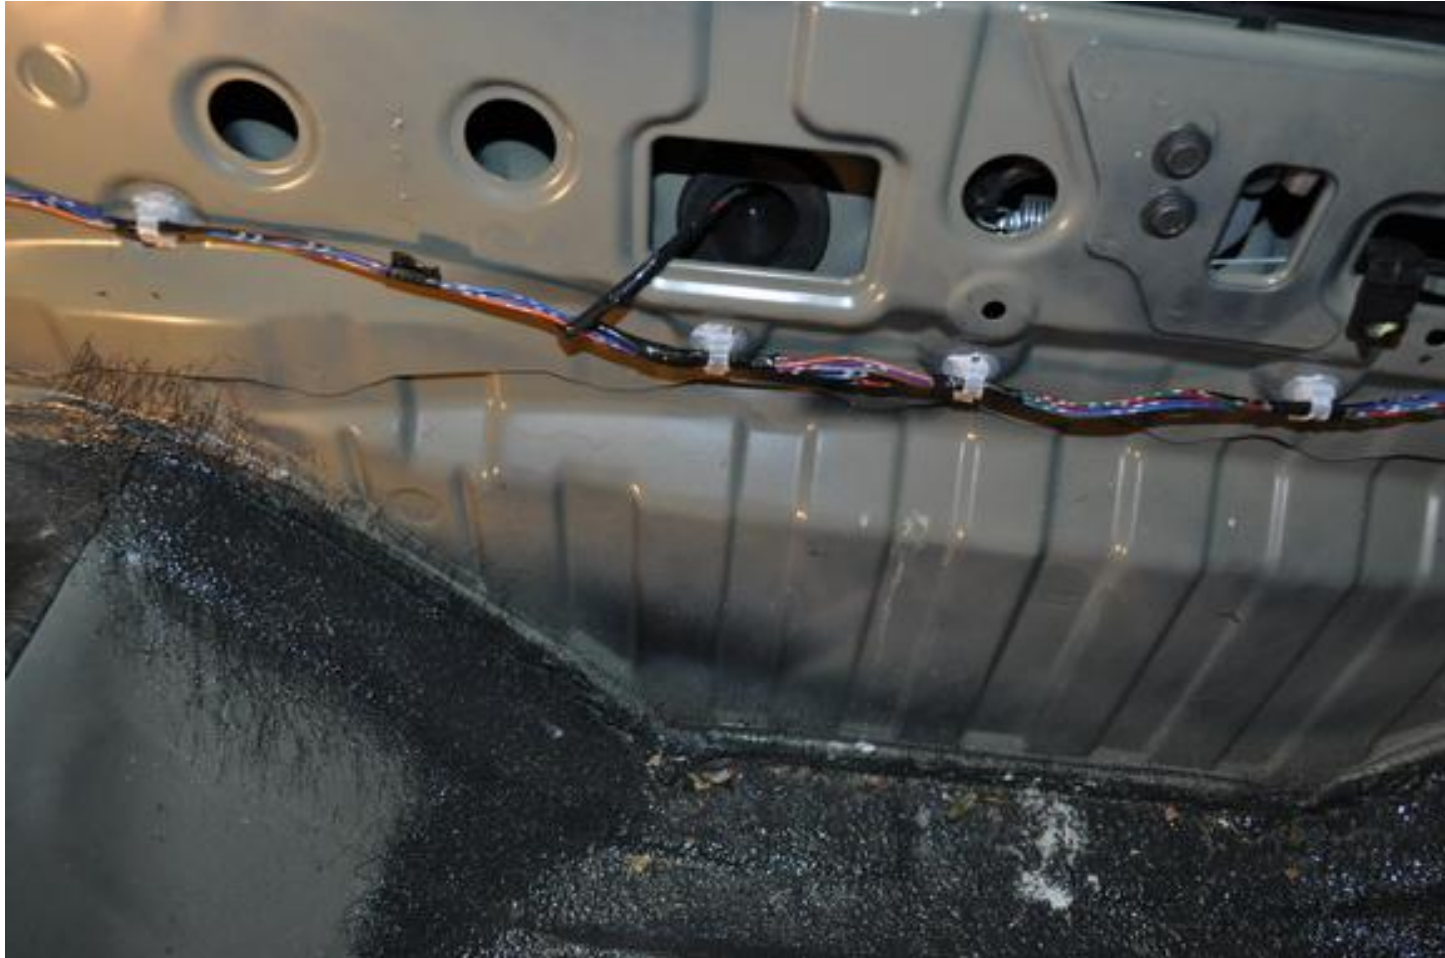
Rear body panel to trunk floor panel, excessive application of sprayable seam sealer.

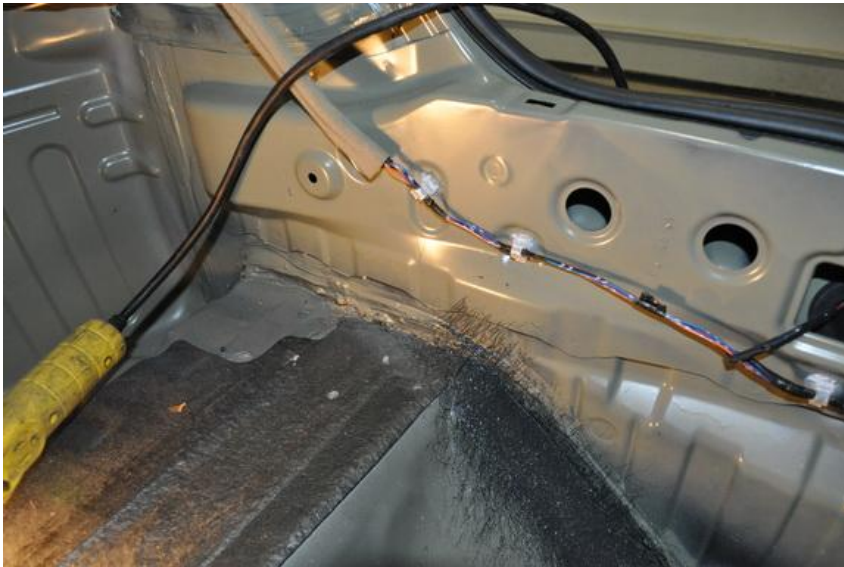
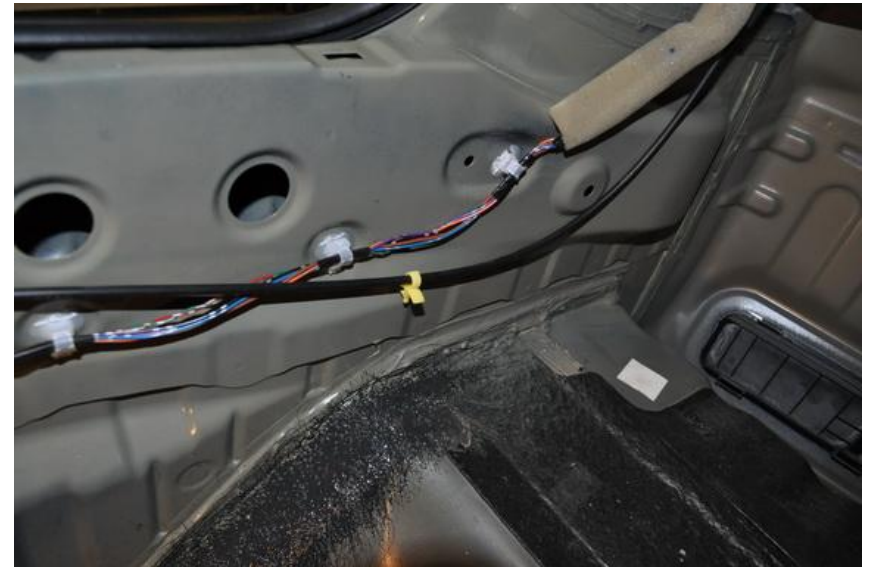
Rear body panel to trunk floor panel, excessive application of sprayable seam sealer.

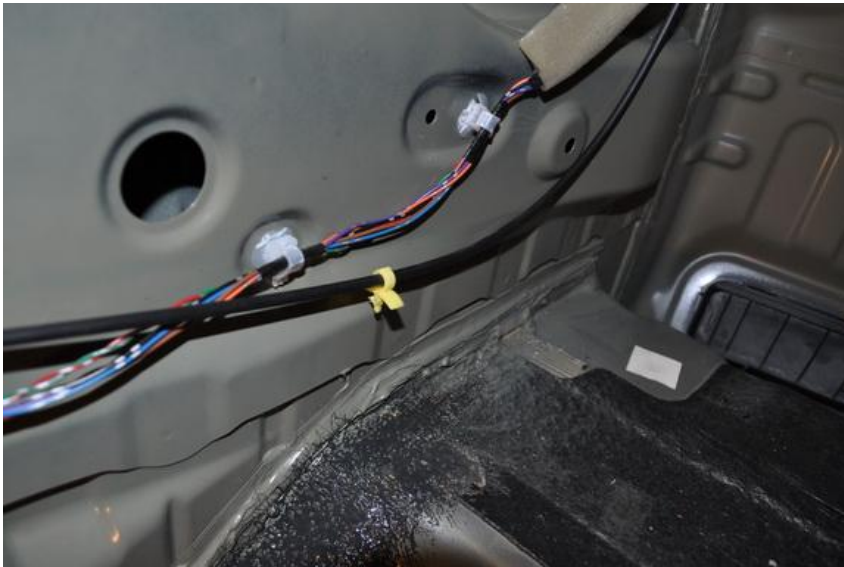
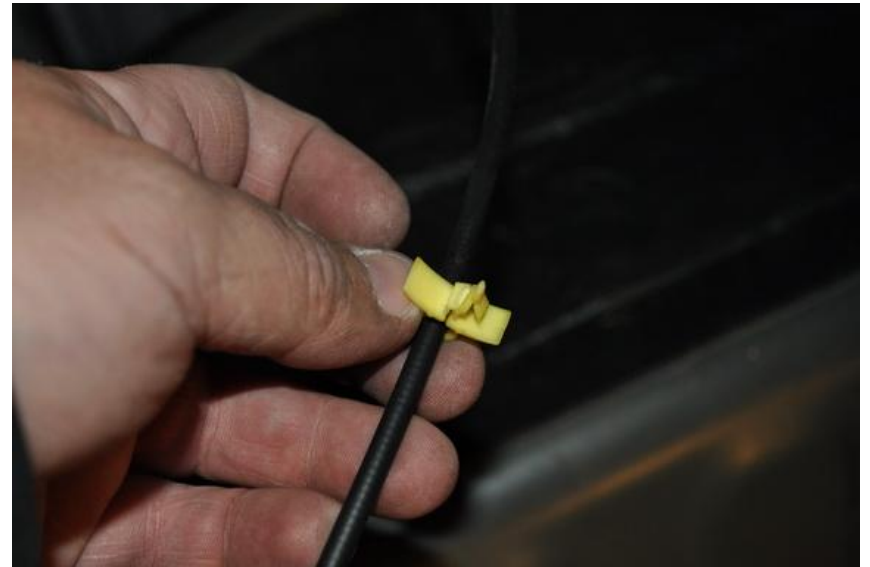
Left side remote deck lid release cable mounting clip, separated with missing tab.

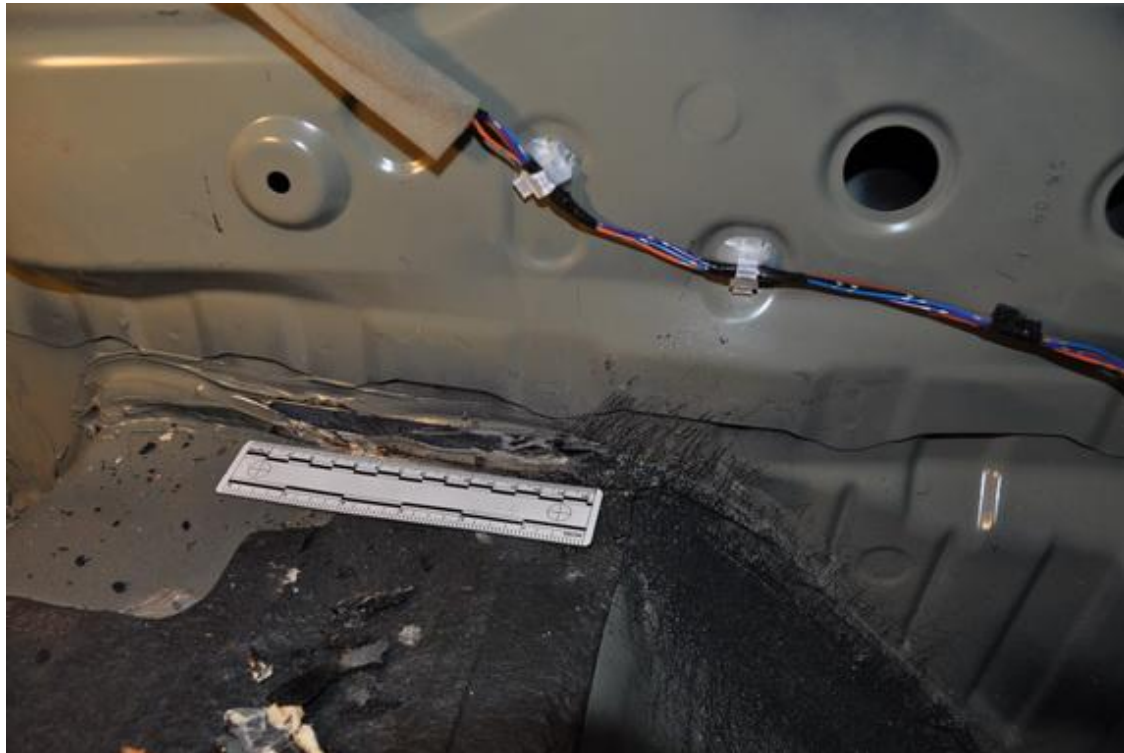
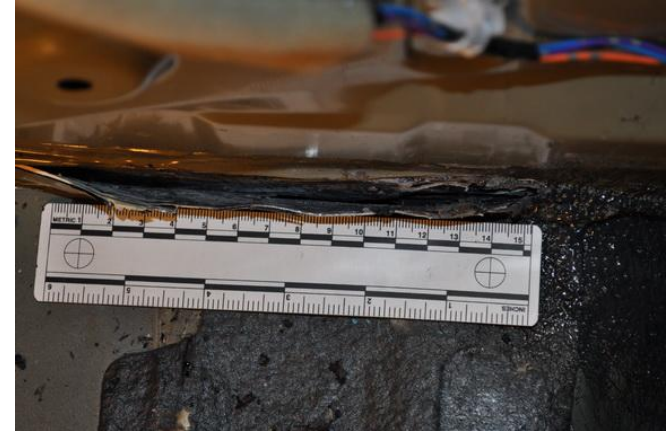
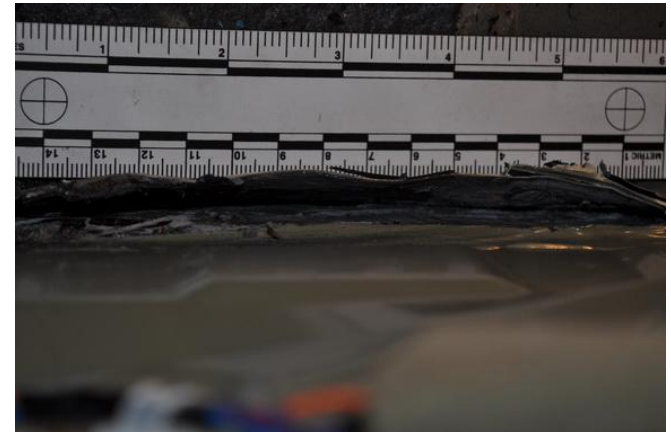
Right side of rear body panel to trunk floor,
indications of bonding adhesive applications and
no indications of resistance welds for 150mm.

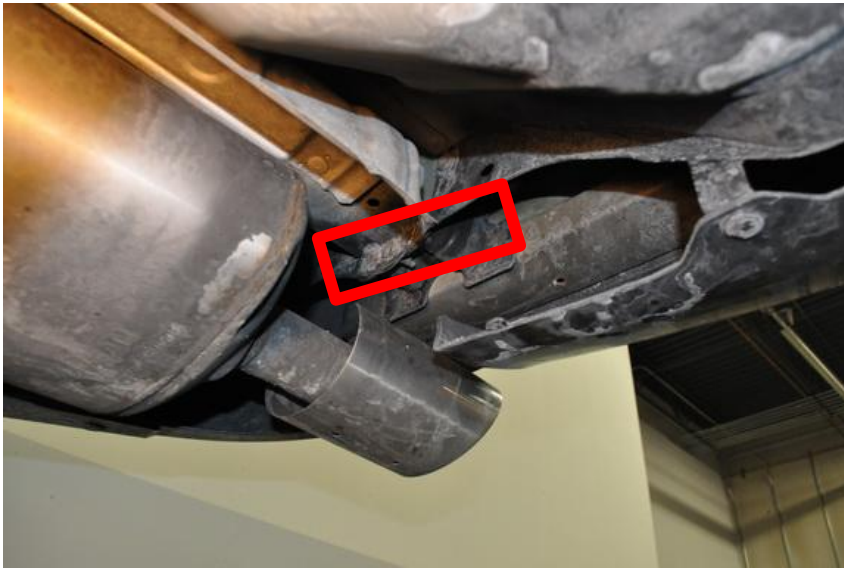
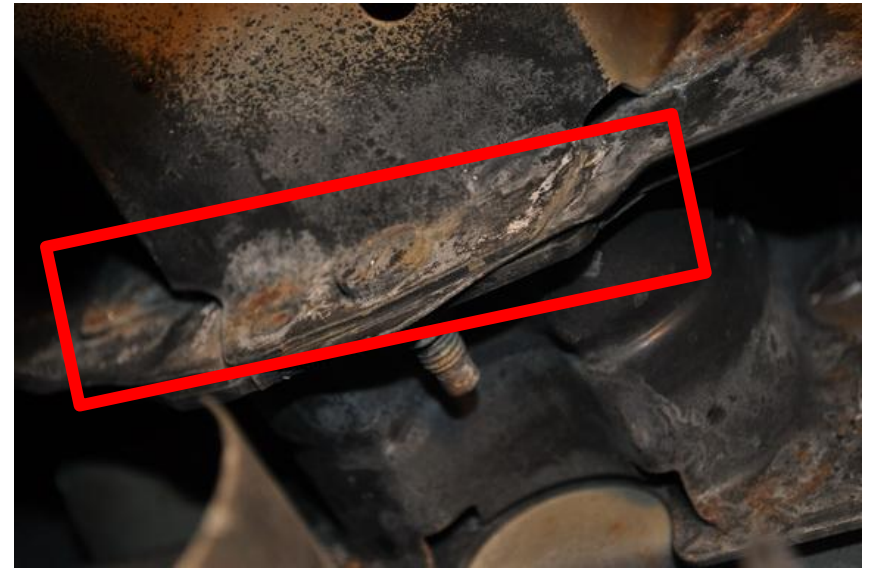
Right lower backside of rear body panel to right lower uni-rail (frame rail), indications of corrosion and lack of weld penetration (red boxes).

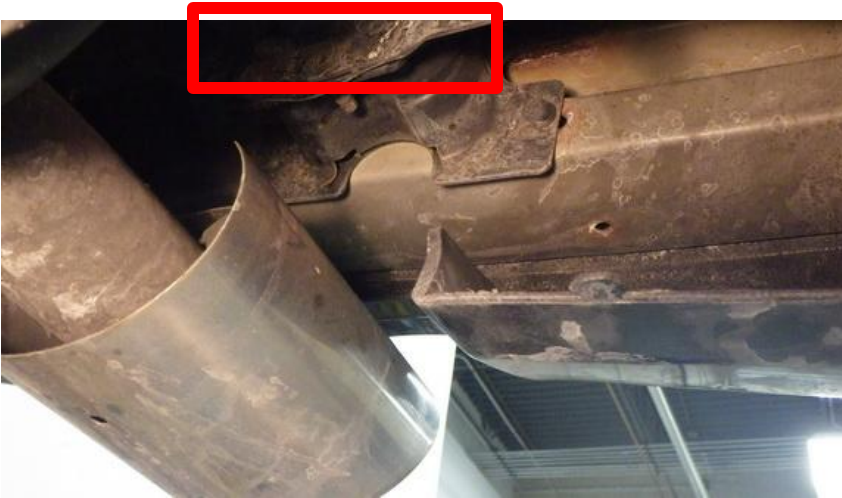
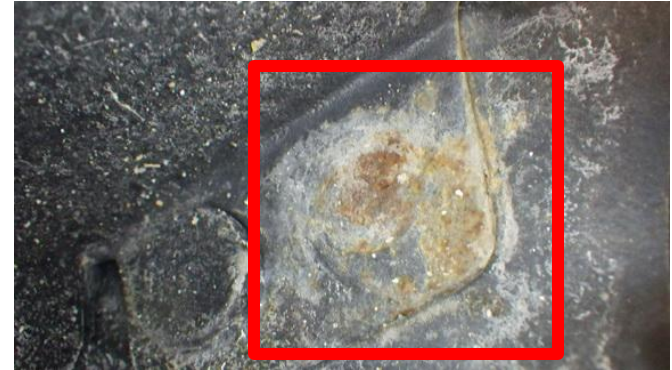
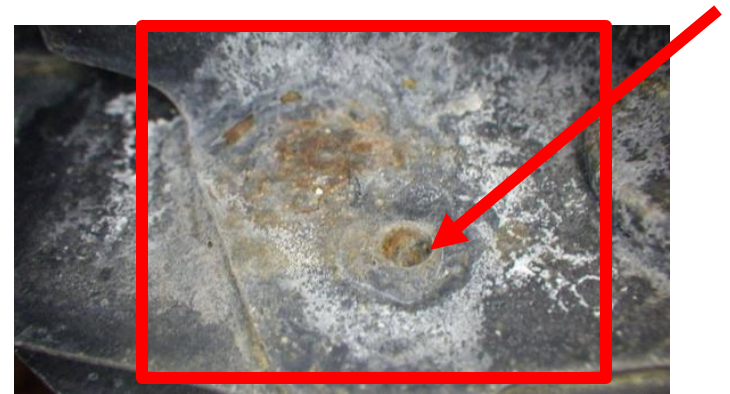
Right lower backside of rear body panel to lower uni-rail (frame rail), indications of corrosion, lack of weld penetration (red boxes) and a hole (red arrow).

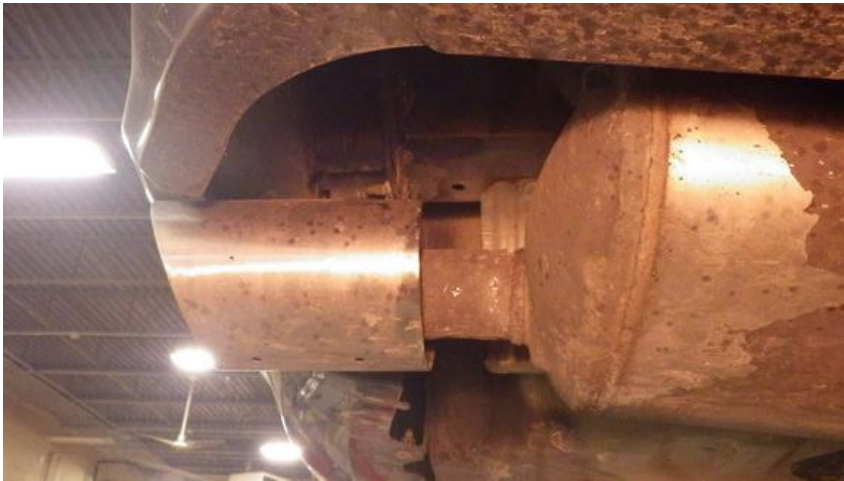
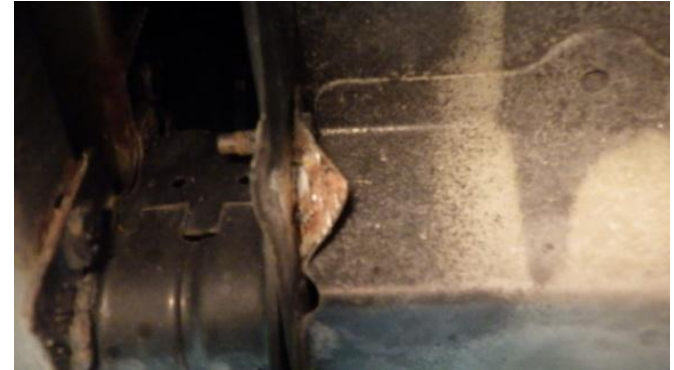
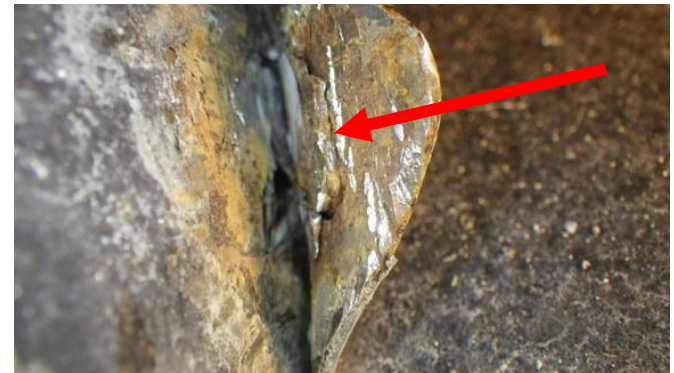
Right lower backside of rear body panel to right lower uni-rail (frame rail), destructive weld test failure, too small of a hole pulled (red arrow).

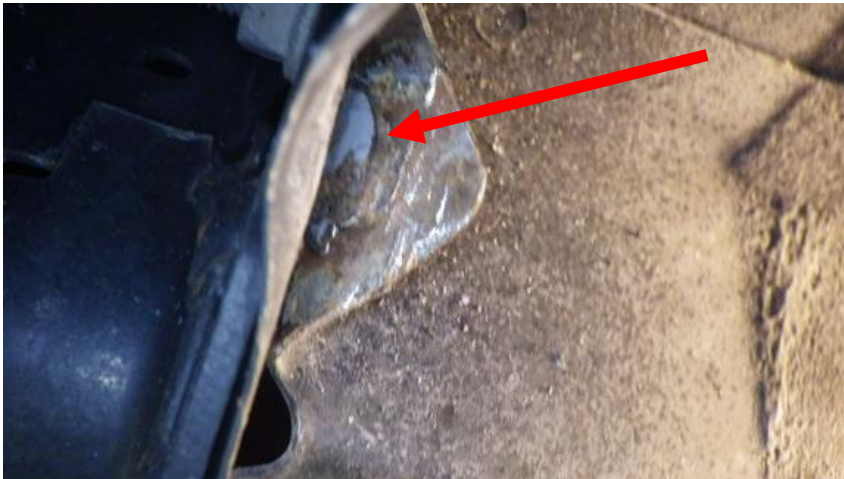
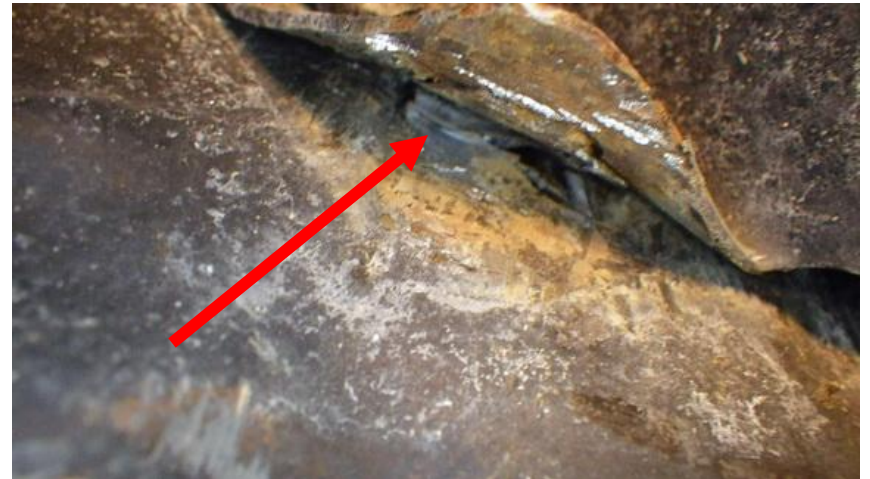
Right lower backside of rear body panel to right lower uni-rail (frame rail), destructive weld test failure, too small of a hole pulled (red arrows).

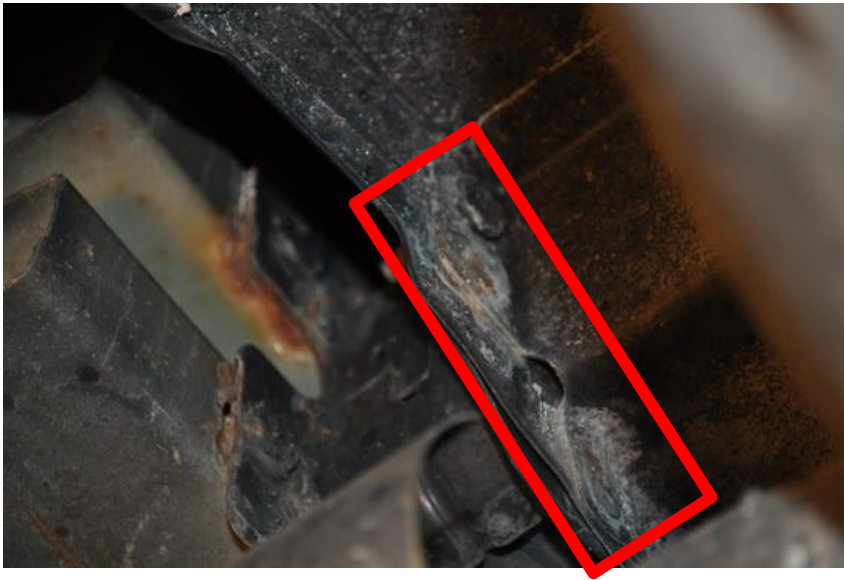
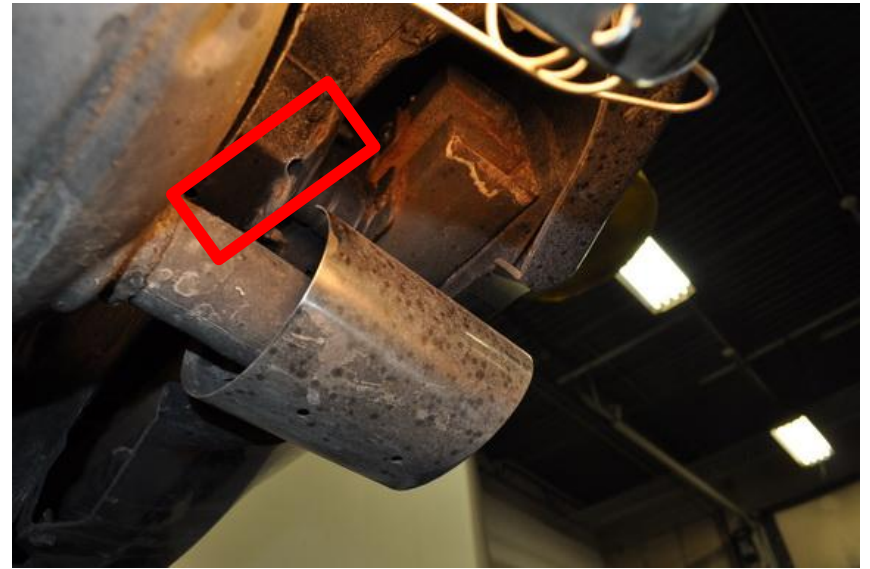
Left lower backside of rear body panel to left lower uni-rail (frame rail), indications of corrosion and lack of weld penetration (red boxes).

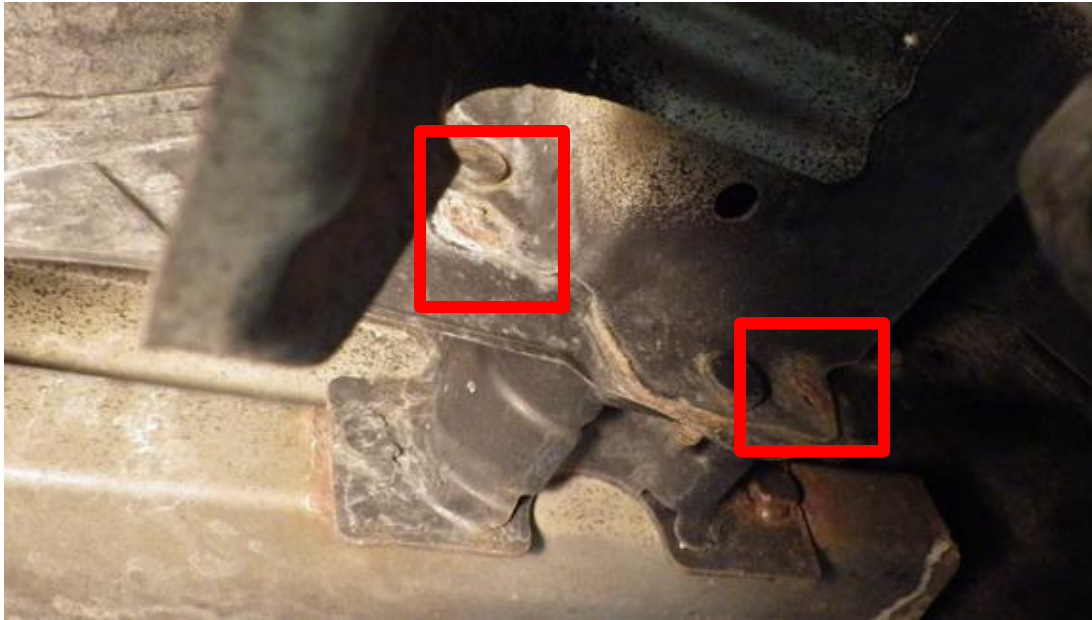
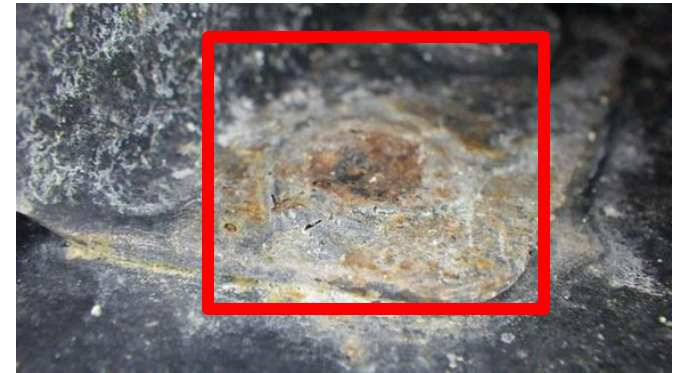
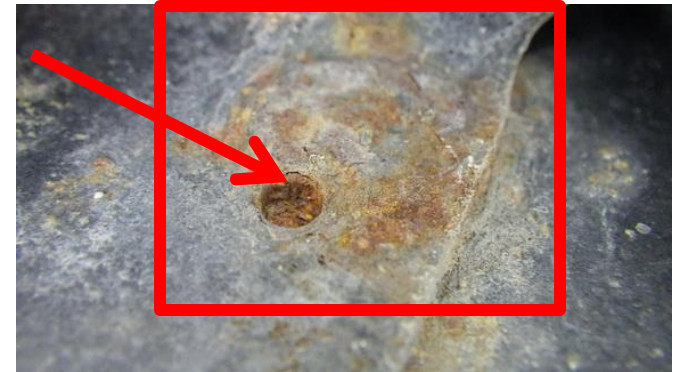
Left lower backside of rear body panel to lower uni-rail (frame rail), indications of corrosion, lack of weld penetration (red boxes) and a hole (red arrow).

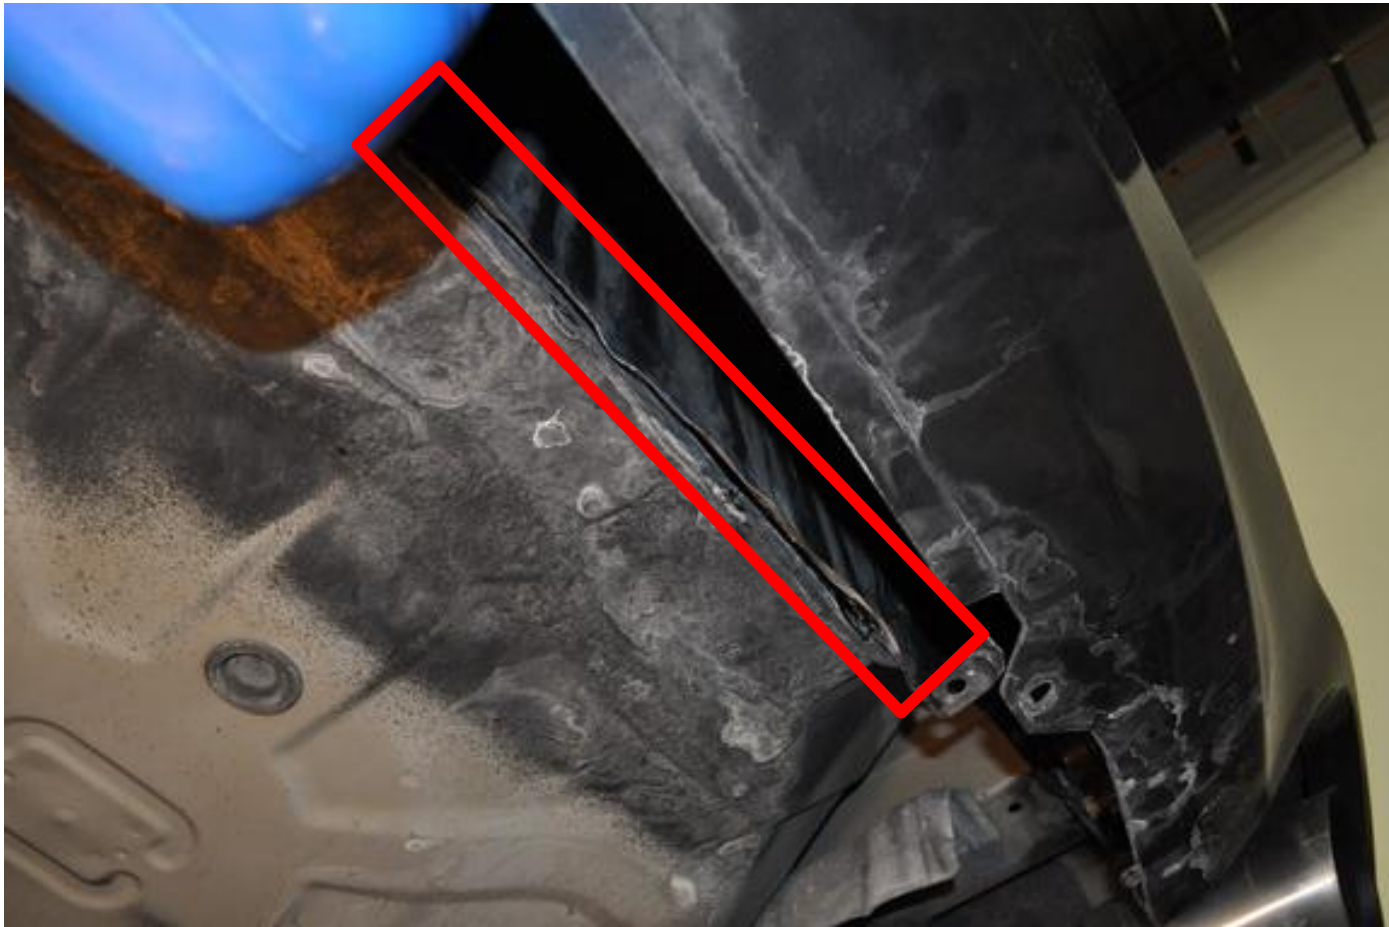
Rear body panel, with seam sealer removed.
Indications of rear body panel to trunk floor
mating flange separation (red box).
