Vehicle as examined

Vehicle Data

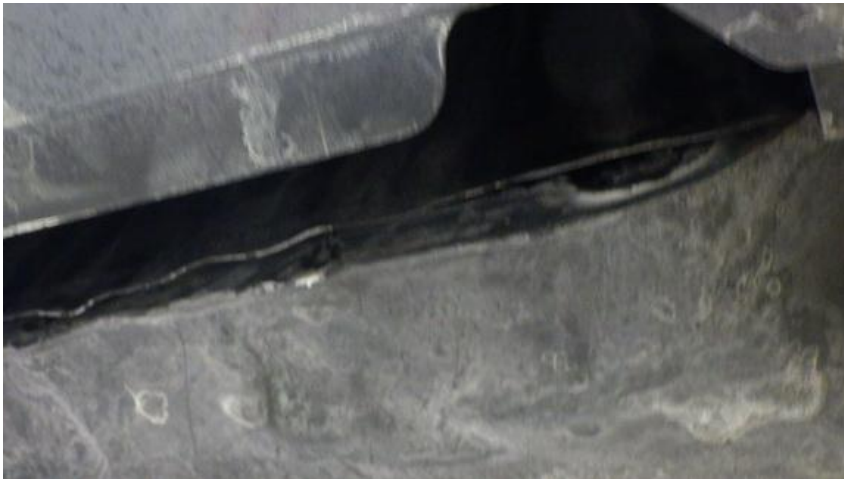
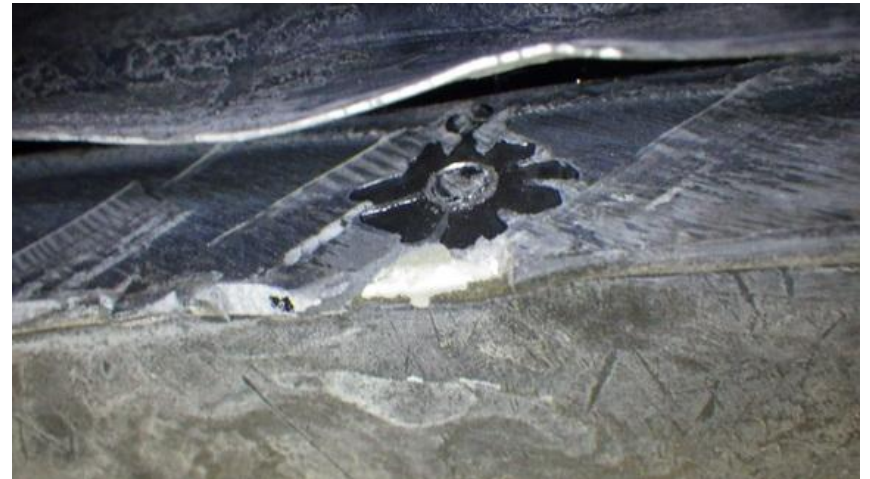
Rear body panel, with seam sealer removed.
Indications of bonding adhesive in the rear body
panel to trunk floor mating flange. Indications of
adhesion failure and drill holes.

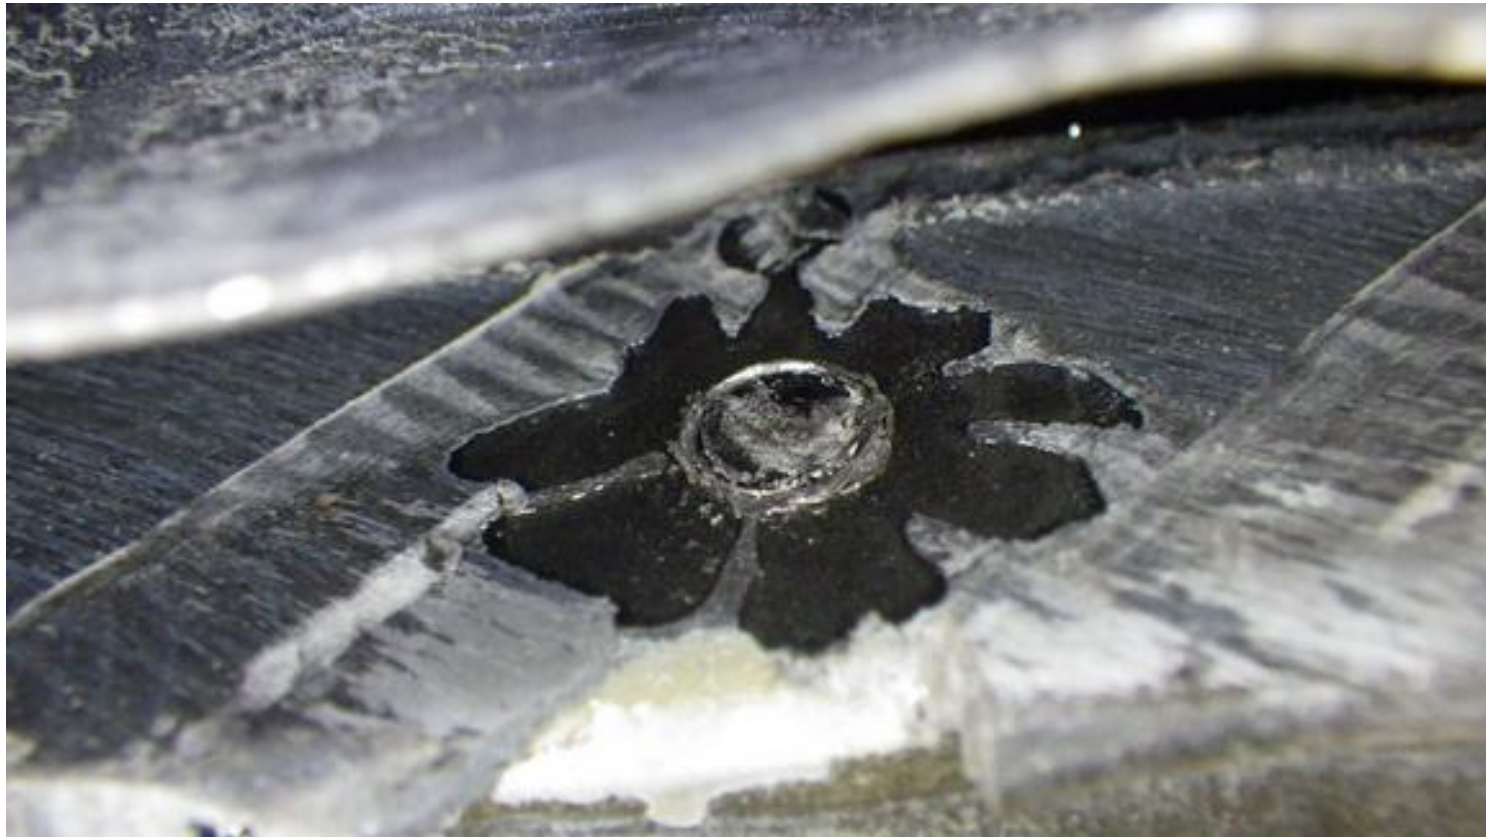
Rear body panel, with seam sealer removed.
Indications of bonding adhesive in the rear body
panel to trunk floor mating flange. Indications of
adhesion failure and drill holes.

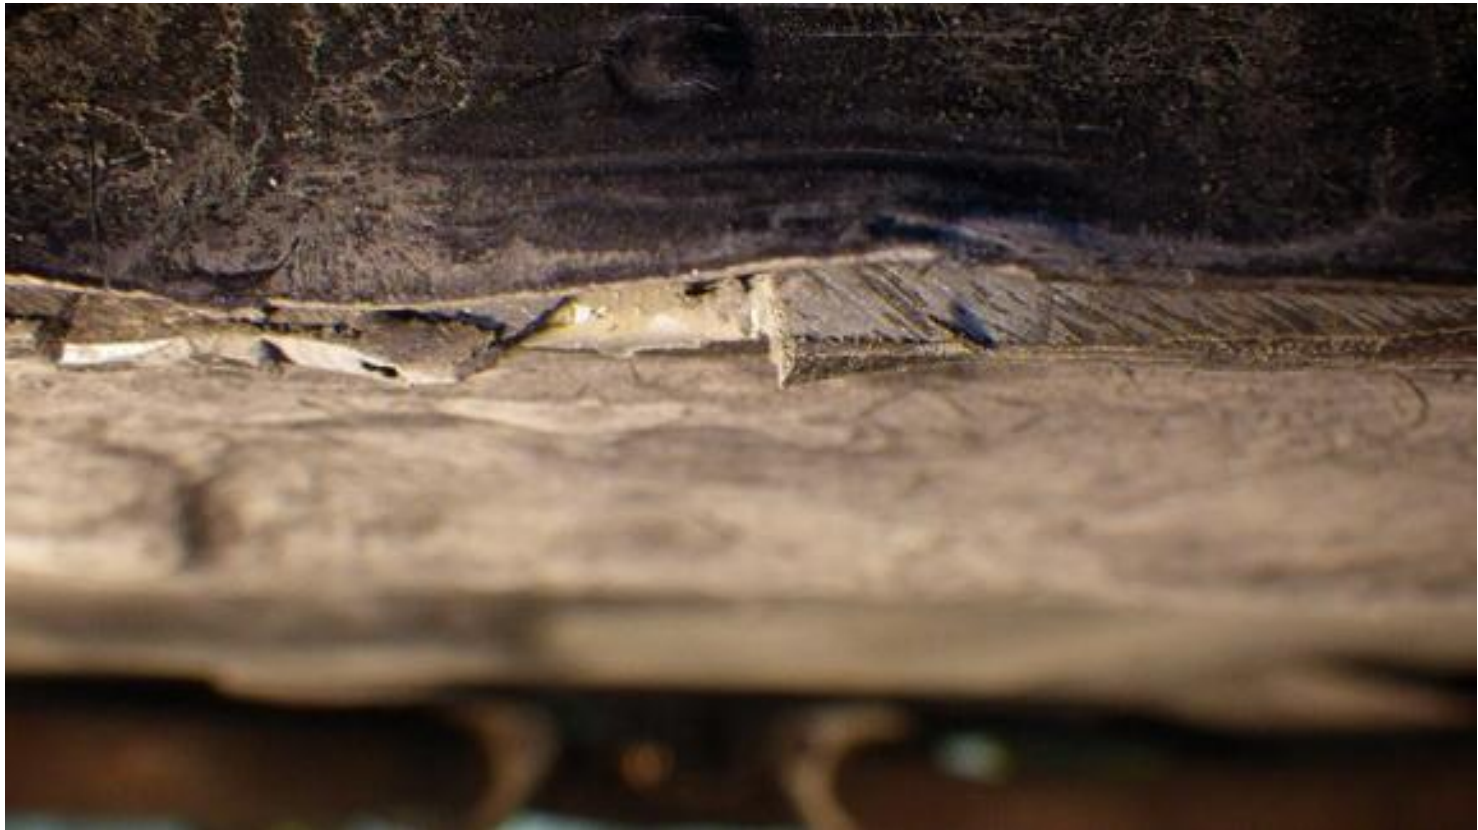
Rear body panel, with seam sealer removed.
Indications of bonding adhesive in the rear body
panel to trunk floor mating flange. Indications of
adhesion failure.

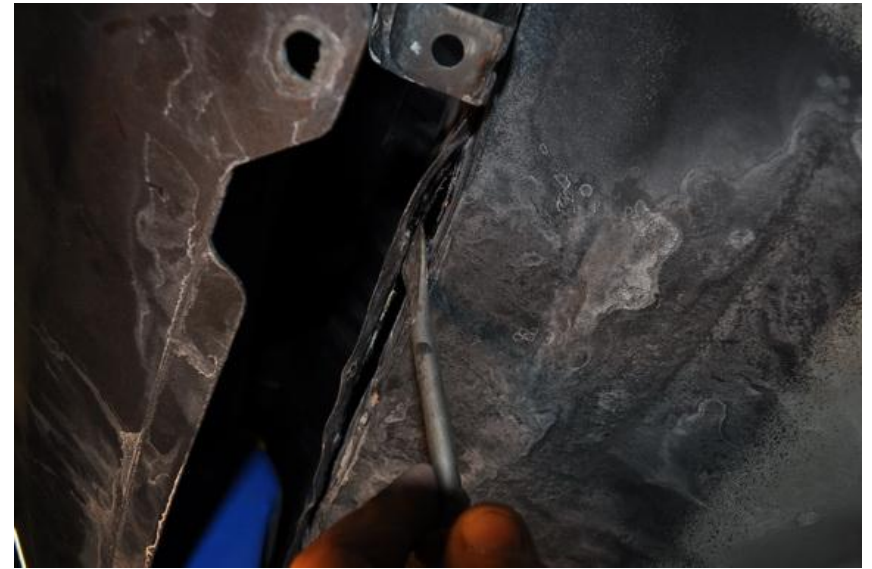
Application of a gasket scraper to the rear body panel to trunk floor mating flange. Light applications of force were applied and flange separated.

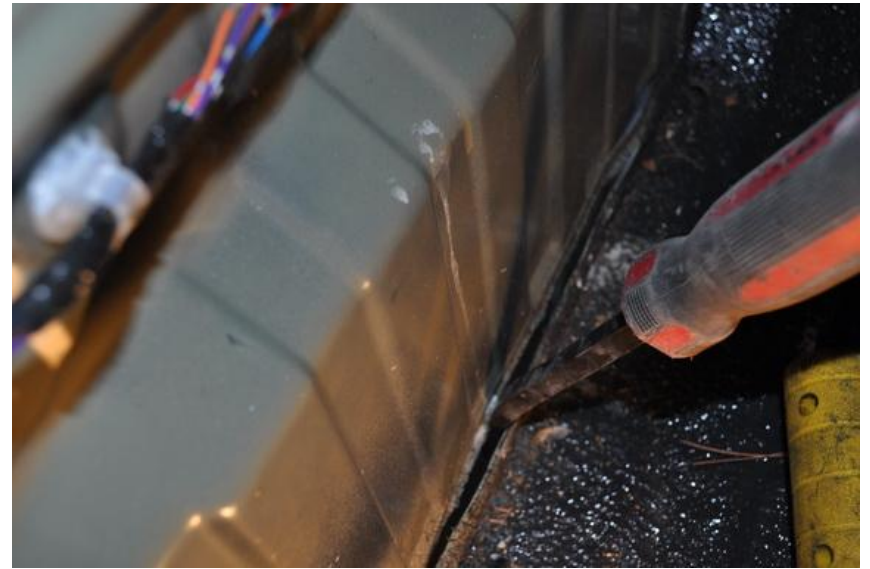
Pry bar placed in to the rear body panel to trunk floor mating flange, to show separation.
