Put Your Money Where Your Mouth is

**Todd Tracy
Dallas, Texas**

**Moderate Overlap Frontal Crashworthiness Evaluation
Crash Test Protocol (Version XVIII)**

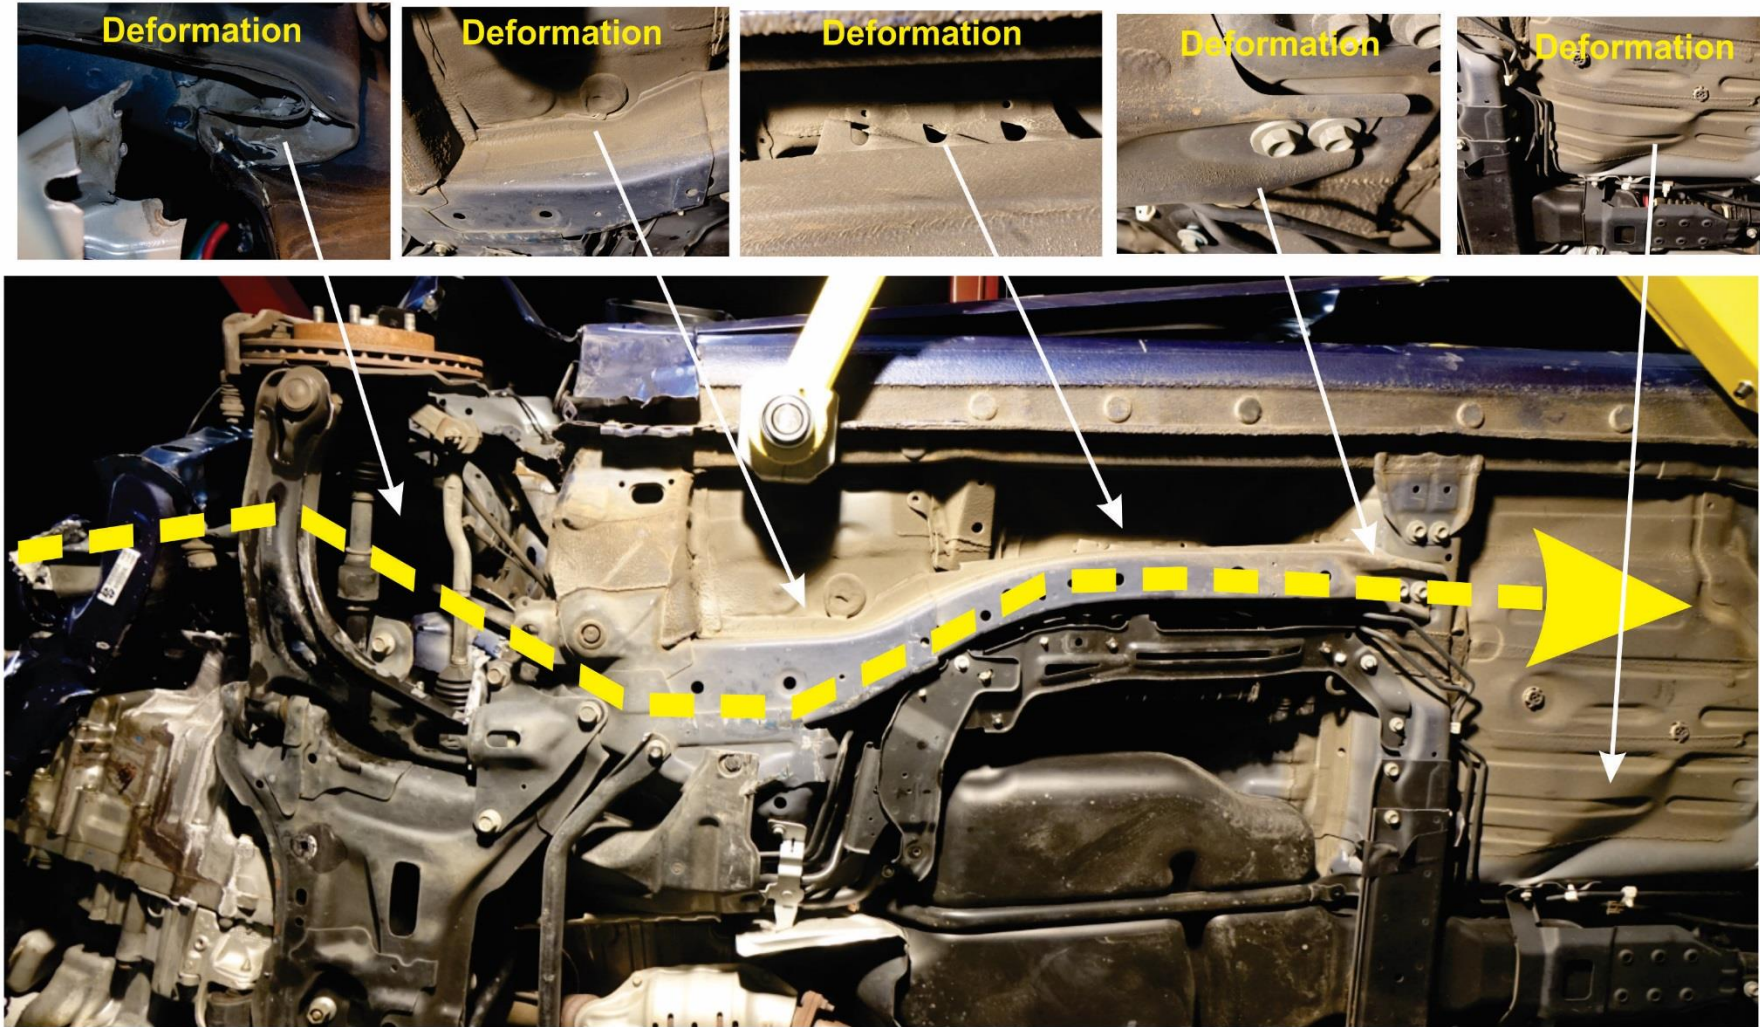
Aftermarket Parts

Structure
Underneath
the
occupants
caused
injurious
vertical
loads

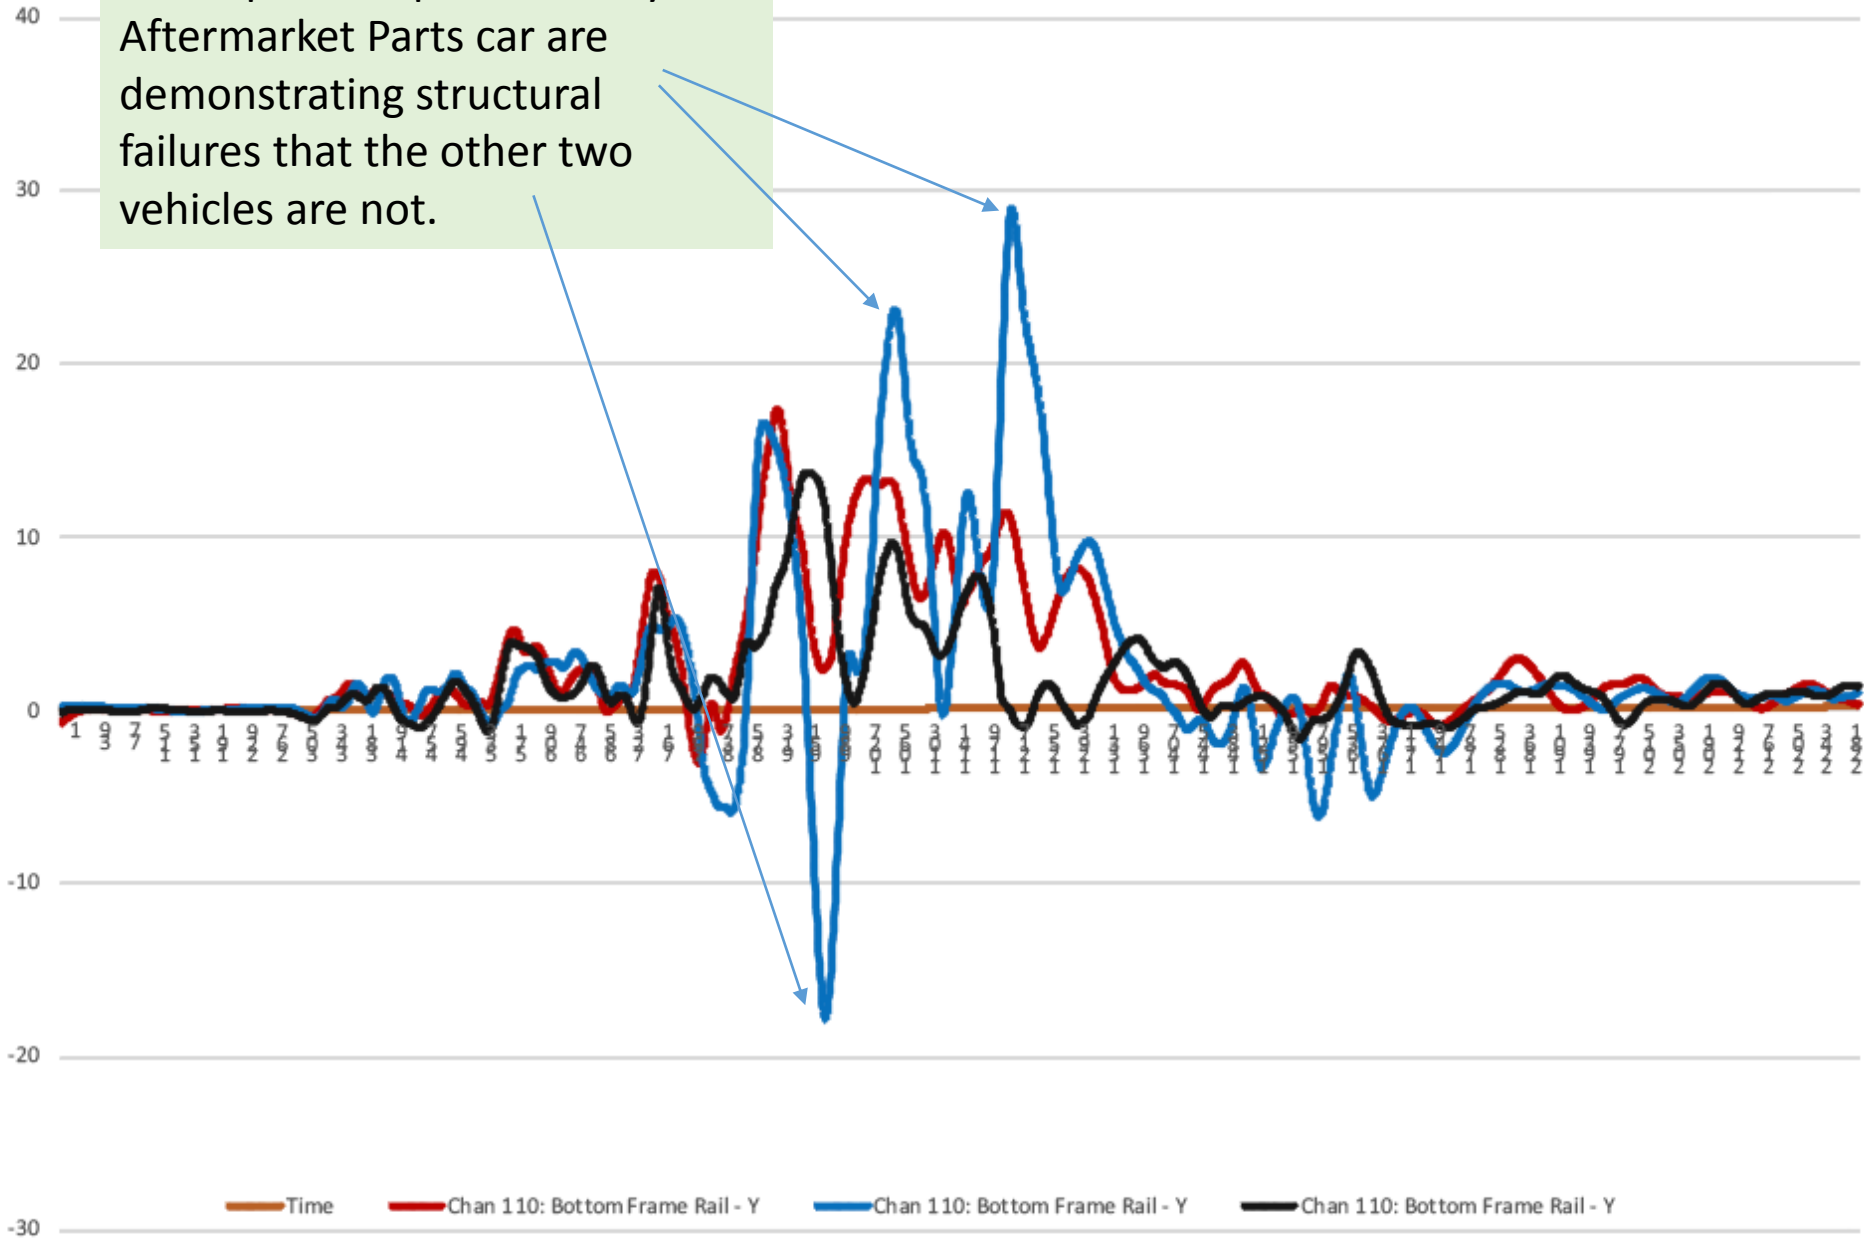
Bottom Frame Rail Sensor - Y

These peaks experienced by the Aftermarket Parts car are demonstrating structural failures that the other two vehicles are not.

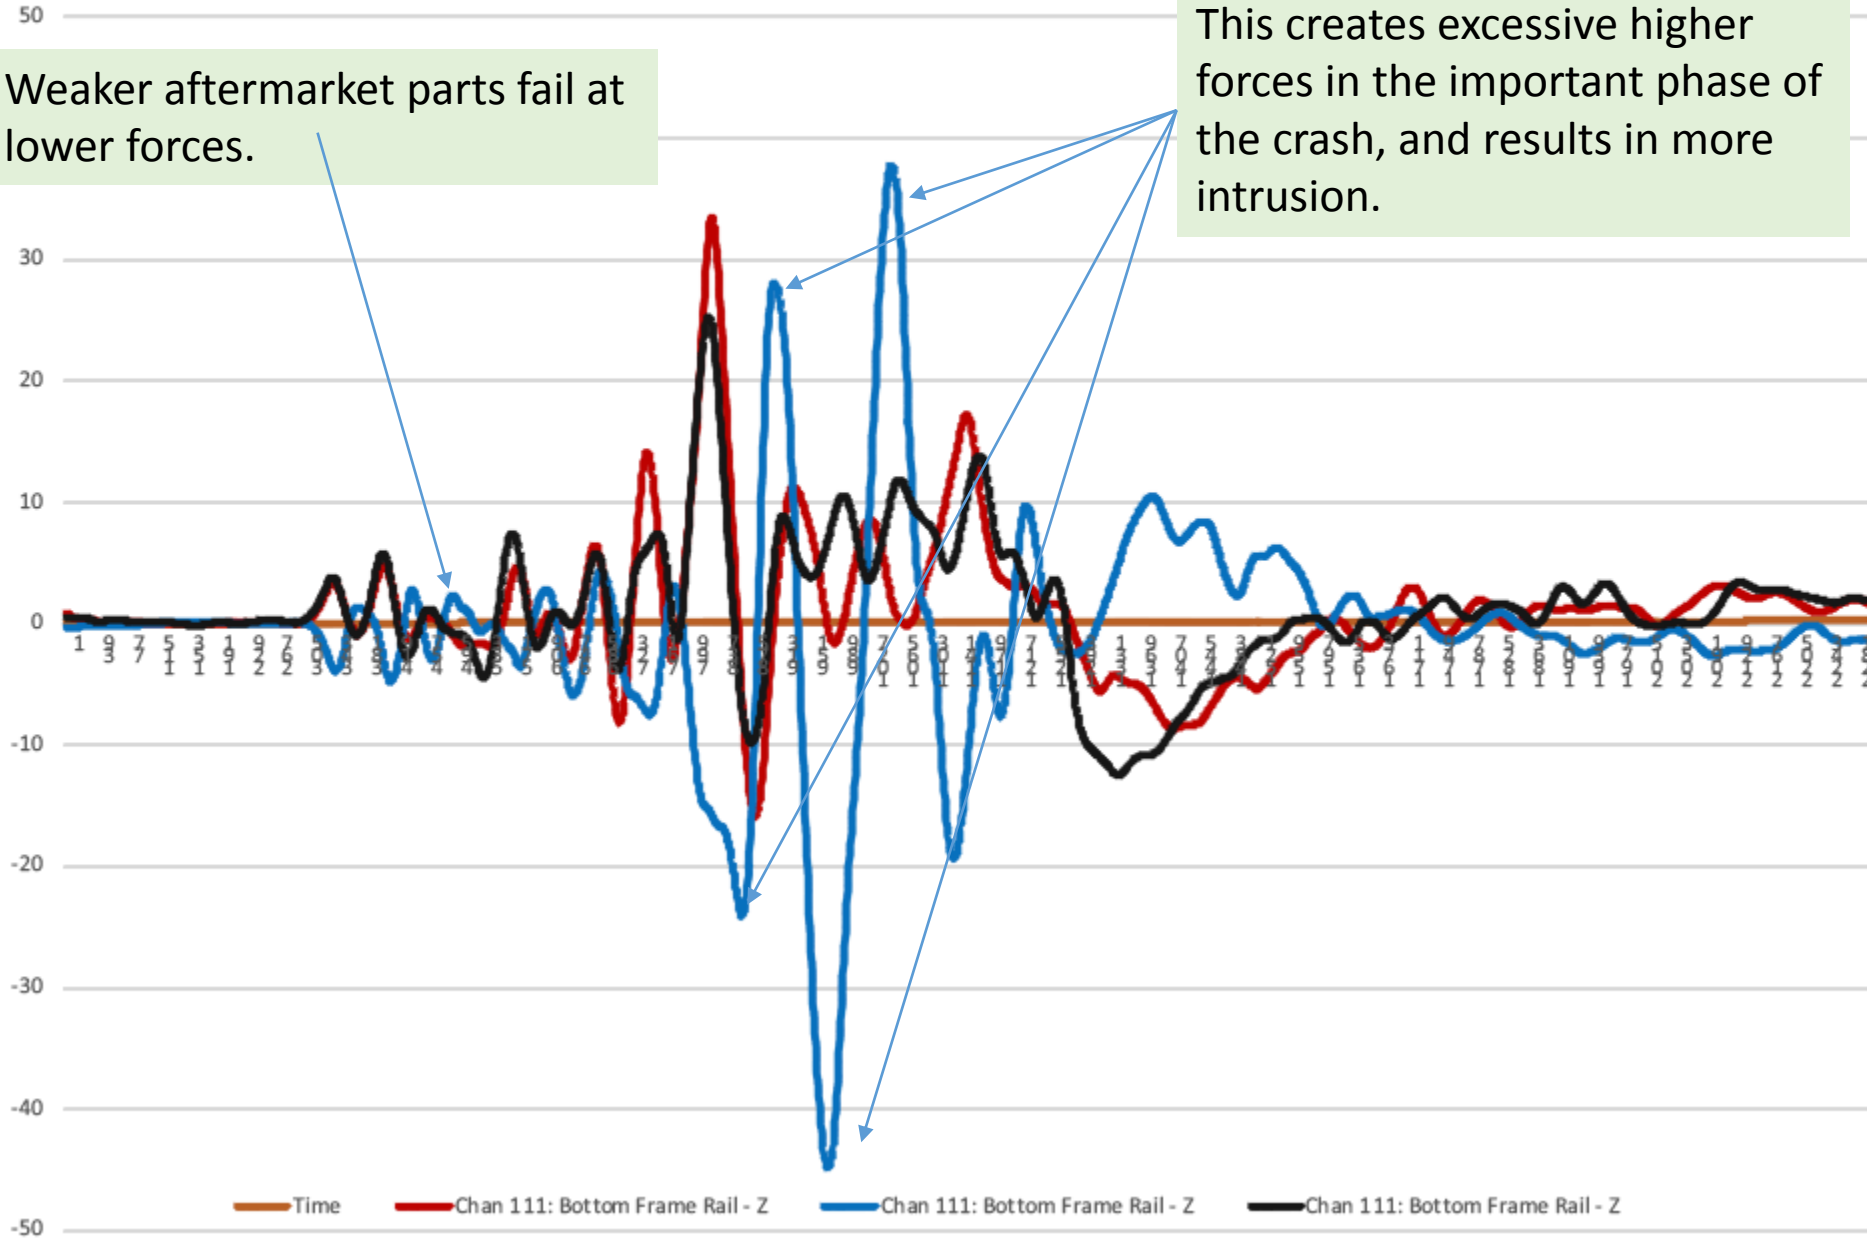
Bottom Frame Rail Sensor - Z

Weaker aftermarket parts fail at lower forces.

This creates excessive higher forces in the important phase of the crash, and results in more intrusion.

Frame buckled underneath the driver

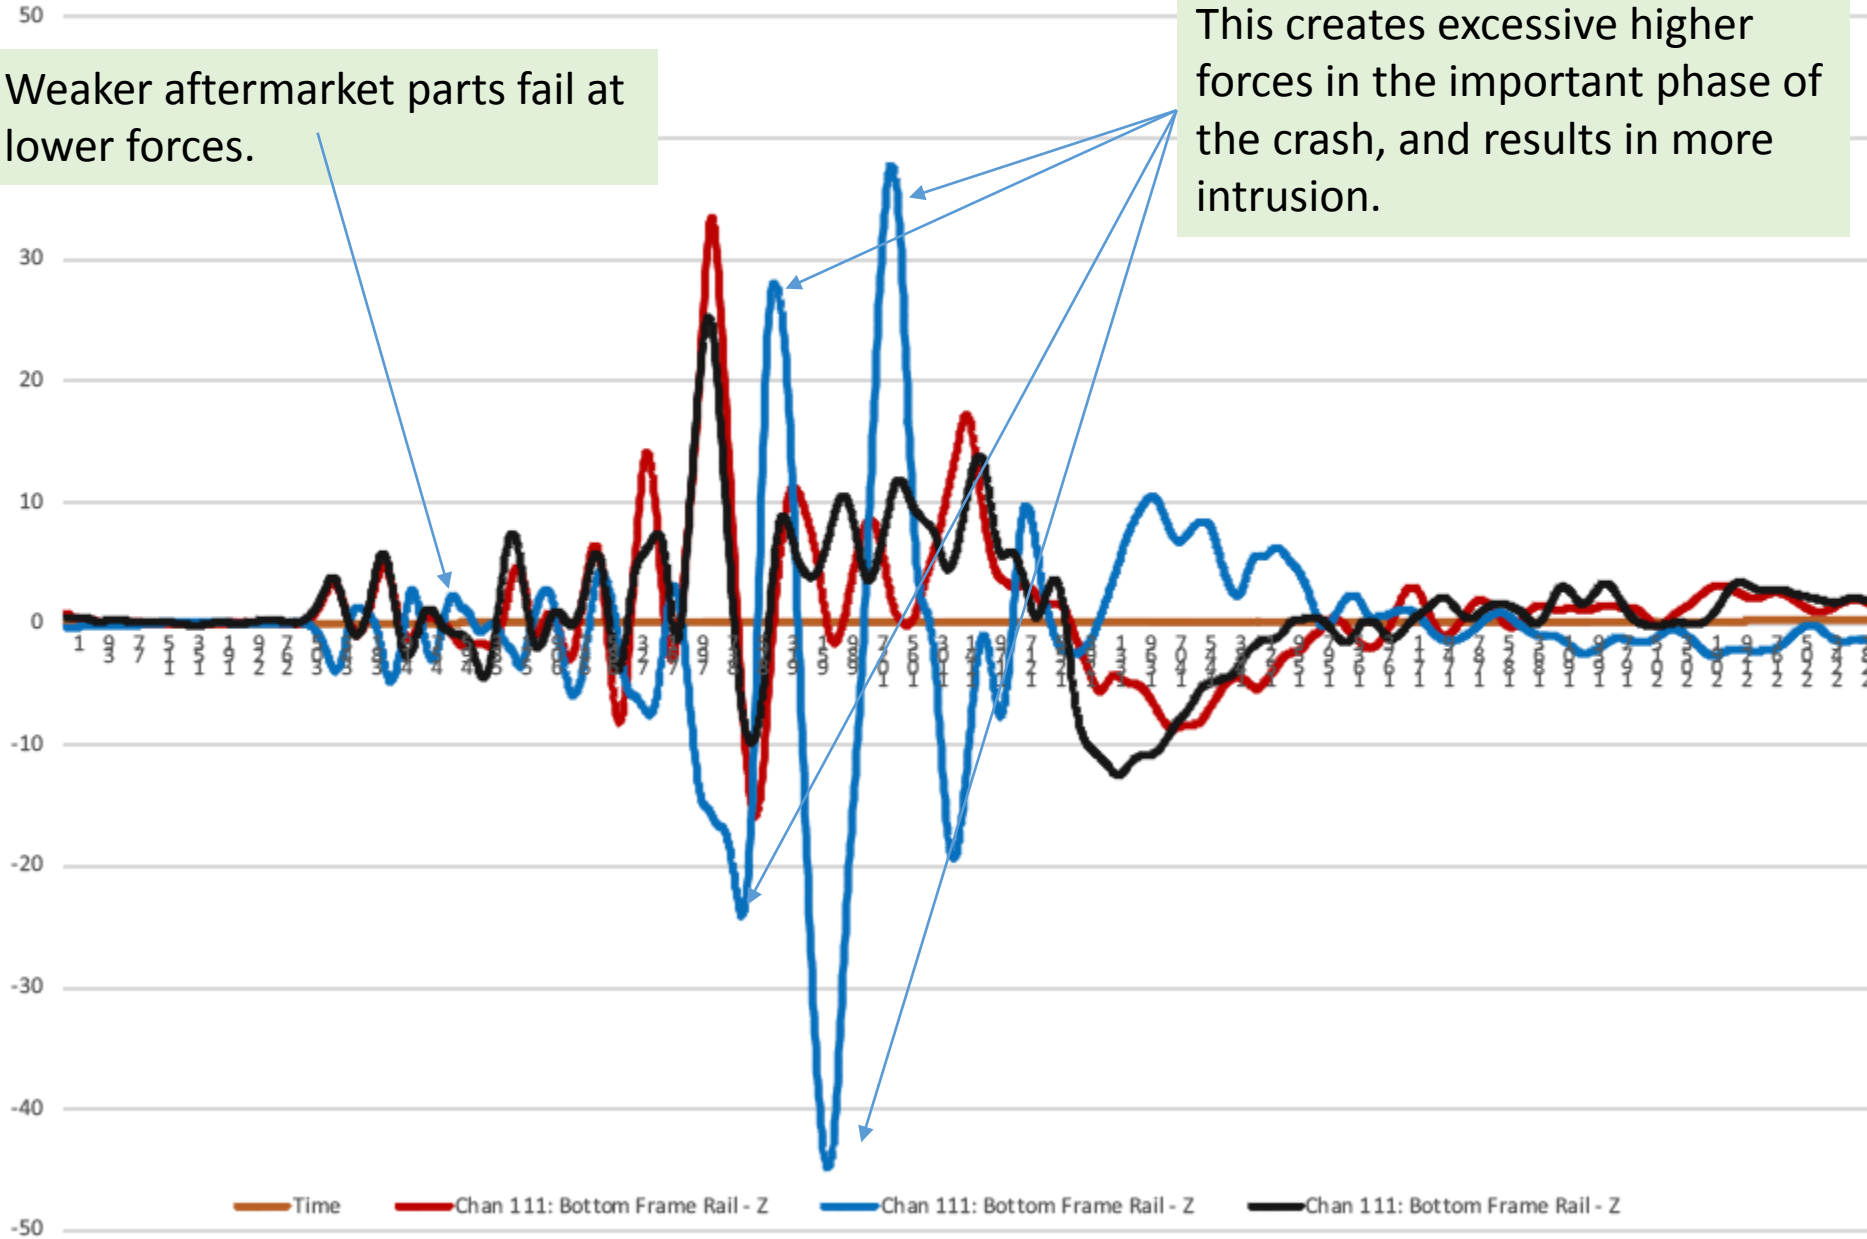
Bottom Frame Rail Sensor - Z

Weaker aftermarket parts fail at lower forces.

This creates excessive higher forces in the important phase of the crash, and results in more intrusion.

No frame damage underneath the driver

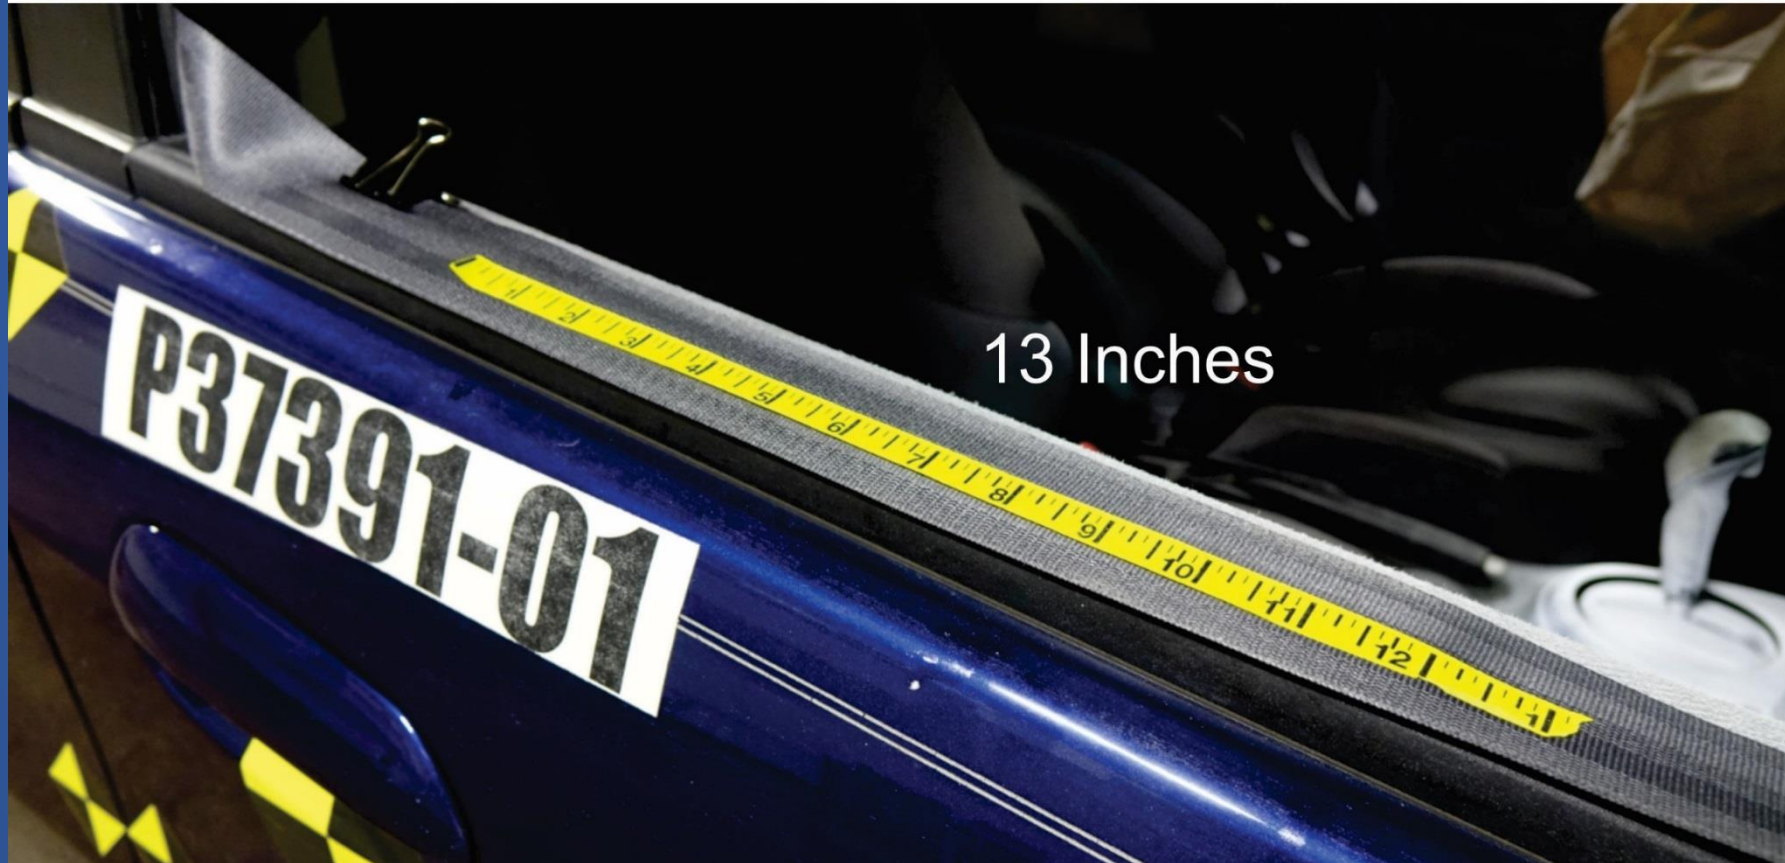
Aftermarket Parts

Excessive Frame Crush Affects Seatbelt Performance

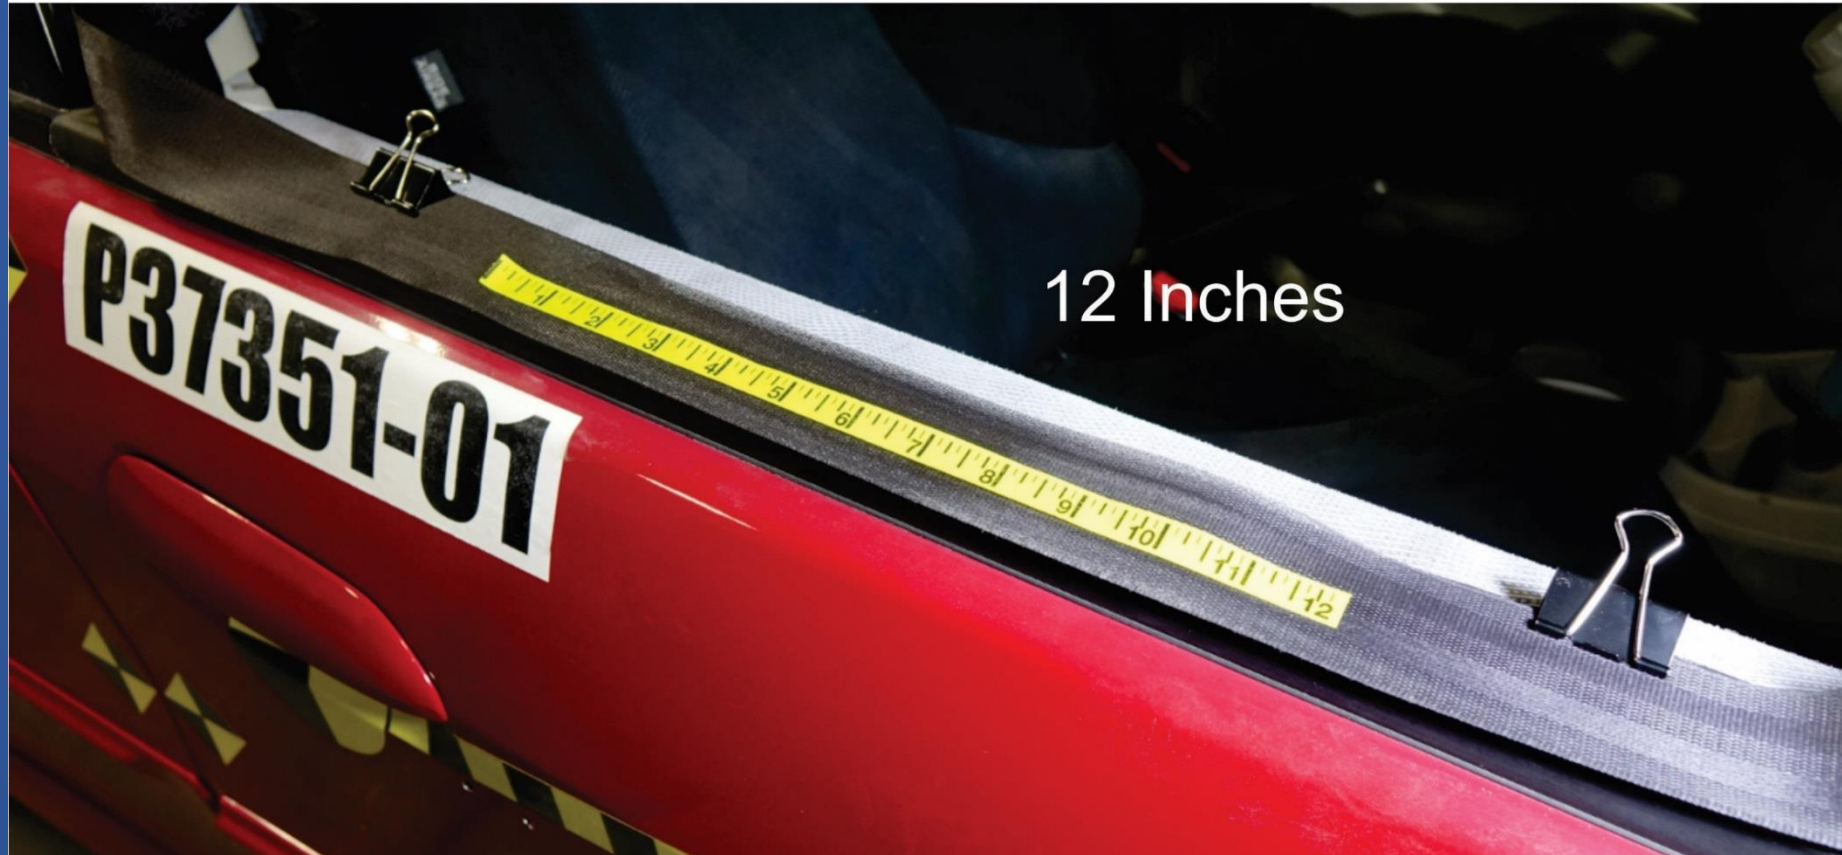
Roof Adhesive

Excessive Frame Crush Affects Seatbelt Performance

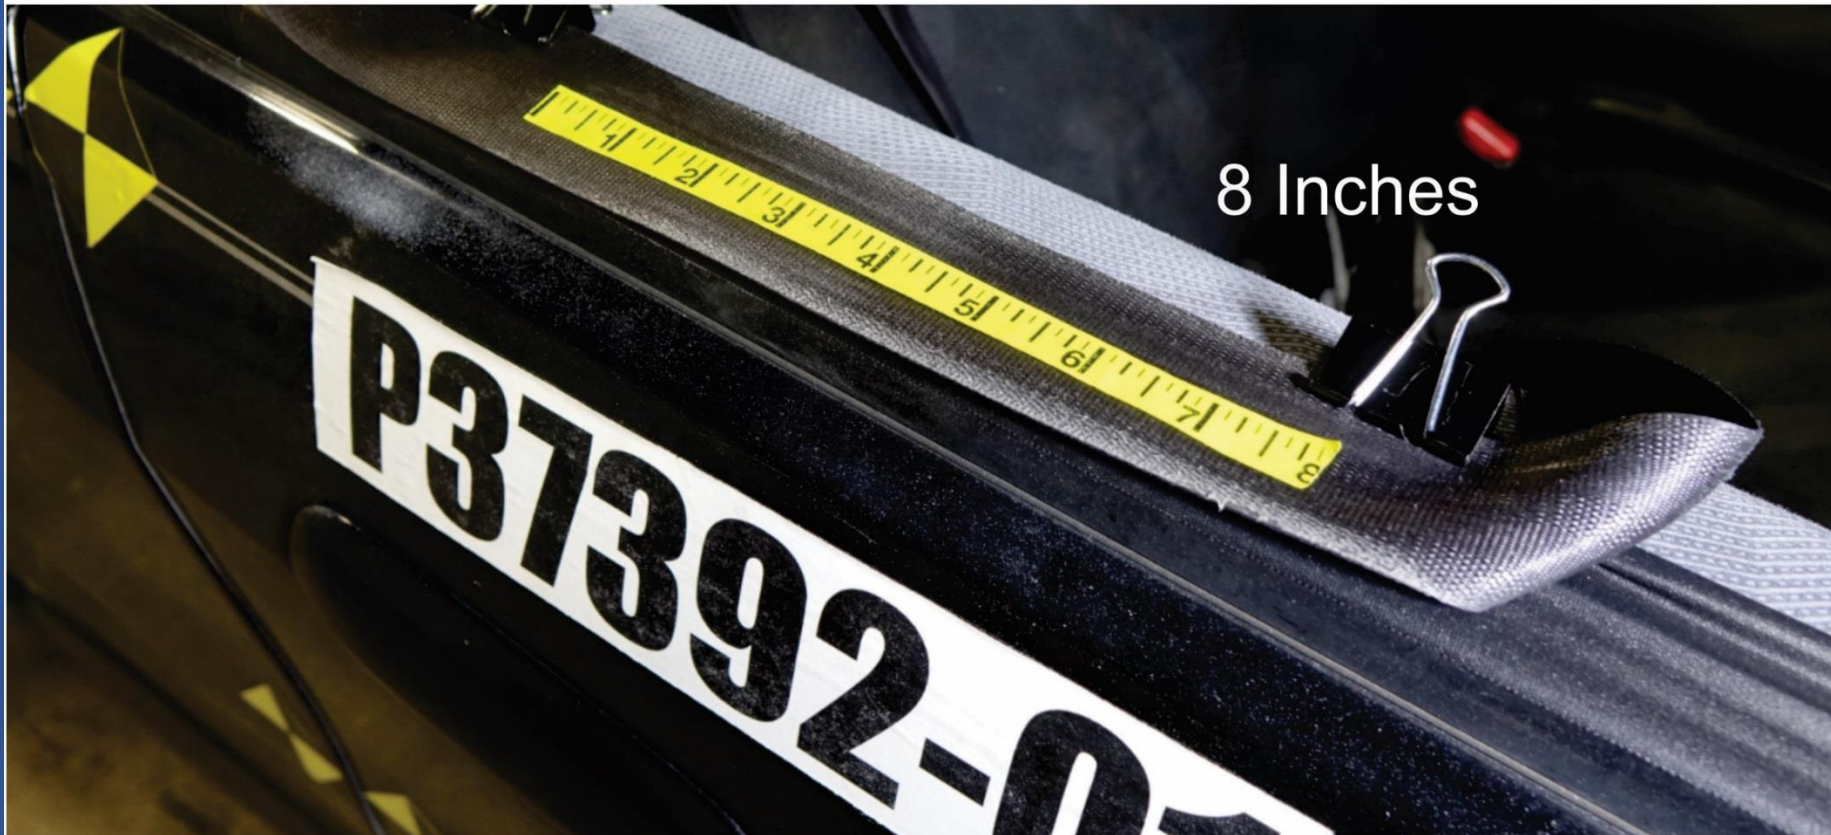
Honda OEM

When Safety Systems Work Together, The Seatbelt System Works More Efficiently

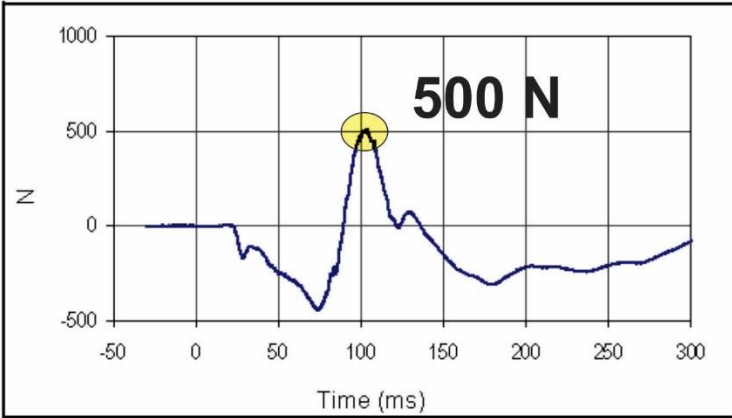
Roof Adhesive

Inadequate Repairs and Material Cause Neck Injury

Curve Description			
Driver Upper Neck Force X			
Plot No.		SAE Class	Units
009		1000	N
Max	Time	Min	Time
508.6	104.2	-444.0	74.3

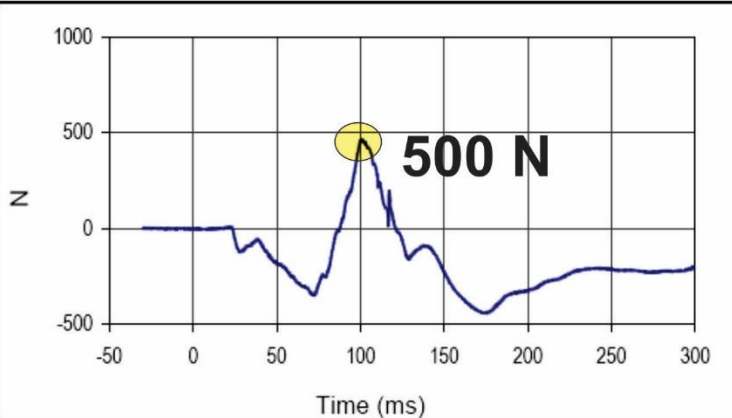
Aftermarket Parts

Curve Description			
Driver Upper Neck Force X			
Plot No.		SAE Class	Units
009		1000	N
Max	Time	Min	Time
465.7	101.4	-439.9	175.3

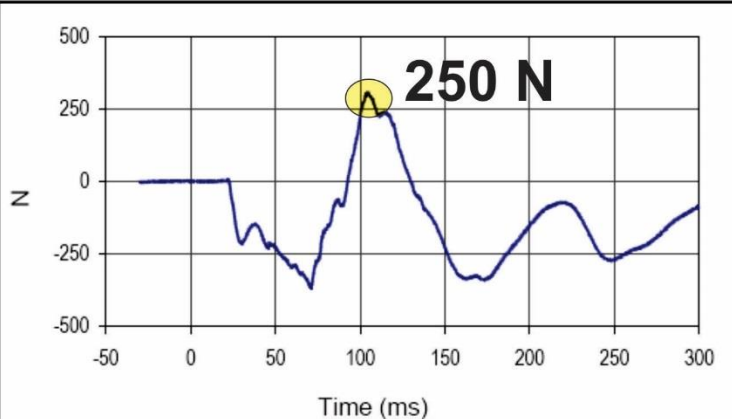
Honda OEM

Curve Description			
Driver Upper Neck Force X			
Plot No.		SAE Class	Units
009		1000	N
Max	Time	Min	Time
306.5	104.4	-370.5	71.1

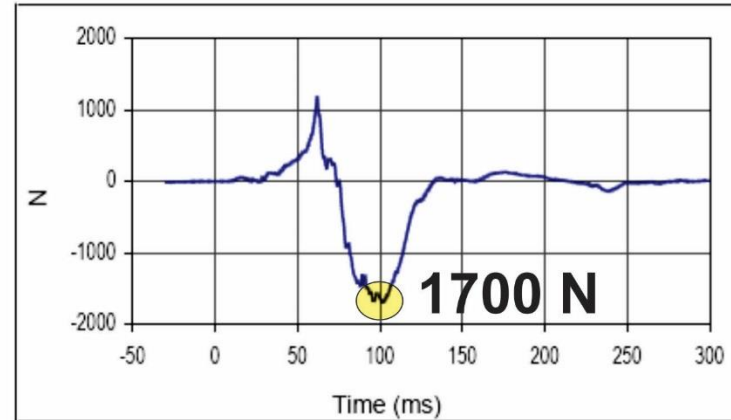
Aftermarket Parts

Curve Description			
Driver Left Femur Force Z			
Plot No.	SAE Class	Units	
033	600	N	
Max	Time	Min	Time
1178.6	61.9	-1685.4	101.4

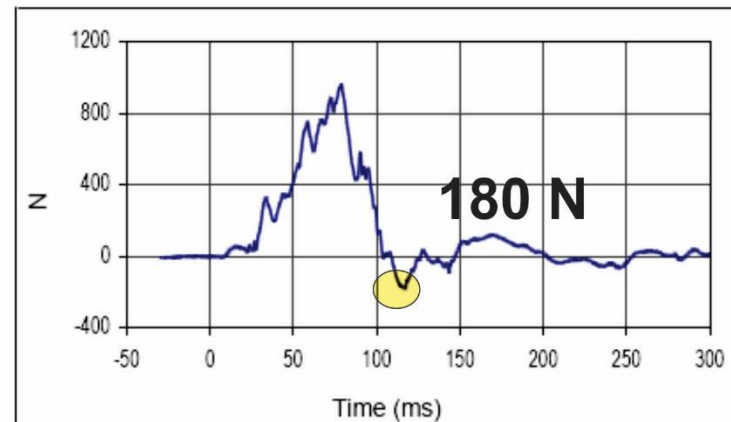
Honda OEM

Curve Description			
Driver Left Femur Force Z			
Plot No.	SAE Class	Units	
033	600	N	
Max	Time	Min	Time
960.8	78.8	-179.7	117.1

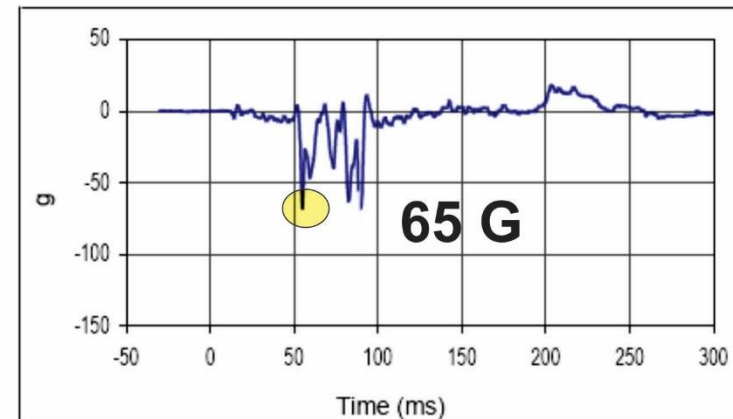
Honda OEM

Curve Description			
Driver Right Toe Acceleration Z			
Plot No.		SAE Class	Units
056		180	g
Max	Time	Min	Time
18.2	203.7	-102.1	89.3
