Service Update

N222387720 Outer Body Panel Split

Release Date: December 2022

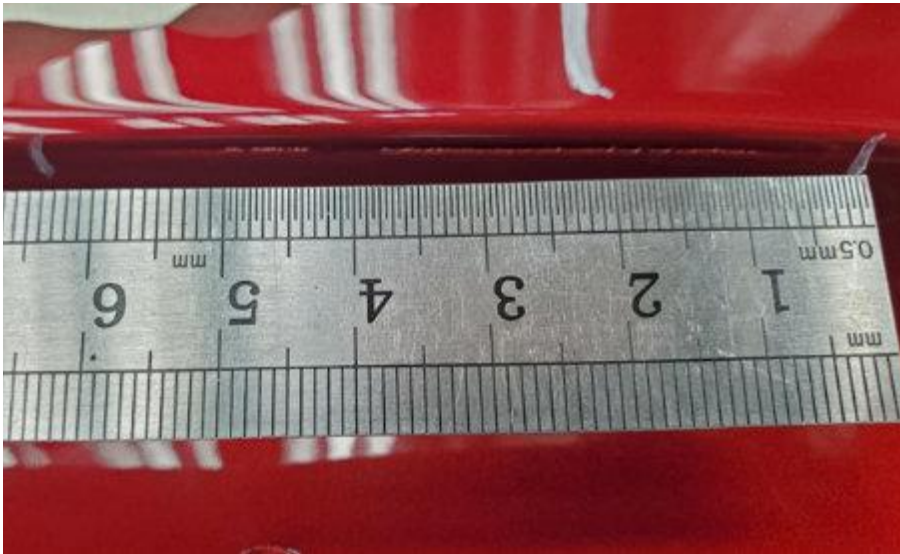
TIP: Use a flashlight to illuminate the area of inspection, the crack is in a recessed area of the sheet metal.

- Carefully inspect the area above the left quarter panel window for a cracking condition. This condition will be directly above the glass to body seal.
