2014 MDX: New Model Body Repair Information

DISCLAIMER: This publication contains a summary of new body and vehicle technology that may affect collision and other body repairs. Always refer to the appropriate service and body repair manuals for complete repair information. A subscription may be purchased at: techinfo.acura.com

OVERVIEW OF BODY FEATURES

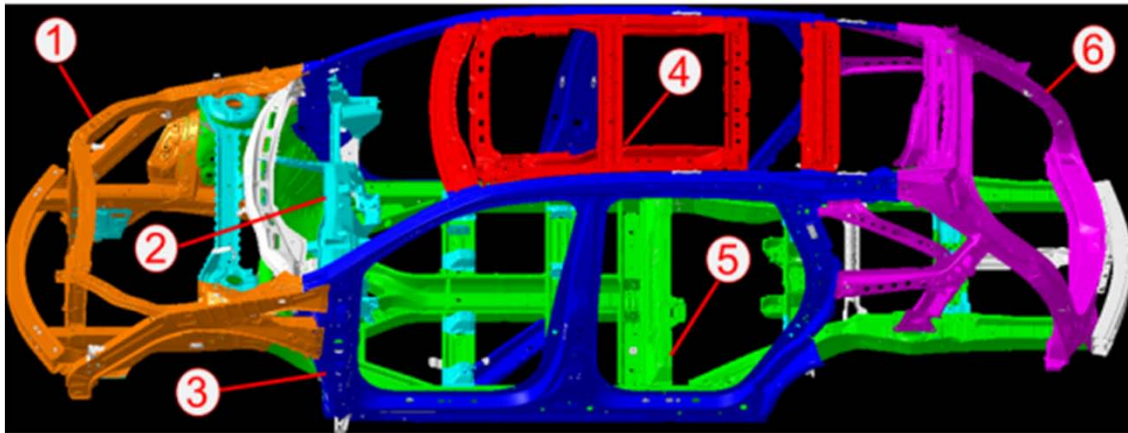
1. Next-Generation Advanced Compatibility Engineering™ (ACE™) body structure.
2. Rigid magnesium steering hanger beam mounts steering column and dashboard components.
3. Reinforced cabin with 1,500 MPa one-piece front door outer stiffener rings.
4. Reinforced roof structure.
5. New “3-Bone” platform with additional stiffeners.
6. Rigid tailgate opening ring with structural foam bulkheads applied at four locations.

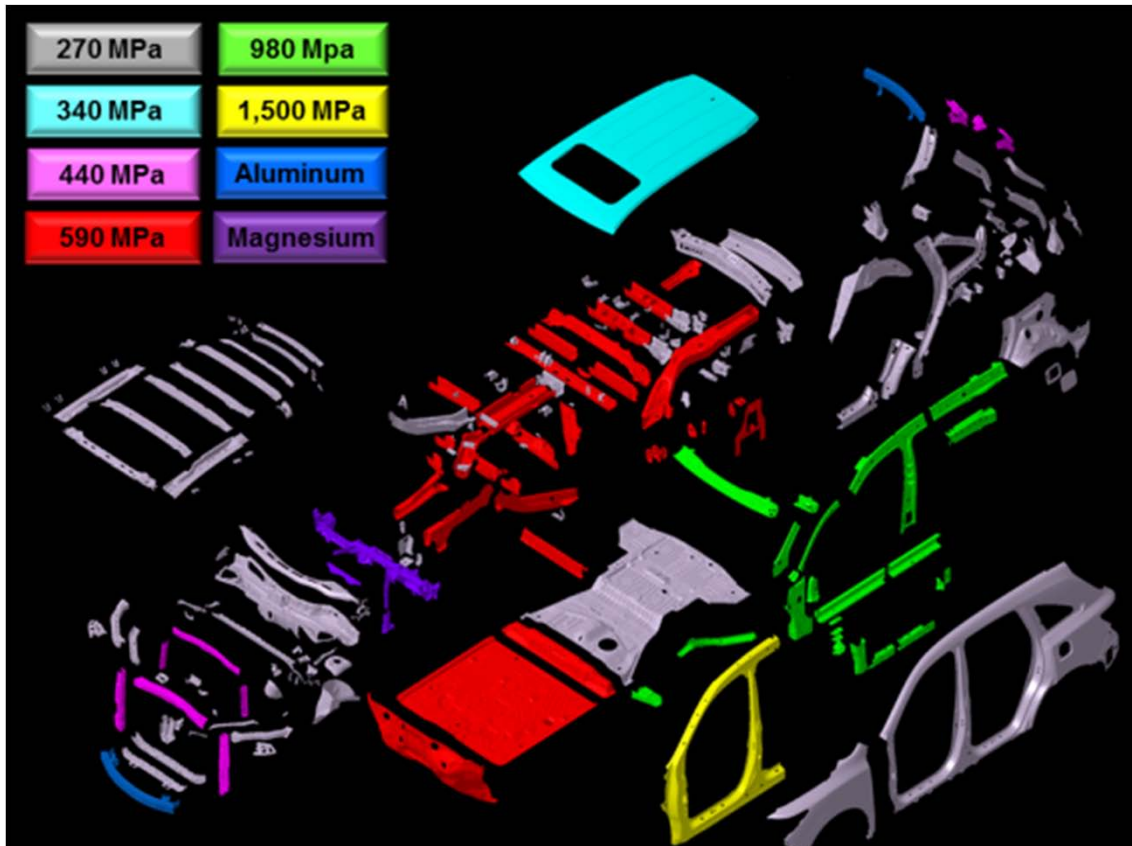
- Steel parts are color-coded based on their tensile strength in megapascals (MPa).
- High strength steel is defined as any steel with a tensile strength of 340 MPa or higher.
- Steel repair and welding procedures vary depending on the tensile strength of the parts involved.
- Refer to the body repair manual for complete information.

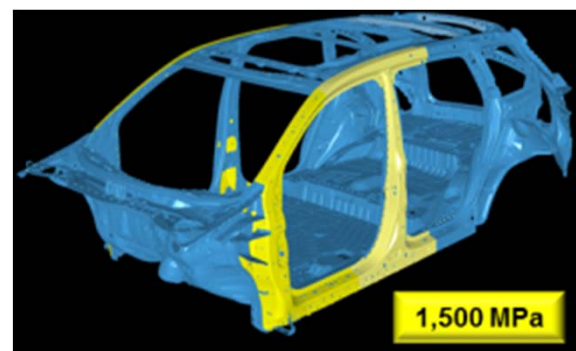
1,500 MPa (HOT STAMP) STEEL LOCATIONS

The one-piece front door outer stiffener rings and door reinforcement beams are made from 1,500 MPa steel. This steel is stronger than ordinary steel, so it can help protect vehicle occupants while reducing overall vehicle weight to improve fuel economy.

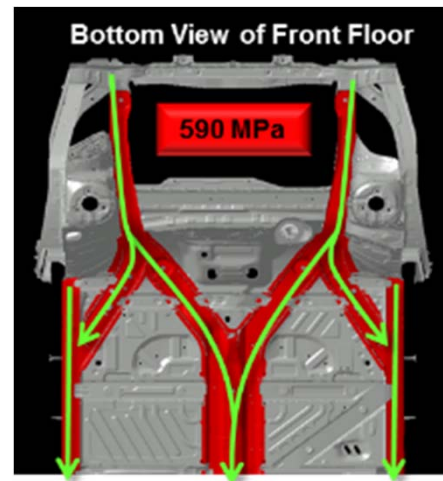
3-BONE PLATFORM STRUCTURE

A new “3-Bone” platform structure is used on this vehicle.

- The structure improves impact load management around the cabin while reducing weight.
- Additional floor reinforcements may require replacement or spot weld removal if damaged in a collision.
- Limited sectioning allowed to the Front side frame and Rear frame B parts. Refer to the body repair manual for complete information.

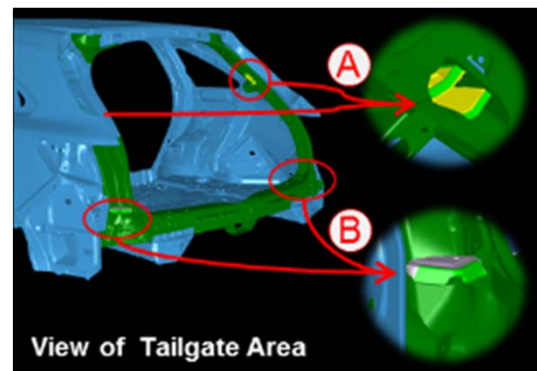
STRUCTURAL FOAM LOCATIONS AND REPAIR

Structural foam bulkheads are used to improve body stiffness at the left and right inner panel assembly (A) and inside the floor rear crossmember assembly (B). Replacement part assemblies have the structural foam pre-installed.

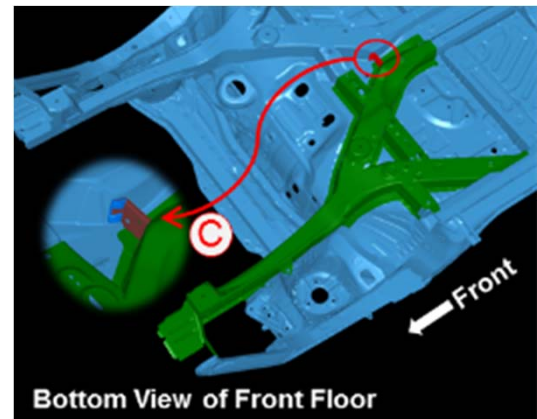
- A structural foam joint is used on a bracket that connects the left and right side center frames under the front floor (C). When replacing either the left or right front side frame assemblies, a special room-temperature cured 2-part epoxy structural adhesive (L&L Products L-0504 or equivalent) is required to replicate this joint.
- Because of limited shelf life, the adhesive must be ordered at the same time as the replacement front side frame.
- Once the adhesive/foam is applied, the parts can be assembled and welded. The repair adhesive material will cure at room temperature in 24 hours.

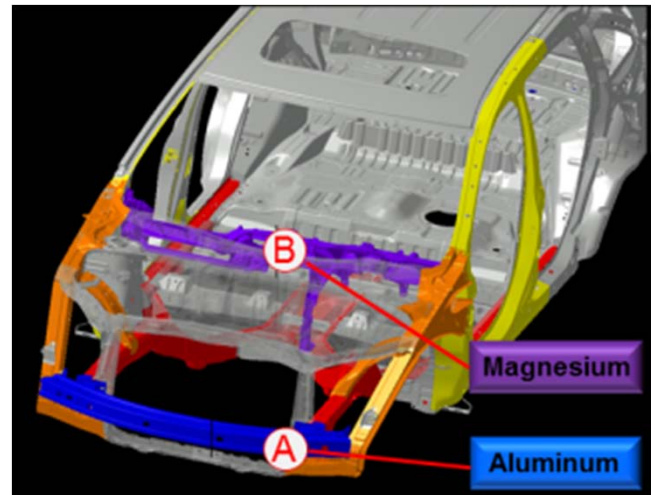
ALUMINUM AND MAGNESIUM PARTS

Aluminum alloy parts include:

- Hood panel.
- Front and rear bumper reinforcement beams (A).

Magnesium alloy parts include:

- Steering hanger beam (B).

Do not attempt to repair magnesium parts and aluminum bumper reinforcement beams if damaged.

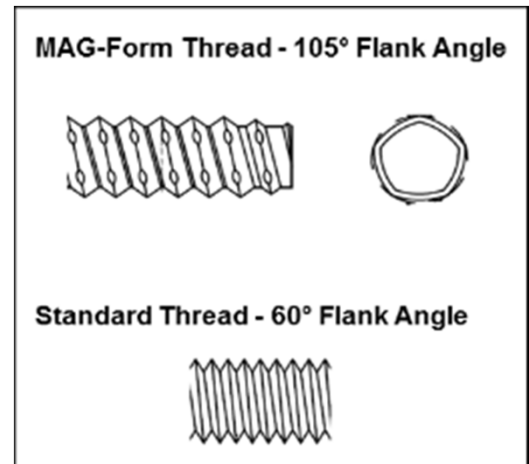
MAG-FORM® BOLTS AND STUDS

- Special Mag-Form bolts and studs are used to fasten some dashboard components and electrical grounds to the magnesium steering hanger beam.
- These bolts have a 105° flank angle that self-forms threads into the beam as the bolt is installed.
- If any hole in the beam is stripped, it can be repaired by ordering a +1 mm oversize service bolt or stud.
- MAG-Form service bolts will form the new repair threads during installation – no drilling or tapping required.
- Always use a torque wrench to tighten MAG-Form bolts or studs to the specifications in the service manual.
- Do not use power tools because the threads formed in the magnesium steering hanger beam are easily stripped.
- If an oversize service bolt or stud has been installed and strips, the steering hanger beam must be replaced.

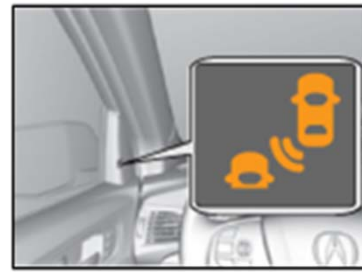
BSI Alert Indicator

Models equipped with this system can be identified by this BSI Alert Indicator, located on both front doors near the outside rearview mirror.

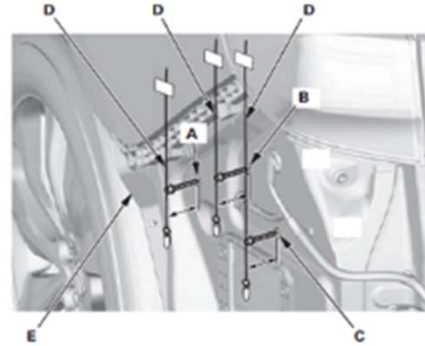
Left Rear of Vehicle Behind Bumper

- The system uses two radar units mounted on each side of the vehicle under the rear bumper.
- The system may malfunction and set DTCs because of damage, improper repairs, or excessive foreign material on any of the following:
 - Rear bumper
 - Outer side panels
 - Radar unit mounting locations
- Several checks and inspections must be done during repairs to the radar unit mounting area. Procedures to check the BSI radar unit mounting area can be found:
 - Body repair manual "Rear Side Outer Panel Installation"
 - Service Manual "BSI radar unit mounting area check."
- If the mounting area check is not done, an Acura dealer may not be able to properly aim the radar units.

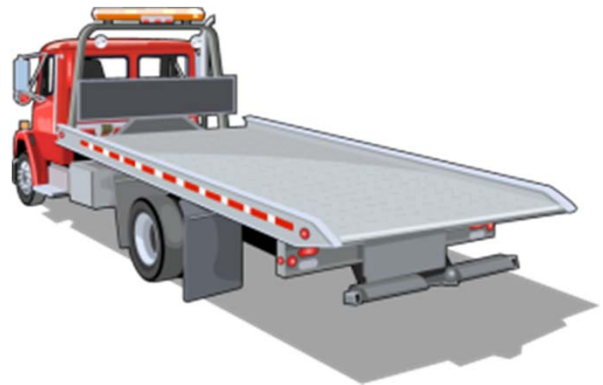
TOWING AND LIFTING PRECAUTIONS

- SH-AWD models must be towed using flat bed towing equipment only, or transmission damage may result.
- 2WD models may be towed using front wheel lift or flat bed towing equipment.
- Models equipped with the SH-AWD system do not have a manual switch to disable the system. Whenever service work requires spinning the front or rear wheels with the engine, always lift and support the vehicle so all four wheels are off the ground.
- Do not lift or tow this vehicle by its bumpers, or serious damage will result.
- For more information, refer to "Lift and Support Points" in the appropriate service or body repair manual.

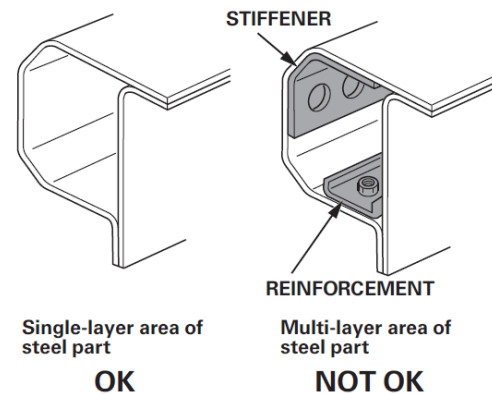
Sectioning Area Examples

- Sectioning (cut and joint) should usually be avoided except for mild steel outer panels and floor panels unless a specific procedure is provided in the body repair manual.
- However, depending on the type of vehicle damage, steel parts with a tensile strength ≤ 780 MPa may be sectioned provided ALL of the following conditions are met:
 - Sectioning must be done in a single-layer area of the part.
 - Multi-layer internal steel reinforcements and stiffeners must not be cut.
 - The repair is not in a load bearing area such as engine, transmission, or suspension mounting points.

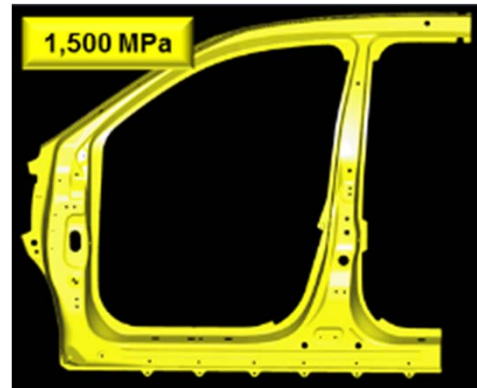
- NEVER attempt to straighten damaged 1,500 MPa steel parts because they may crack.
- 1,500 MPa steel parts MUST be replaced at factory seams using squeeze-type resistance spot welding (STRSW).
- MIG brazed joints should be used ONLY in locations not accessible by a spot welder.
- To assure adequate weld tensile strength, always set the spot welder to the specifications provided in the body repair manual.

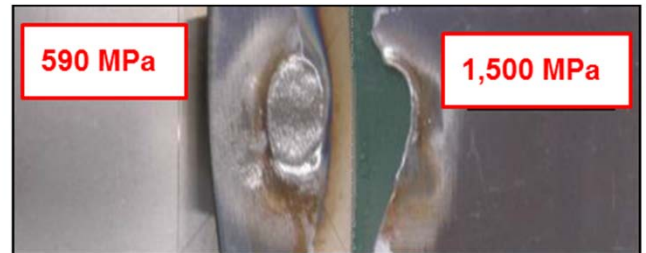
Tensile Test Results of MAG Welded 1,500 MPa Steel

- NEVER perform MAG welding on 1,500 MPa steel. The heat generated during welding will significantly reduce the strength and structural integrity of 1,500 MPa steel parts.
- This photo shows tensile strength test results of welded 1,500 MPa steel. The 1,500 MPa steel fractured first, because the welding heat reduced its strength far below 590 MPa.
- For more information, refer to “Hot Stamp (1,500 MPa) Parts Welding Specifications” in the body repair manual.

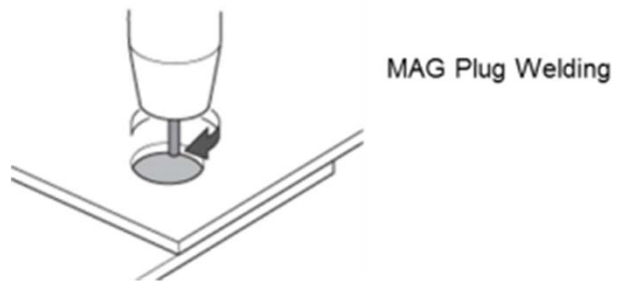
MAG PLUG WELDING GUIDELINES

- MAG plug welding may be done when joining body components to 590-980 MPa steel parts.
- Follow the recommendations described in the body repair manual section "MAG welding specifications for high-strength steel parts 590 MPa and higher."

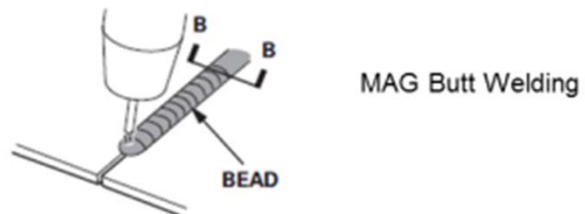
MAG BUTT WELDING GUIDELINES

- MAG butt welding may only be done on steel parts with a tensile strength of 780 MPa and lower.
- Welding speed is critical to achieve the correct weld strength and minimize the heat affected zone (HAZ).
- Follow the recommendations described in the body repair manual section "MAG welding specifications for high-strength steel parts 590 MPa and higher."

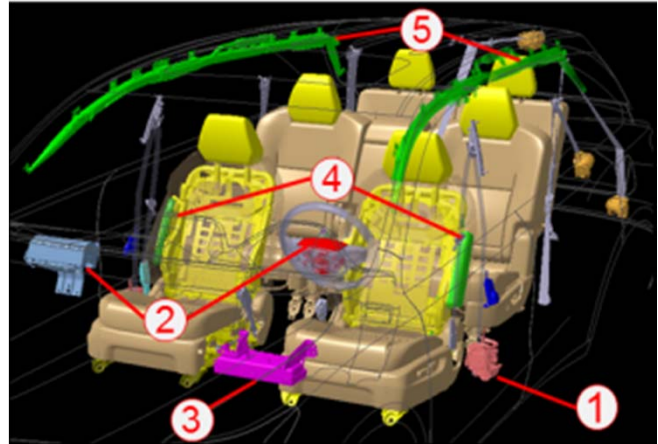
1. Driver and front passenger seat belt tensioners (may deploy independently from any airbags).
2. Driver and front passenger SRS airbags.
3. Driver's knee SRS airbag.
4. Side airbags mounted in the outer driver and front passenger seat-backs.
5. Left-and-right-side curtain airbags mounted above the side windows under the headliner.

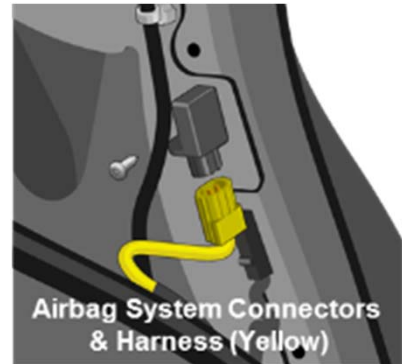
- For easier identification, electrical connectors that contain only airbag system wiring are yellow in color.
- Many harnesses that contain primarily airbag wiring are also wrapped in yellow tape.
- Airbag system wiring that runs in a common harness, such as a floor harness, is generally not marked.
- NEVER attempt to modify, splice, or repair airbag system wiring. If airbag system wiring is damaged, replace the wiring harness(es).

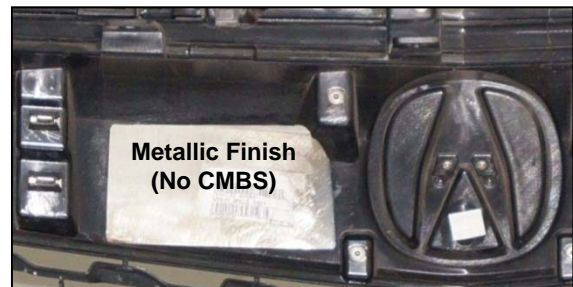
Back Side View of Grille Molding (w/o CMBS)

- This unit senses through the front grille upper molding.
- To prevent radar interference, a special black coating is used on the back side of the molding. This coating also significantly increases the part's cost.
- Installation of the wrong grille molding will cause the CMBS indicator to come on and DTC P2583-97 (dust or dirt on the millimeter wave radar) to set.
- To check for this without removing the bumper, remove the front bulkhead cover and look down at the back side of the front grille upper molding.
- If the back side of the grille molding has a metallic finish, the wrong grille upper molding was installed.

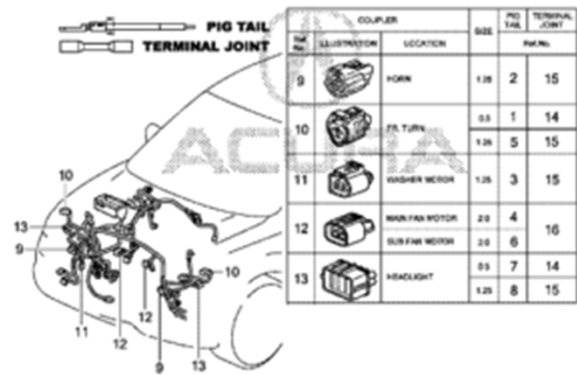
- Certain front and rear electrical connectors subject to collision damage may be repaired using pigtails and connectors listed in the ELECTRICAL CONNECTORS illustrations in the parts catalog (example shown here).

- Pigtails attach to the vehicle wiring using special crimp-and-seal terminal joints. After crimping, the joints are heated using a heat gun to seal out the environment.

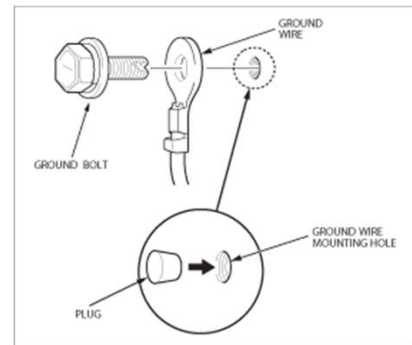
- Painting over electrical ground locations may cause electrical systems, such as Vehicle Stability Assist (VSA), to malfunction and set DTCs that may be difficult to diagnose.
- Protect the ground wire and the ground wire mounting hole threads with a bolt or plug when priming or painting.
