# Technical Committee

November, 2016

JIGS are ordered for the 2016  
Toyota Camry from Celette.

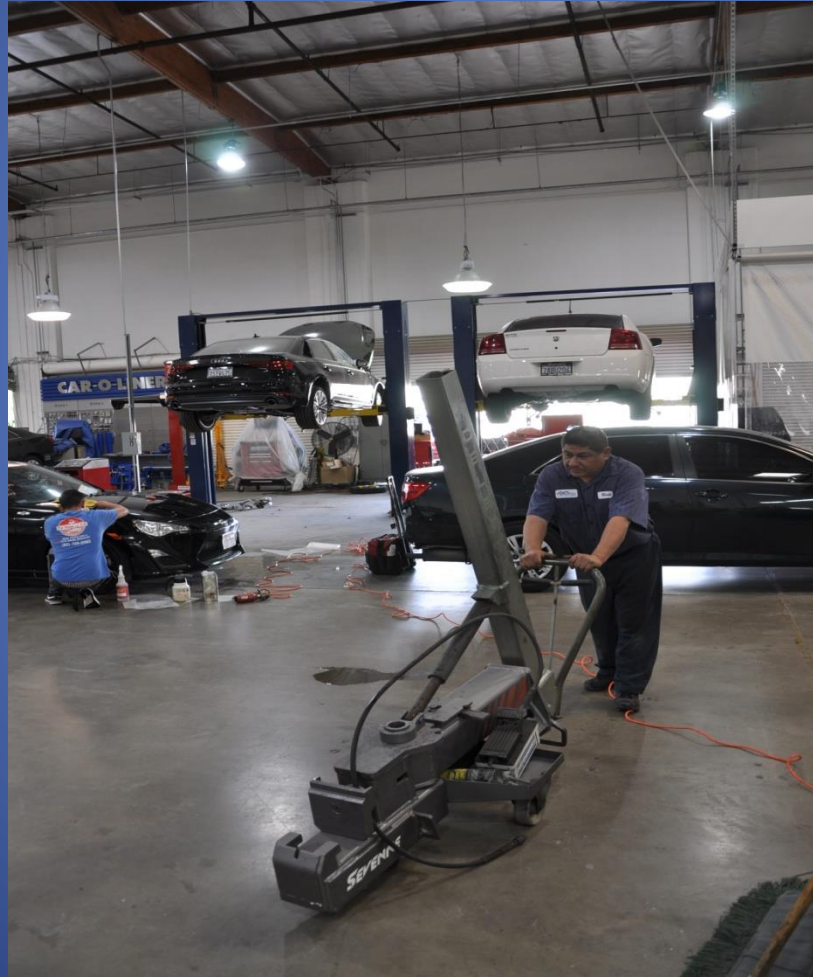
The pulling arm is moved to the repair stall.

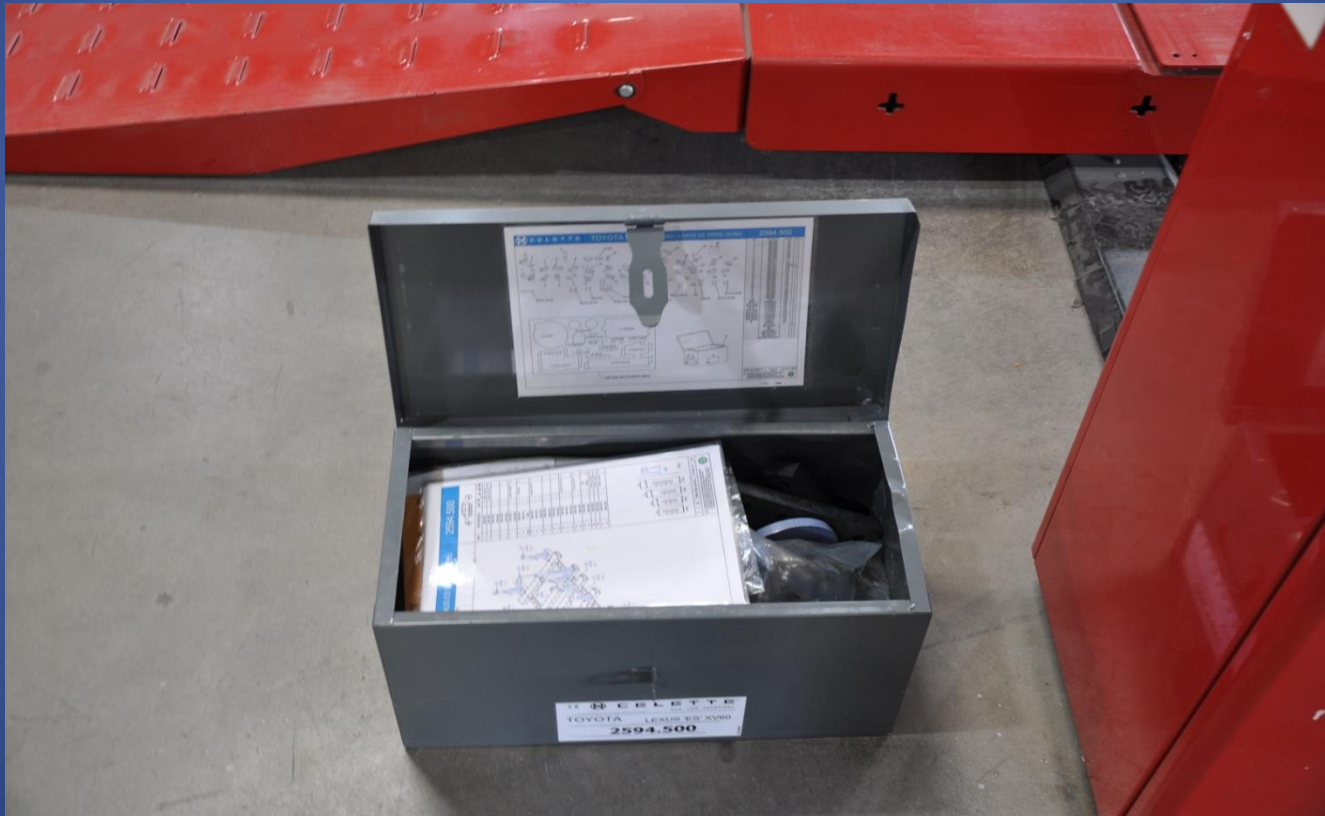
# Note the numerical location of front beams and the 4 cross beams

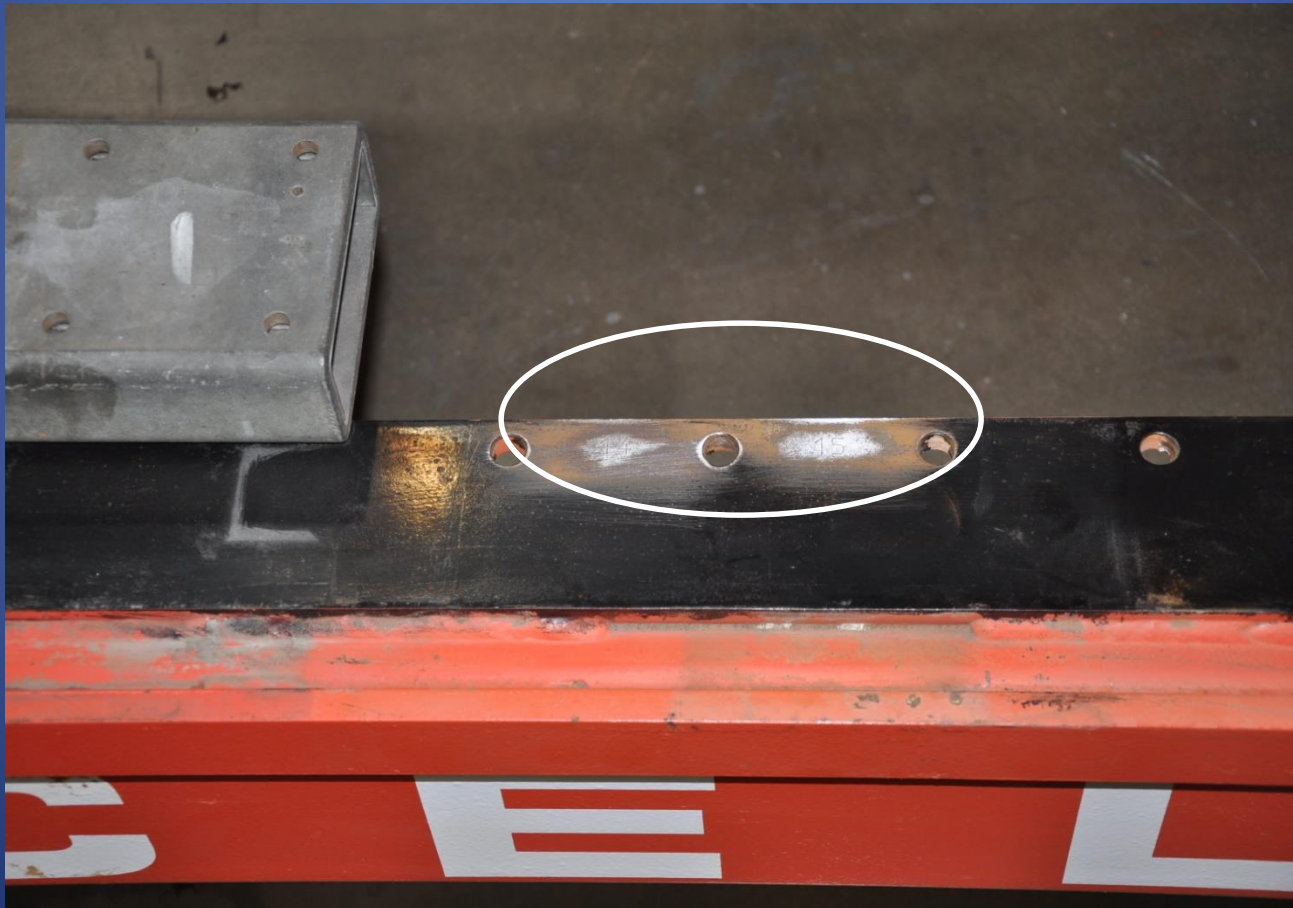
The technician has moved the front beams to their correct position for the 2016 Toyota Camry as outlined in the Celette speciation sheet that that is included with the jigs.

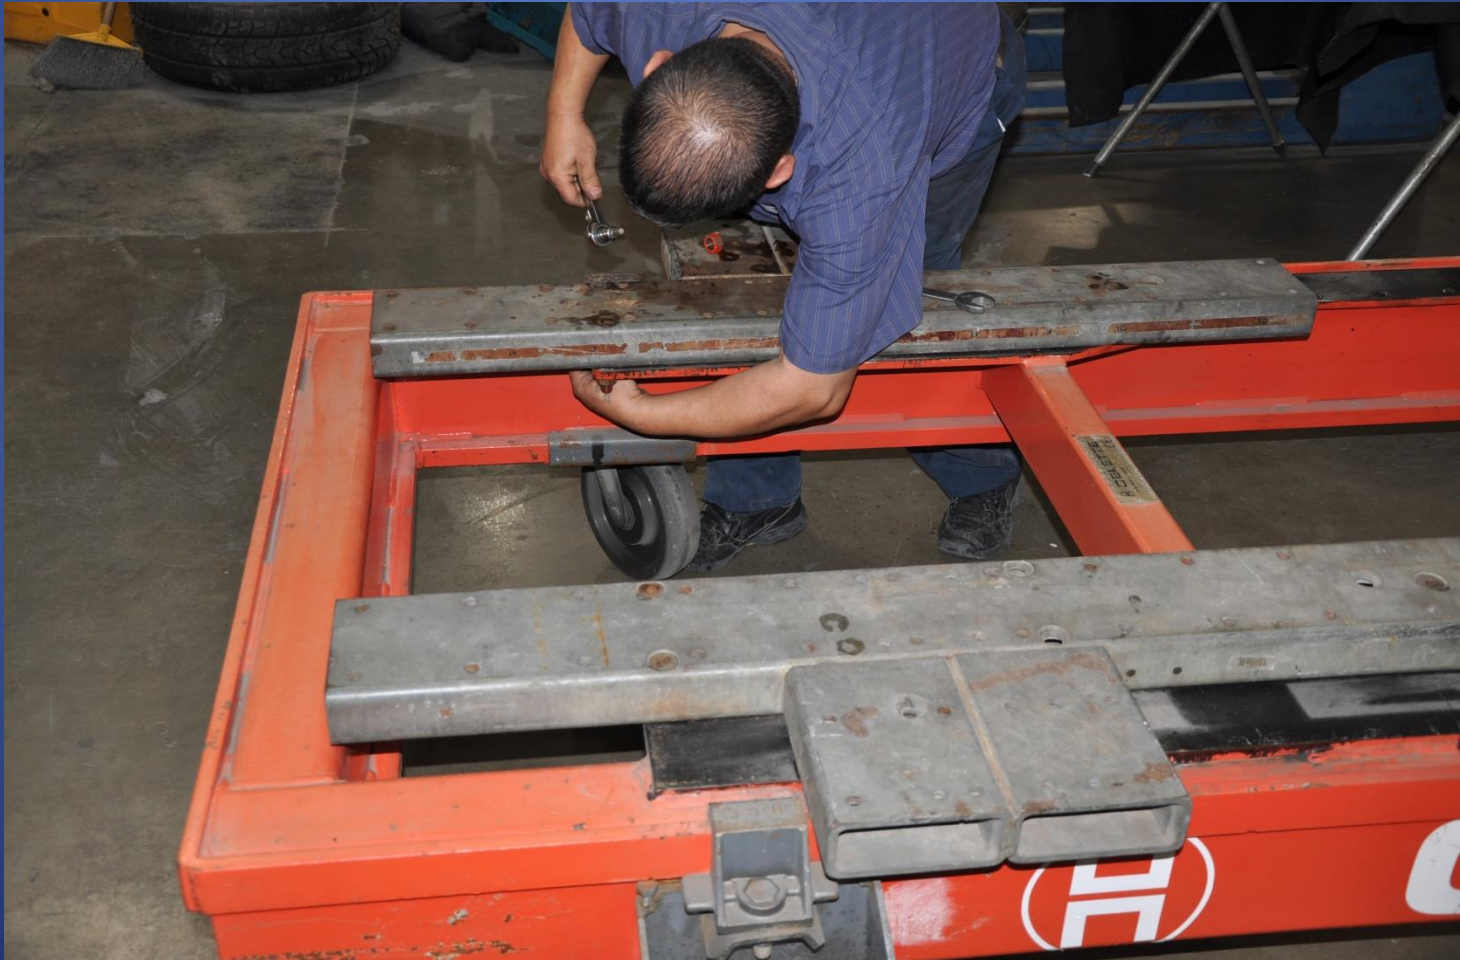
Cross beam is placed on the bench  
at its designated position.

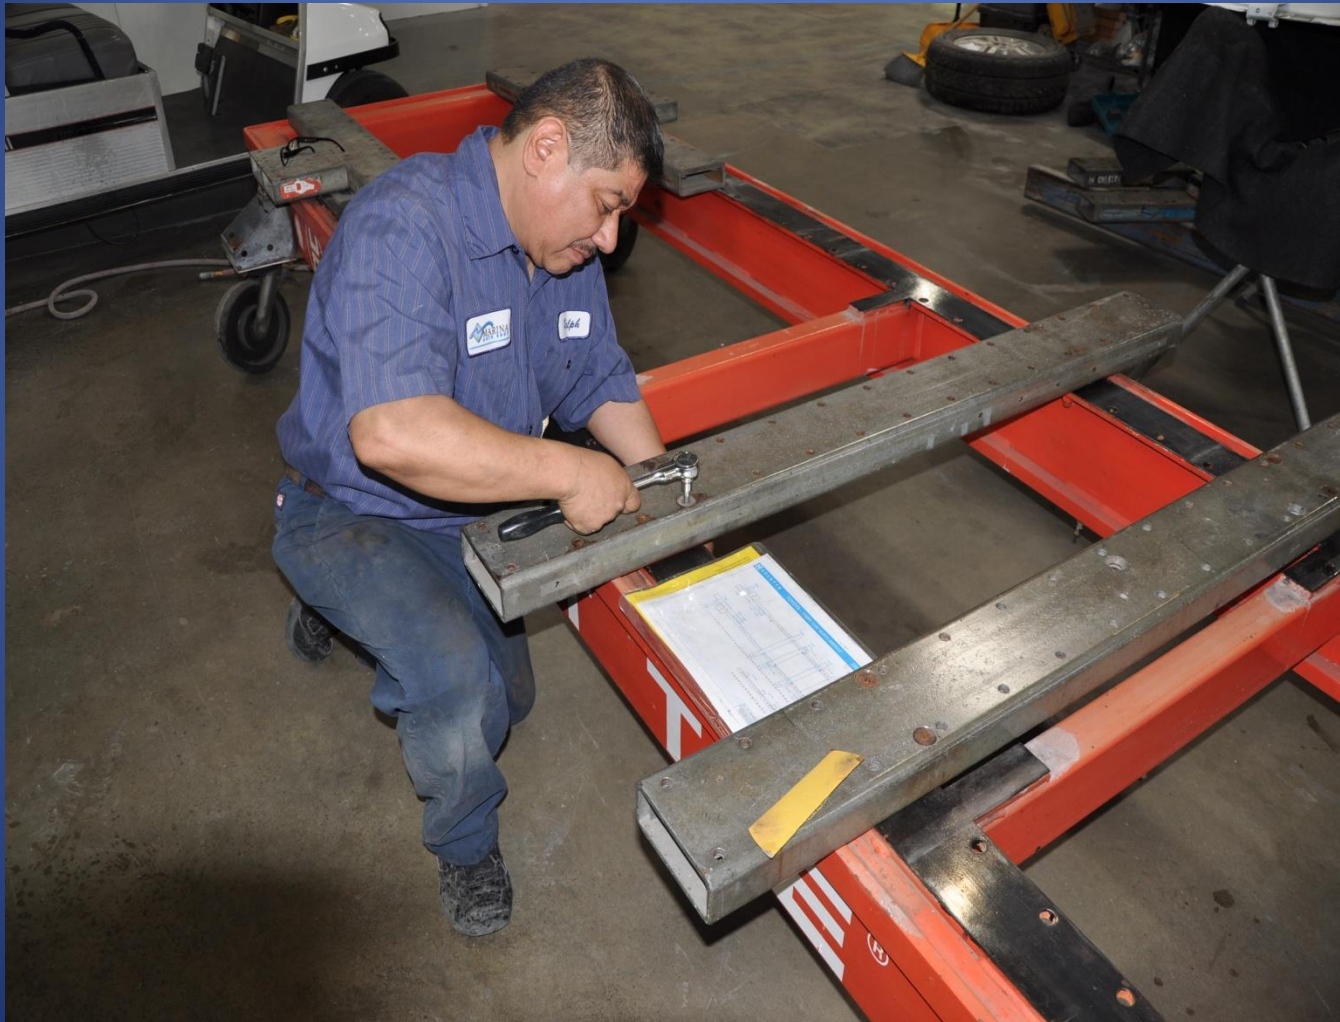
# Location of each specified base is located and placed on the bench

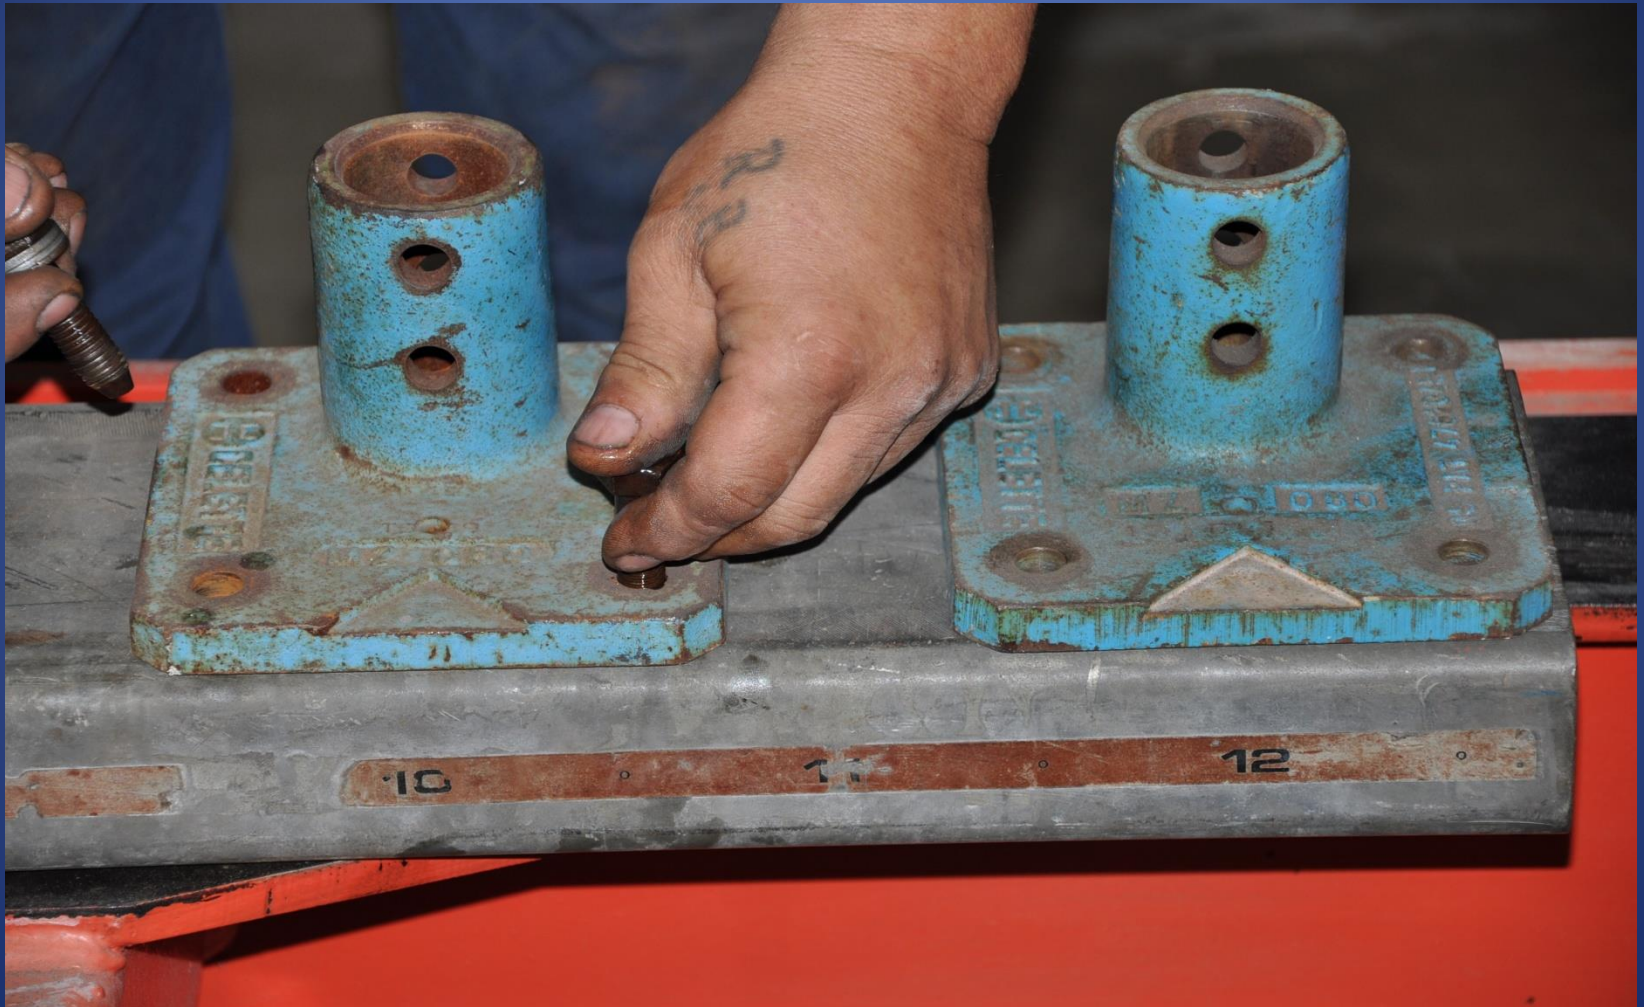
A side arm is installed as per the data sheet on the front beams.

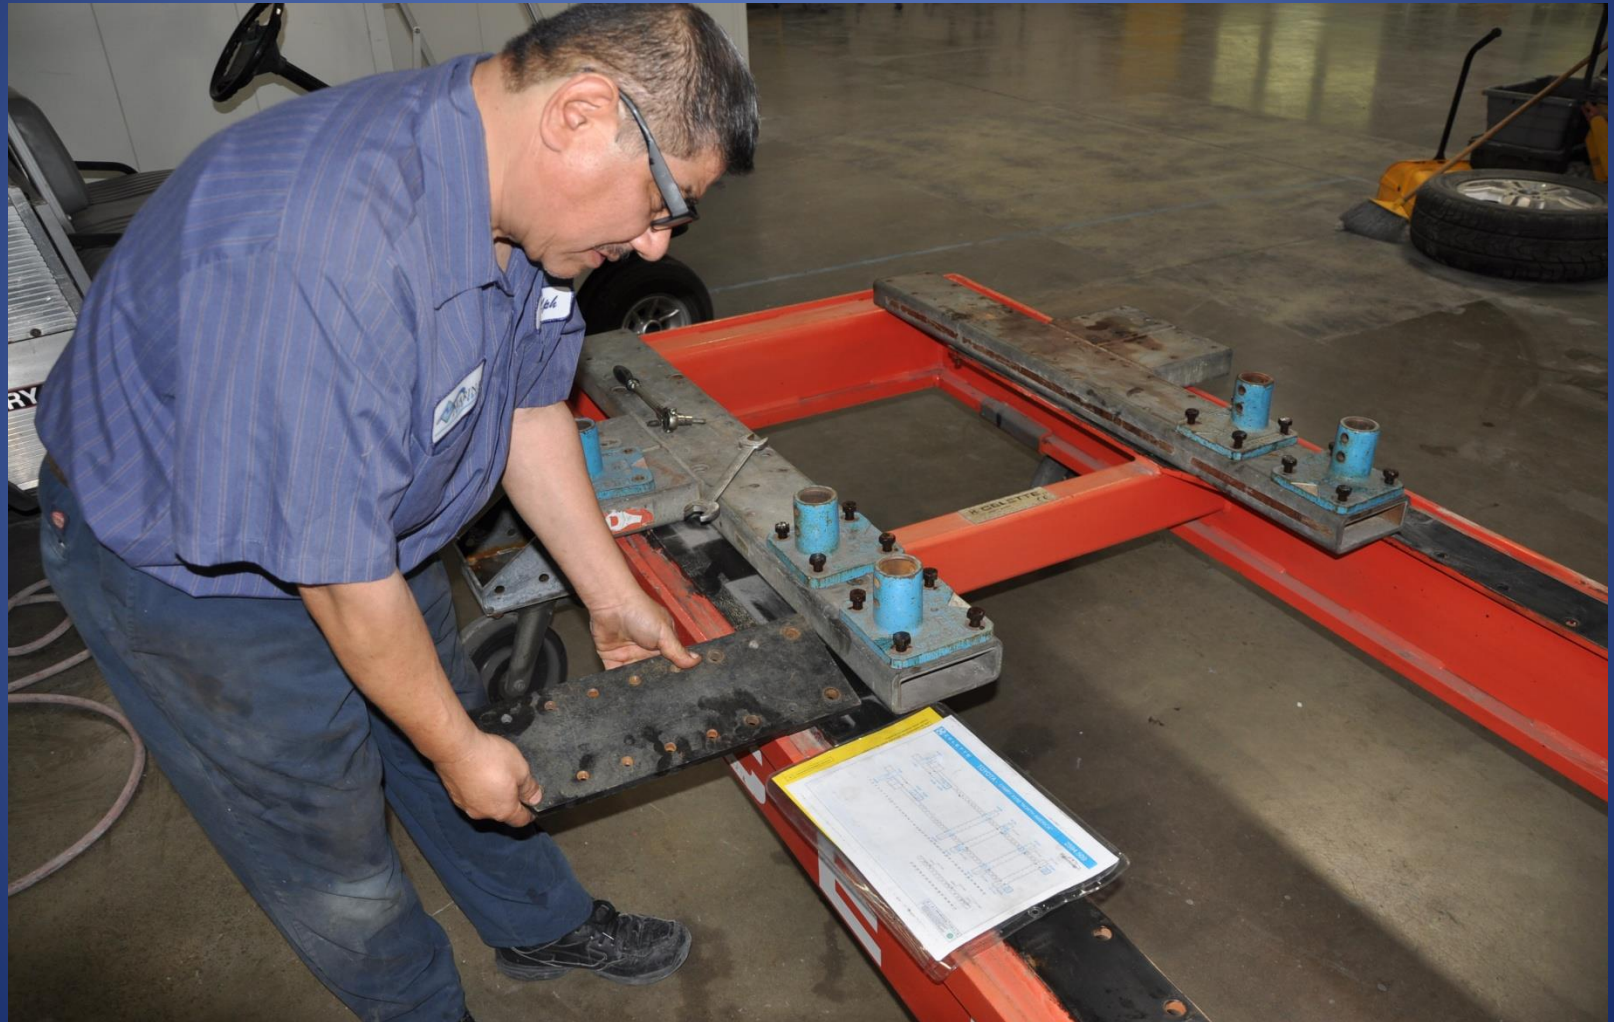
All of the bases have been installed  
on the bench.

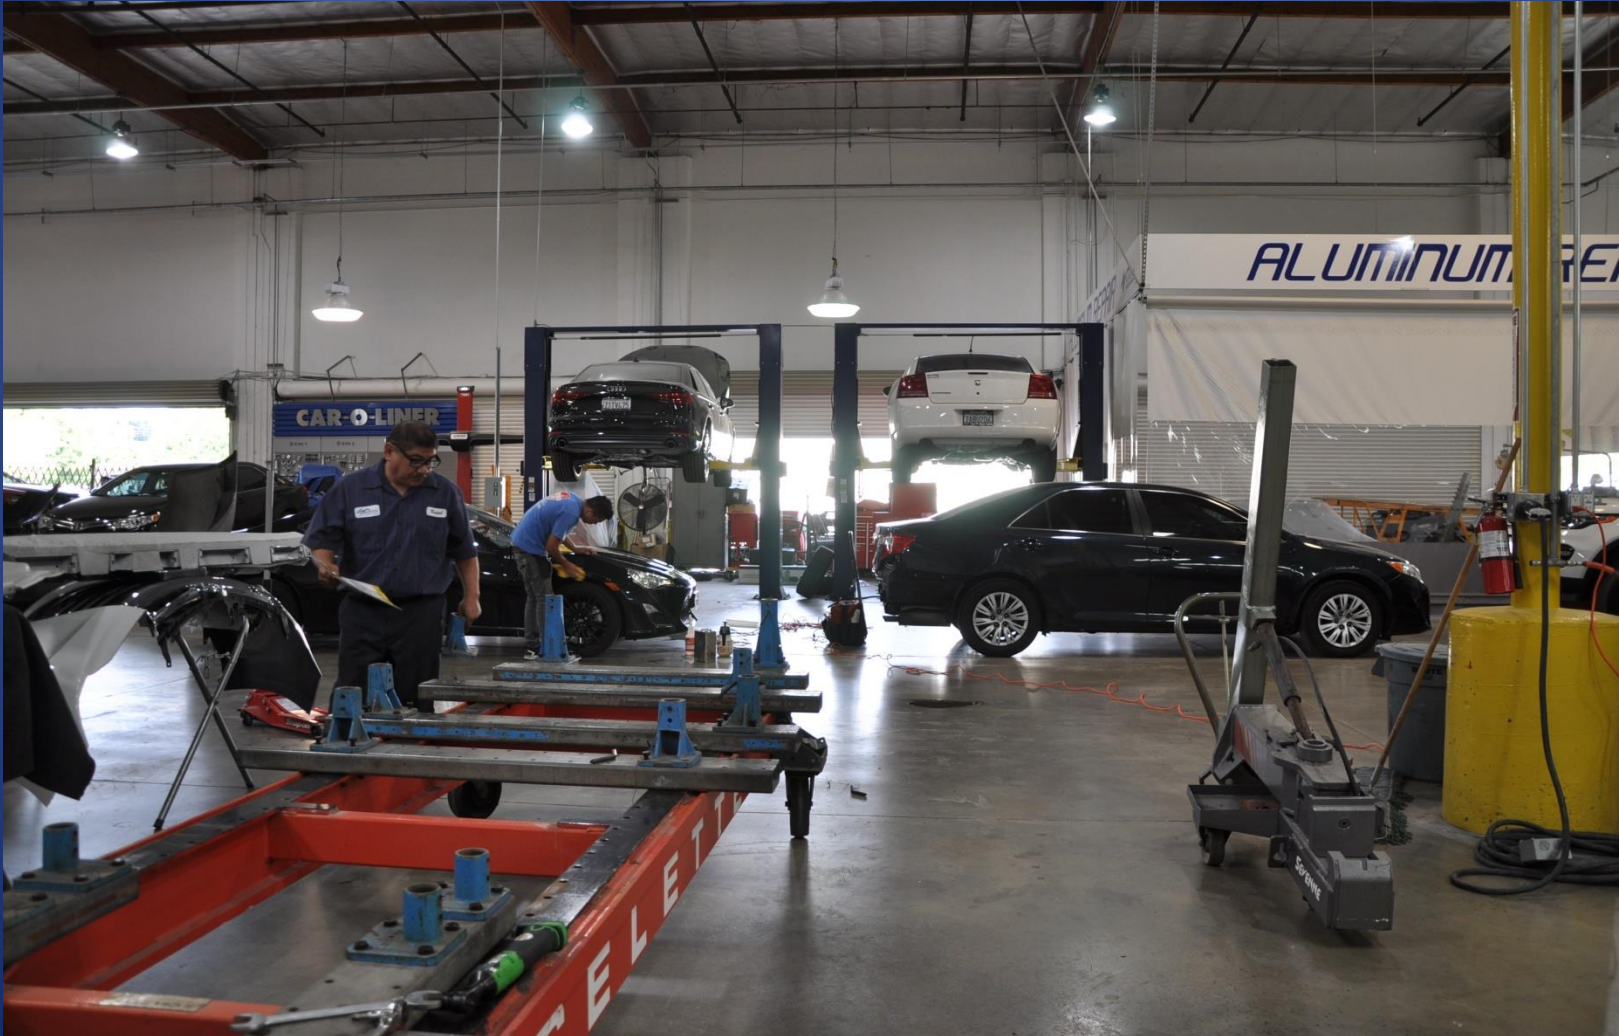
All the bolts are tightened and torqued on base mounts.

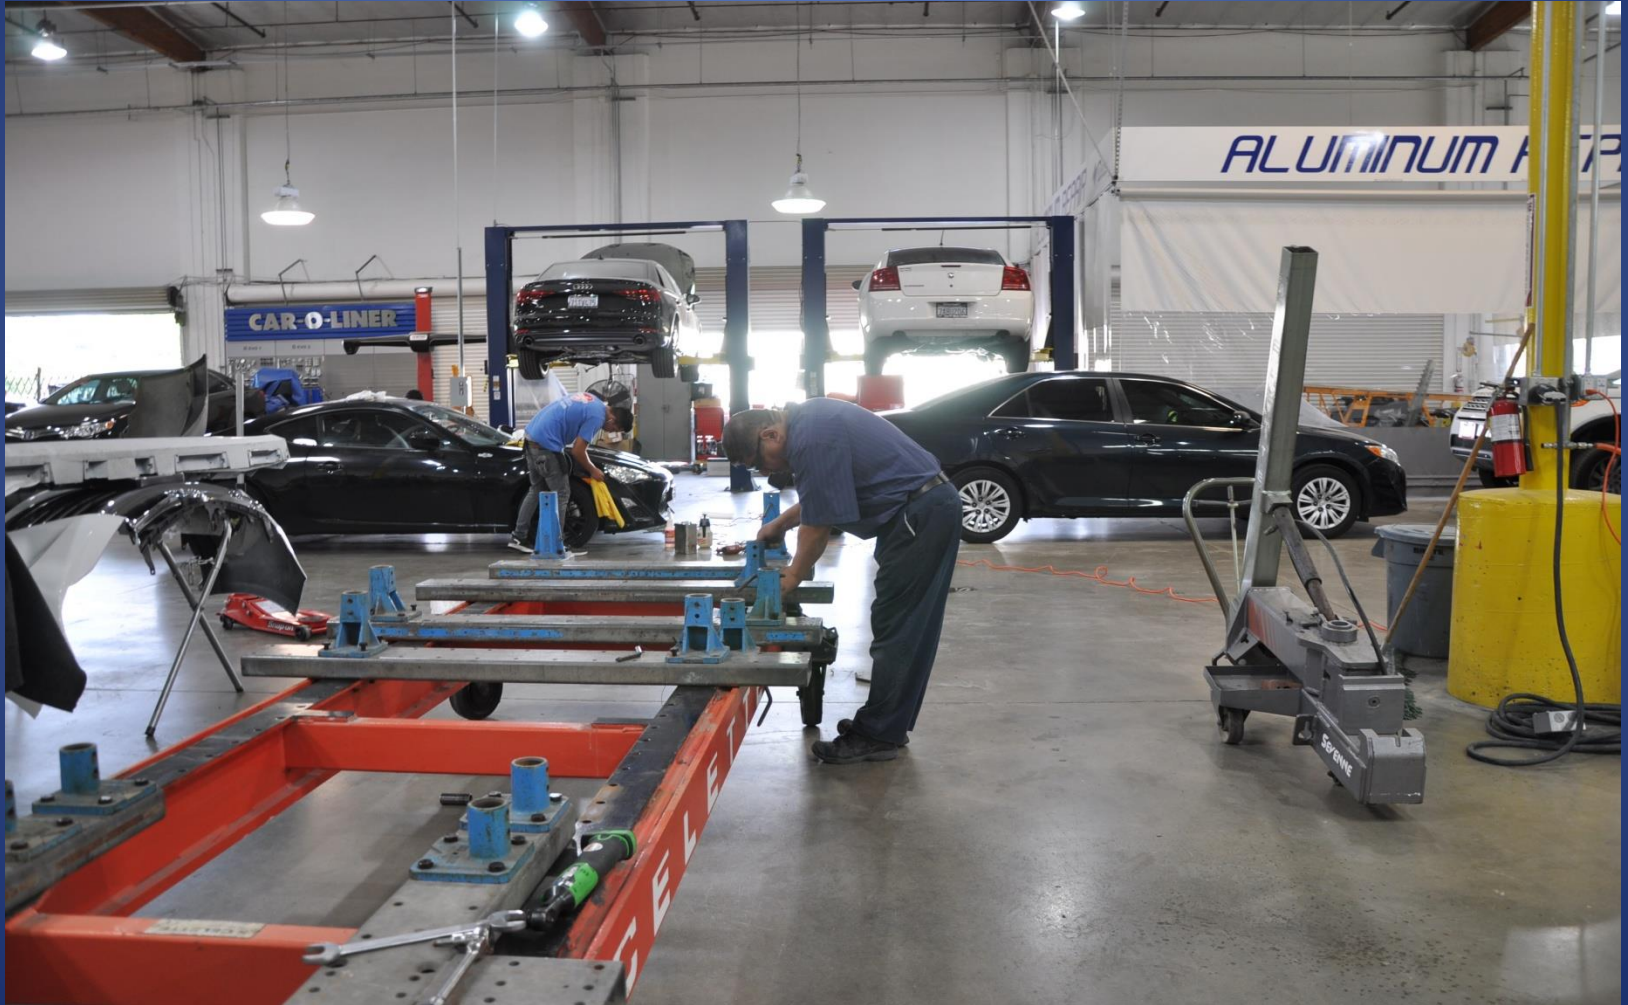
# The jig diagram is reviewed

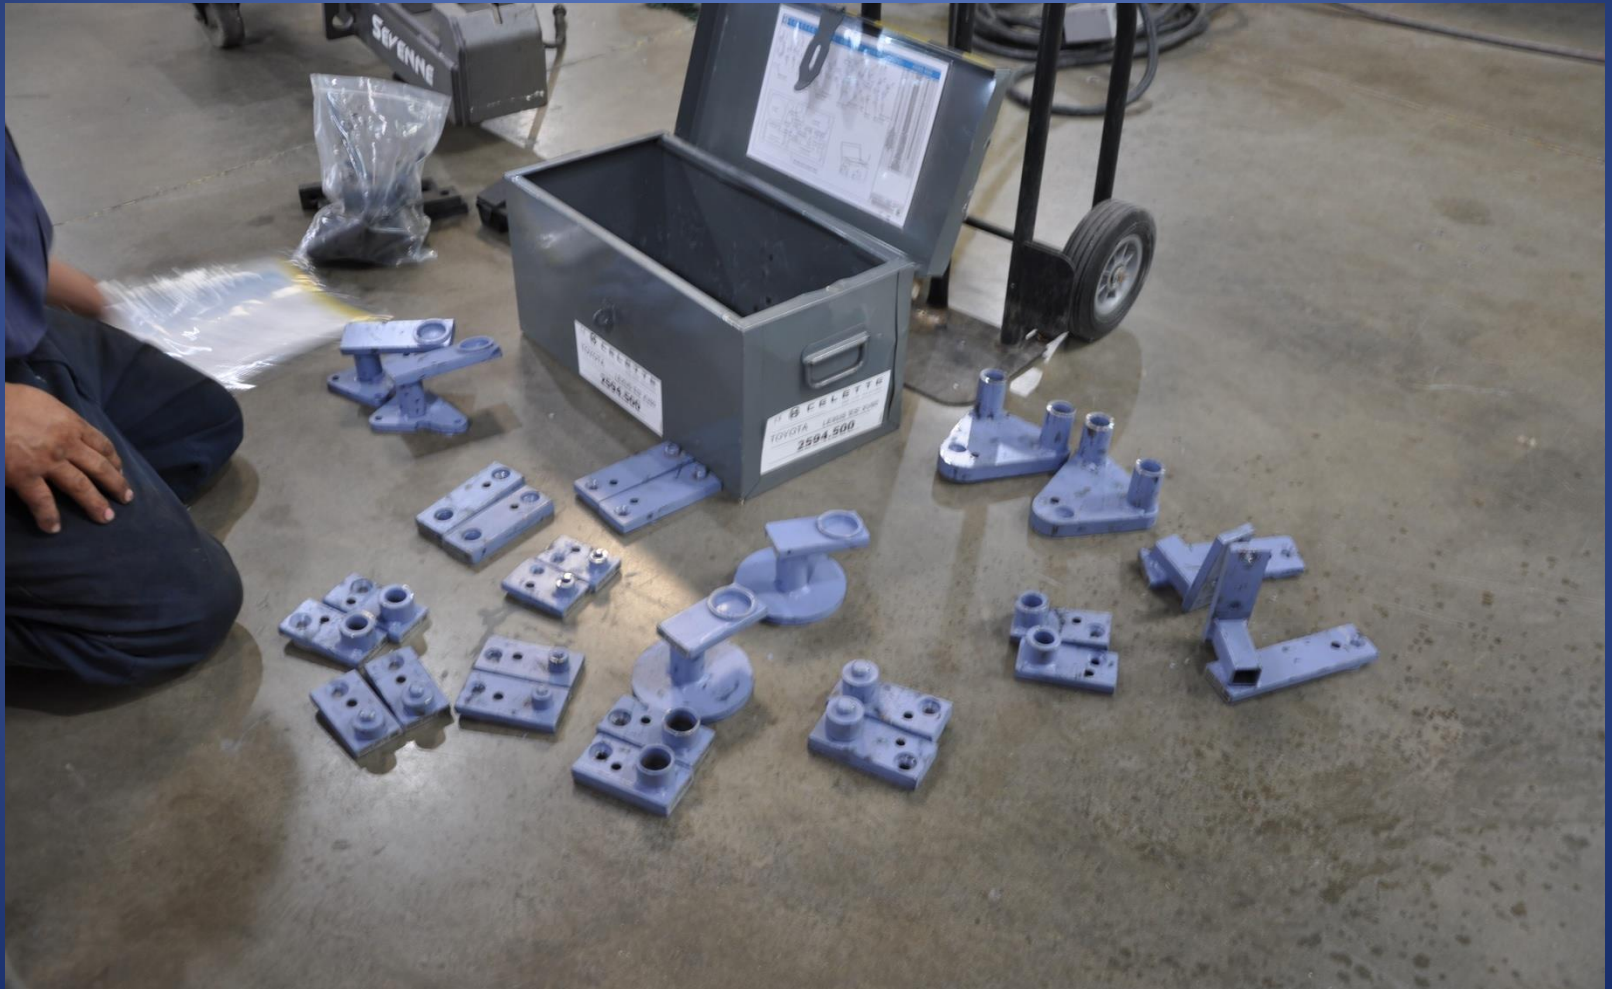
The base extensions are removed according to the specification sheet.

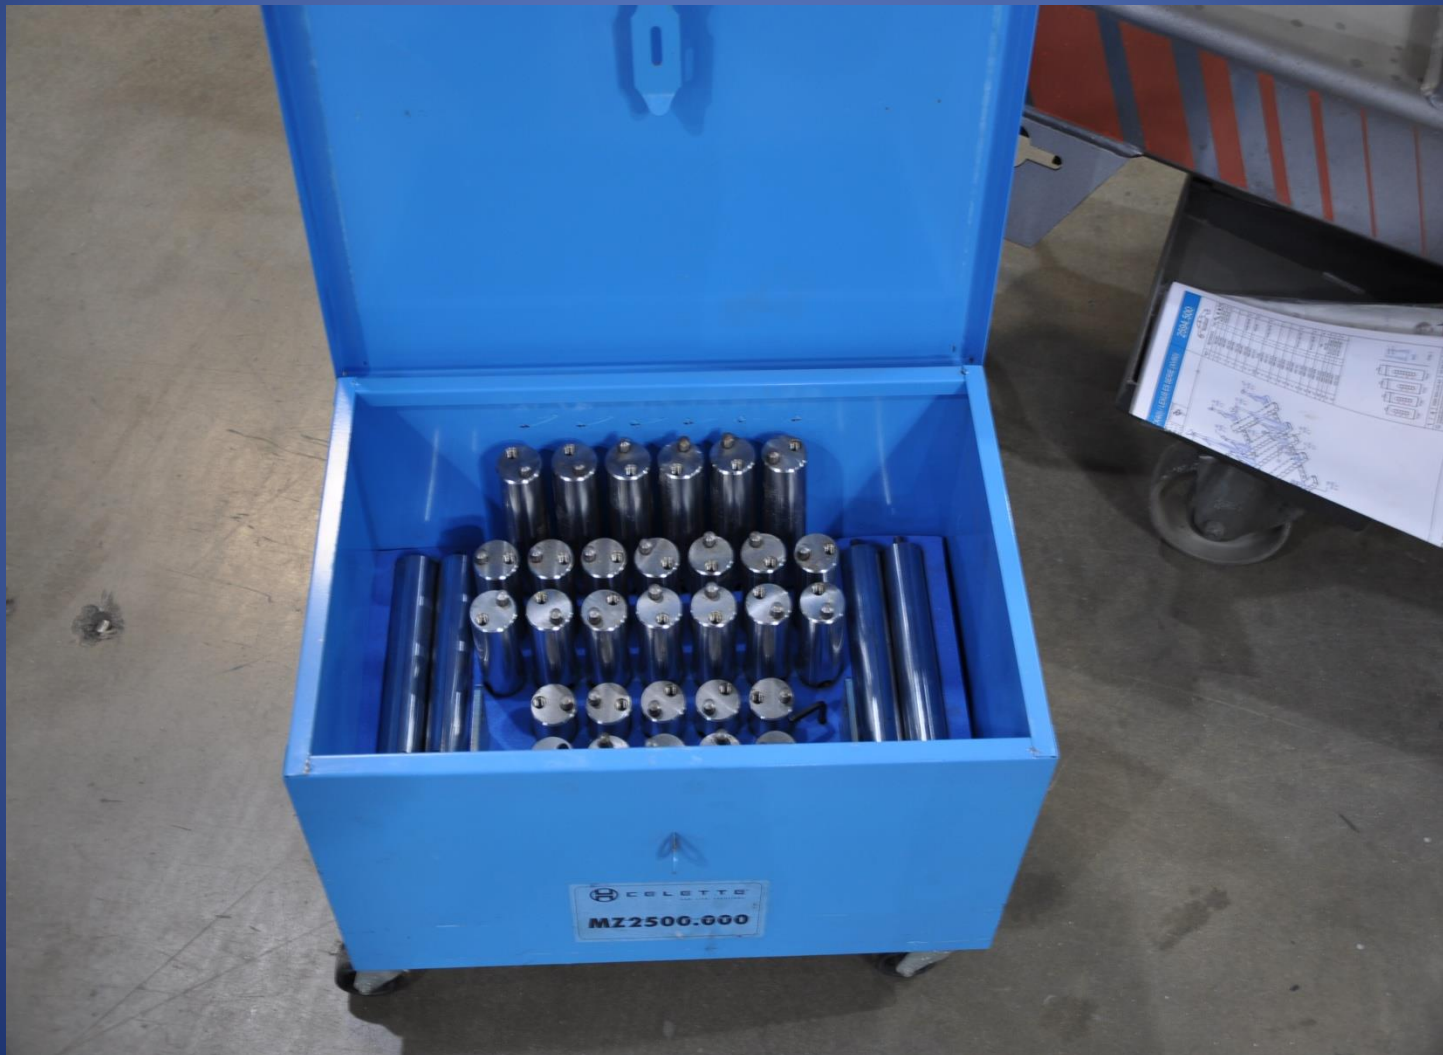
The base extensions are attached to the jigs.

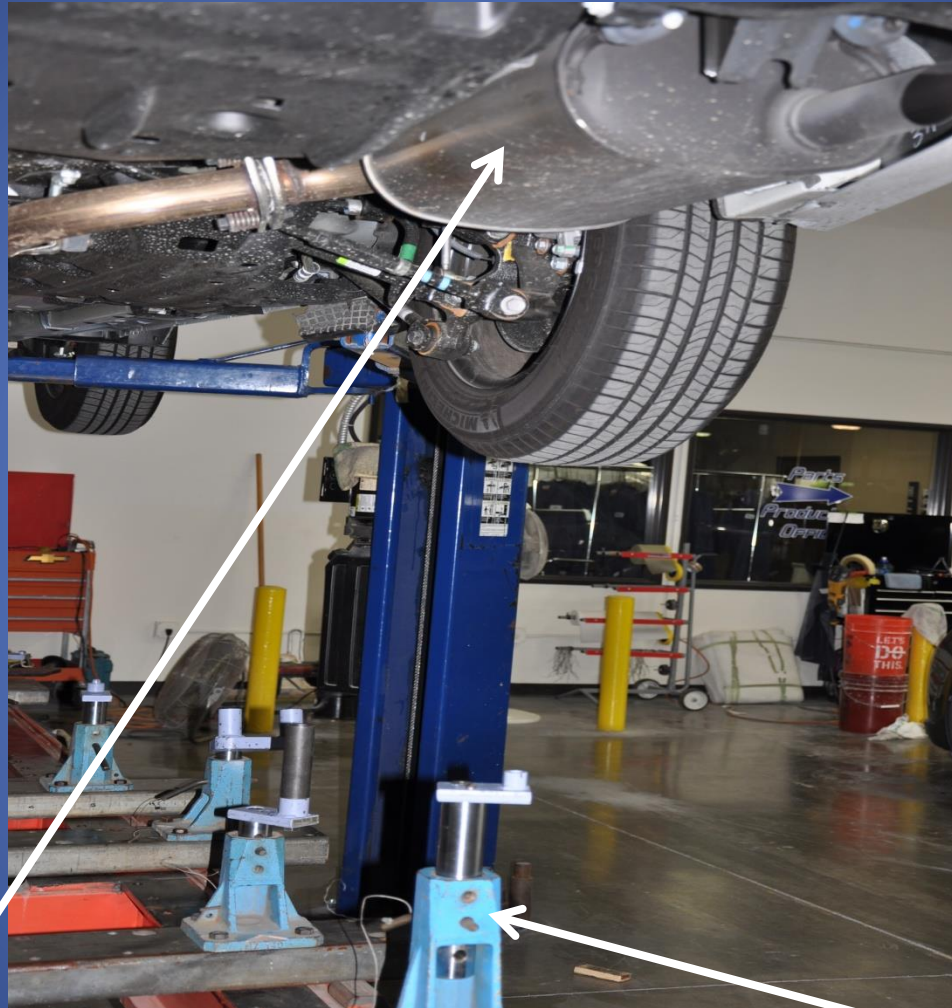
Note: The muffler will need to be removed to accommodate the last passenger fixture

All of the lower plastic shields along with the emergency brake cables are removed and/or loosened.

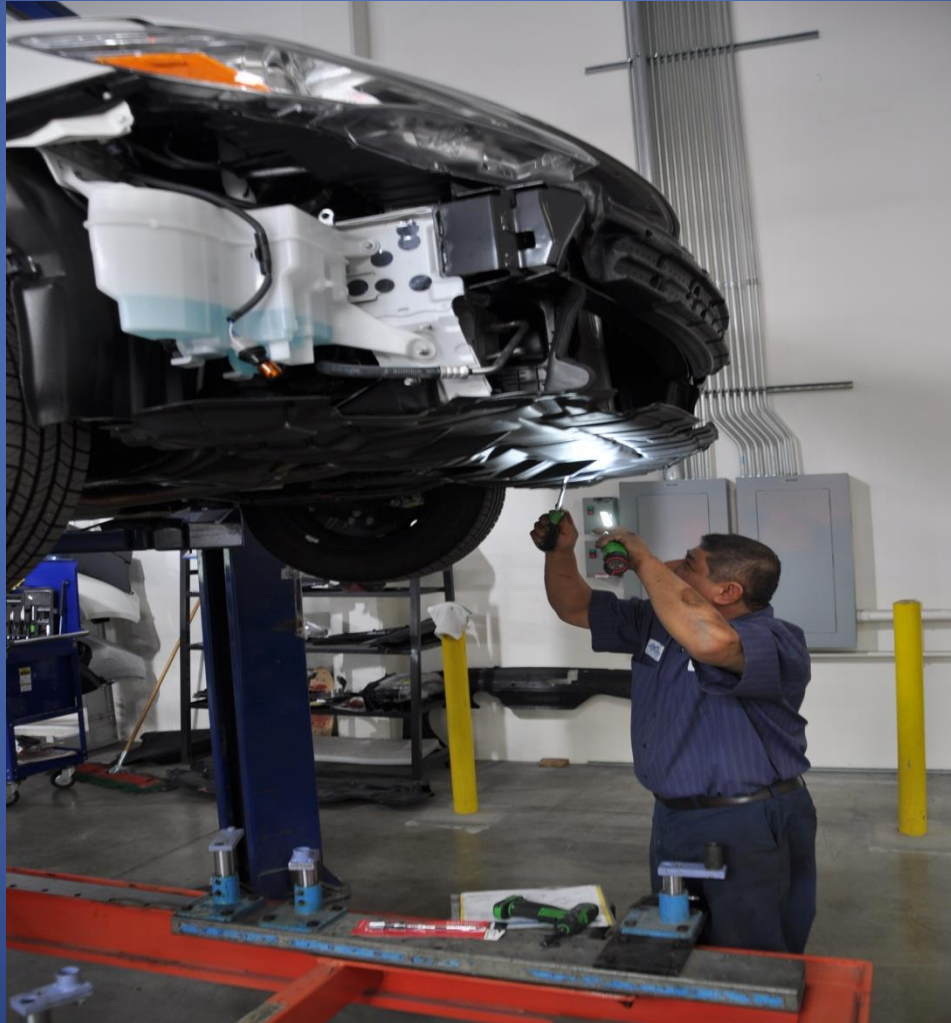
The vehicle is lowered on to the Celette Bench. The operation took 2 technicians.
