On Target

For Ford and Lincoln wholesalers and the collision repair industry

2023 Ford F-150® Highlights New Safety Technology

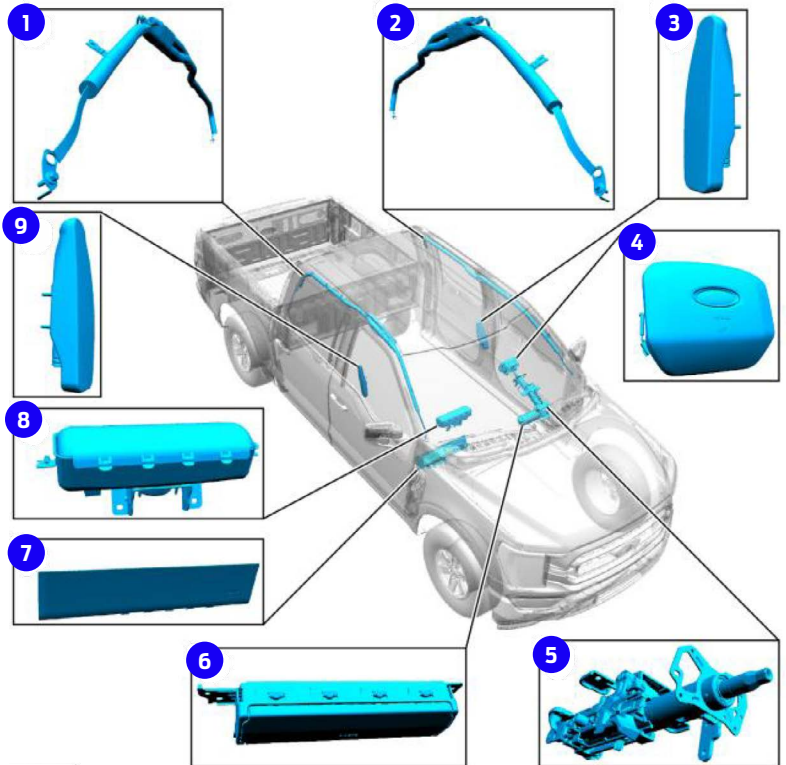
Airbag & Seatbelt Pretensioner Supplemental Restraint System

Item	Description
1	Passenger side curtain airbag
2	Driver side curtain airbag
3	Driver side airbag
4	Driver airbag
5	Adaptive energy absorption steering column
6	Driver knee airbag (if equipped)
7	Passenger knee airbag (if equipped)
8	Passenger airbag (includes canister vent)
9	Passenger side airbag

The adaptive energy absorption steering column includes a device that, once deployed, reduces the amount of force necessary to collapse the steering column during a crash event. The deployable device is activated by the restraints control module (RCM), depending on the driver seat position and the force of the crash. After deployment, a new steering column **must** be installed.

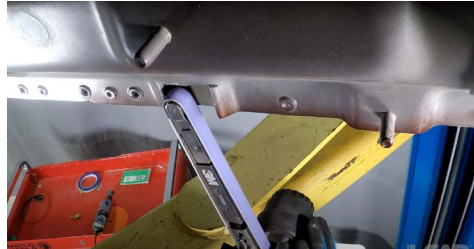
The use of different tools can help accommodate repairs over different types of contours and angles. Staying on the raised portion of the inner rocker panels allows the repairer to avoid the adhesive layer in the pinch-weld area.

Hauboldt commented that if you can stay on the raised portion of the inner rocker panel where the running board attaches, you can avoid the adhesive in between the pinch-weld in that area.

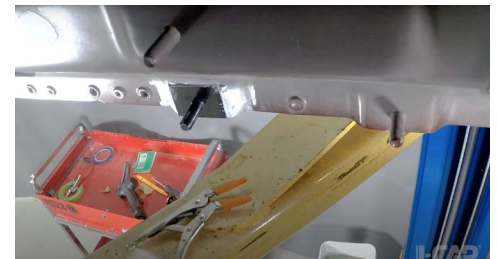
The near-finished repair with the new attachment in place.
