Mariusz Ziejewski, Ph.D., Inż.

RE: Matthew and Marcia Seebachan

Pursuant to your request, I am setting forth my biomechanical opinions regarding the motor vehicle incident on December 21, 2013 involving Matthew and Marcia Seebachan. I am also providing a summary synopsis of my background and qualifications to render my opinions.

To perform a biomechanical analysis of the incident involving Matthew and Marcia Seebachan on December 21, 2013.

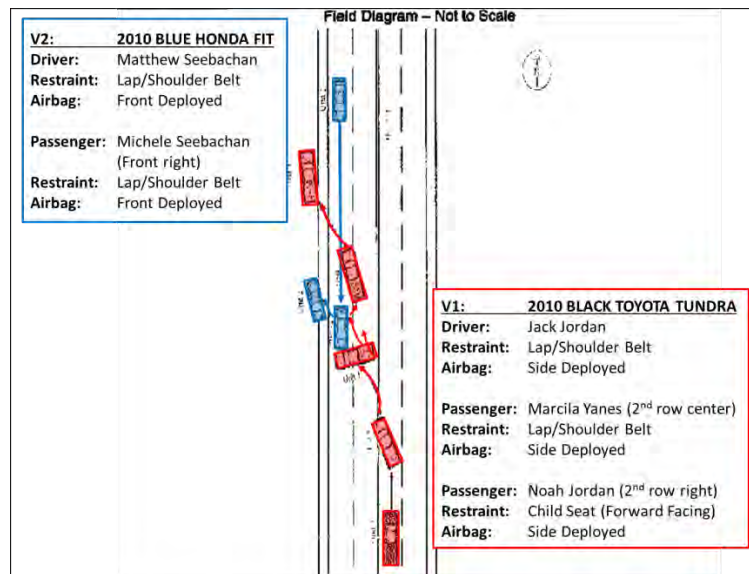
Figure 2 – Officer's Diagram

"Unit 1 was traveling Northbound on US 281 in the inside Northbound lane. Unit 2 was traveling Southbound on US 281 in the Southbound outside lane. Unit 1 began to hydroplane due to the driver's unsafe speed (rain/wet road). Unit 1 rotated counterclockwise and crossed into the Southbound lanes of US 281. While in a right side skid Unit 1 struck Unit 2's front bumper area with Unit 1's right front quarter area. At impact Unit 1 rotated counterclockwise striking Unit 2's left rear quarter area with Unit 1's right rear quarter area. Unit 2 traveled backwards from the impact with

Unit 1 and came to rest facing Southbound in the west side ditch of US 281. Unit 1 continued it's [sic]counter clockwise rotation, rotating 360 degrees before coming to rest facing Northbound in the Southbound bar ditch of US281."

The officer's diagram is shown in Figure 2 (colors and labels added). The location of the incident was found on Google Earth (Figure 3) using latitudinal and longitudinal coordinates from the crash report. Selected scene photos are shown in Figure 4 and the Google Earth Image in Figure 5 depicts the area of the incident at street level.

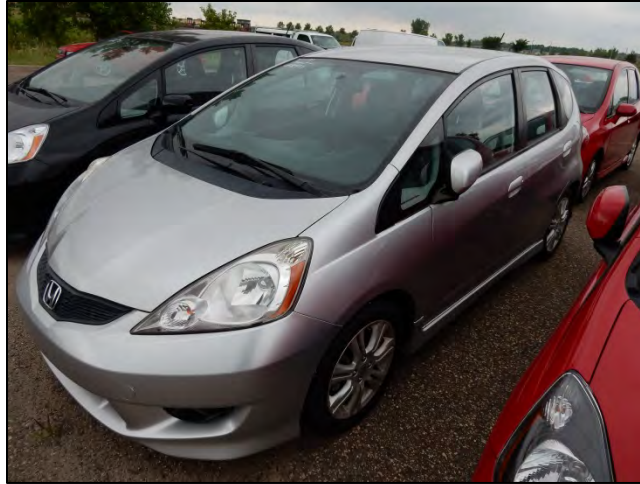
Figure 6 – Exemplar Honda Fit

An exemplar Honda Fit was located. The exterior of the exemplar vehicle was measured and photographed (Figure 6).

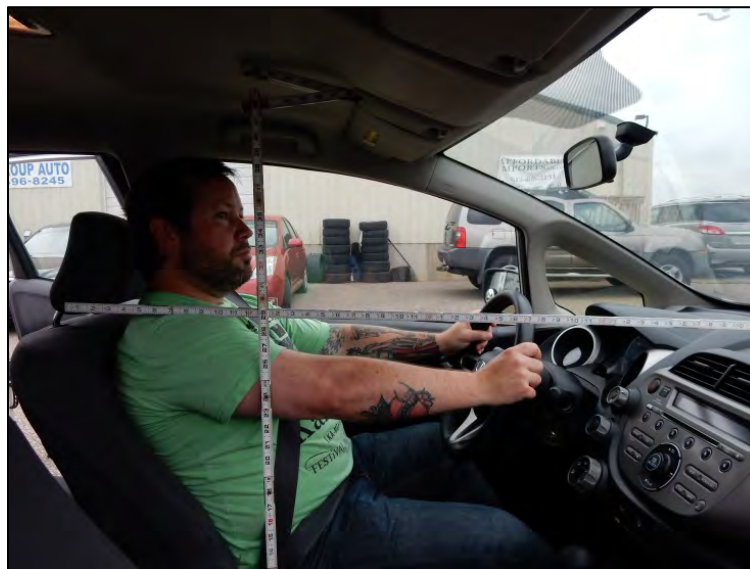
Figure 14 – Driver's Surrogate Fit in Exemplar Honda Fit

The objective of the surrogate fit (Figures 14 and 15), was to relate geometrical dimensions of the Honda Fit to the heights of Mr. and Mrs. Seebachan of 69 inches and 68 inches, respectively. The GEBOD (AL/WPAFB) computer program was used to generate the body descriptions for Mr. and Mrs. Seebachan's anthropometry. The GEBOD output indicates Mr. Seebachan's seated height of 36.18 inches. The selected surrogate GEBOD output had a seated height of 36.54 inches resulting in a 0.36 inch greater seated height for the surrogate. The GEBOD output indicates Mrs. Seebachan's seated height of 35.64 inches. The selected surrogate GEBOD output had a seated height of 35.91 inches resulting in a 0.27 inch greater seated height for the surrogate. Additionally, GEBOD output data set includes the body segments' geometric and mass properties and the joints' locations and range of motion characteristics that allows for detailed dimensional comparisons. Only the surrogate's heights in comparison to the Mr. and Mrs. Seebachan's are of relevance in static geometrical fit.
