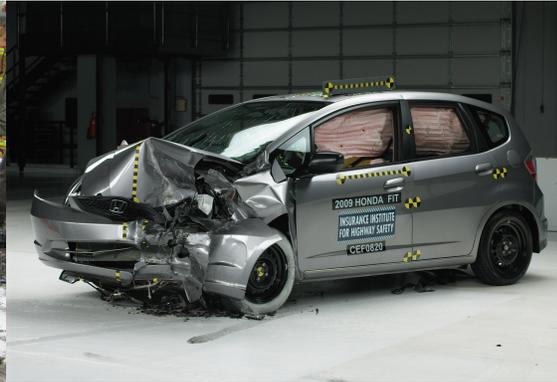
Figure 2. IIHS moderate overlap test

In the Institute’s moderate overlap test, a vehicle travels at 40 mph toward a barrier with a deformable face. A Hybrid III dummy representing an average-size man is positioned in the driver seat. Forty percent of the total width of the vehicle strikes the barrier on the driver side. The forces in the test are similar to those that would result from a frontal offset crash between two vehicles of the same weight, each going just under 40 mph.
