2016 Civic: New Model Body Repair Information

DISCLAIMER: This publication contains a summary of new body and vehicle technology that may affect collision and other body repairs. Always refer to the appropriate electronic service information for complete repair information. A subscription may be purchased at: techinfo.honda.com

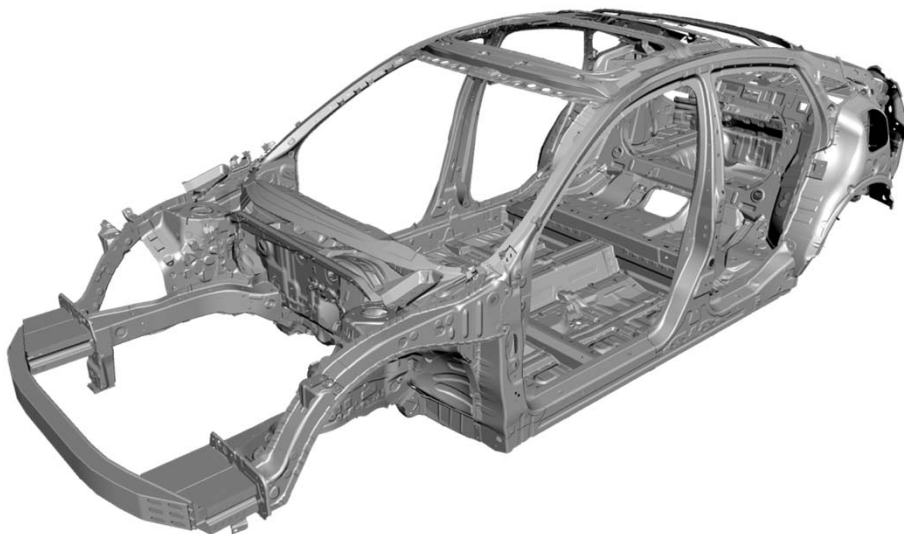
OVERVIEW OF BODY FEATURES

- Next-Generation Advanced Compatibility Engineering™ (ACE™) body structure
- Body construction using 58% high-tensile-strength steel (HSS), including 26% ultra-high-strength steel (UHSS - 980 MPa and higher)
- Weight-saving 1,500 MPa steel center pillar stiffener and rear frame with soft zones for crash performance
- Bolt-on resin composite lower front bulkhead assembly
- Introduction of the Honda Sensing™ suite of advanced safety and driver-assistive technologies, including: Adaptive Cruise Control with Low Speed Follow, Lane Keeping Assist System, Road Departure Mitigation, and Collision Mitigation Braking System™ with pedestrian sensing capability

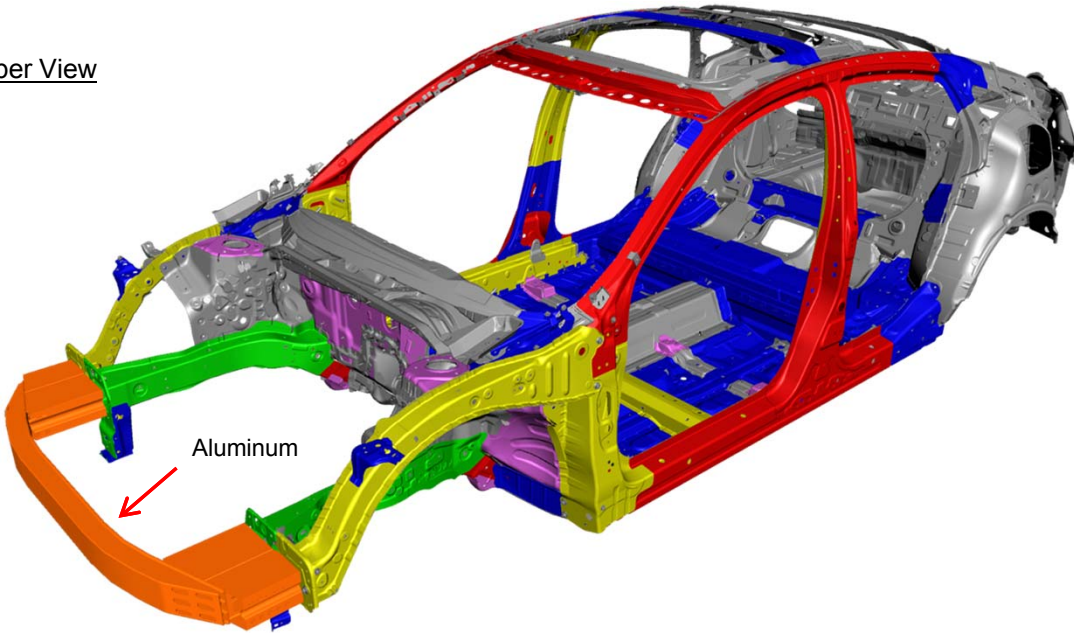
Upper View

- Steel parts are color coded based on their tensile strength in megapascals (MPa).
- High-strength steel (HSS) is defined as any steel with a tensile strength of 340 MPa or higher.
- Ultra-high-strength steel (UHSS) is defined as any steel with a tensile strength of 980 MPa or higher.
- Steel repair and welding procedures vary depending on the tensile strength of the parts involved.

These illustrations are for general reference only. Some body parts are constructed from multiple layers of different tensile strength steels. Refer to the body service information's body construction section for specific steel tensile strength information.

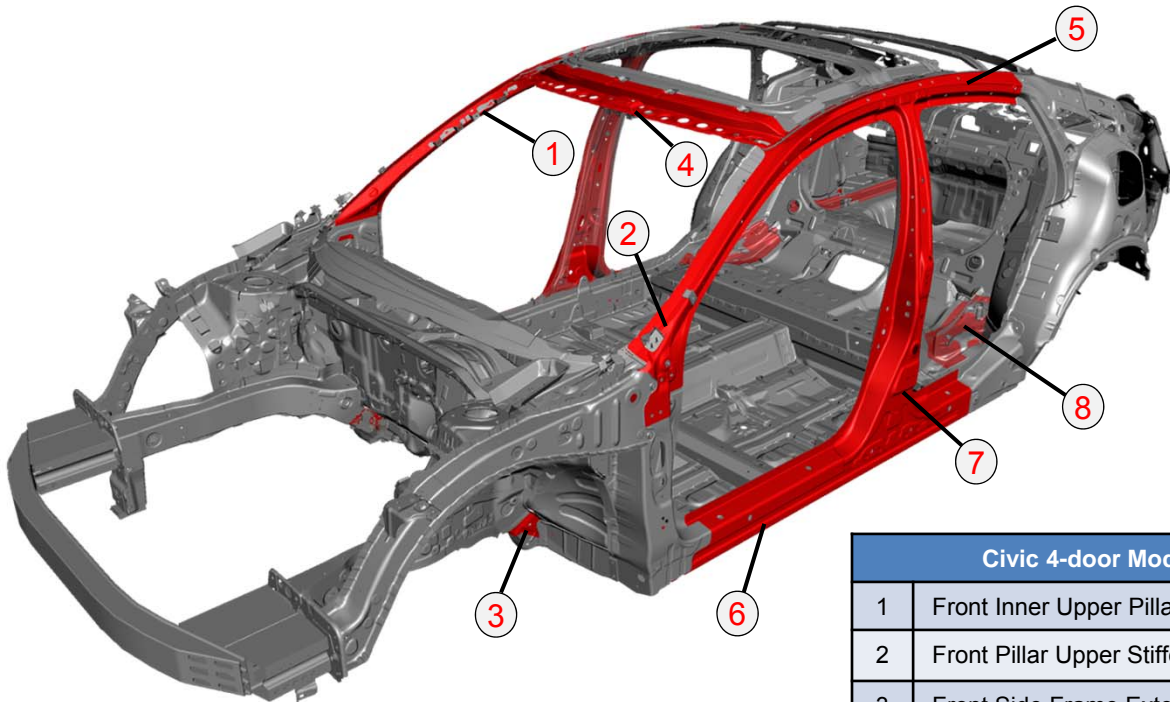
1,500 MPa steel is stronger than ordinary steel, so it can help protect vehicle occupants while reducing overall vehicle weight to improve fuel efficiency.

The numbered parts in the diagram below are constructed of 1,500 MPa steel:

Civic 4-door Models	
1	Front Inner Upper Pillar
2	Front Pillar Upper Stiffener
3	Front Side Frame Extension
4	Roof Front Rail
5	Roof Side Stiffener
6	Side Sill Reinforcement
7	Center Pillar Stiffener
8	Rear Frame

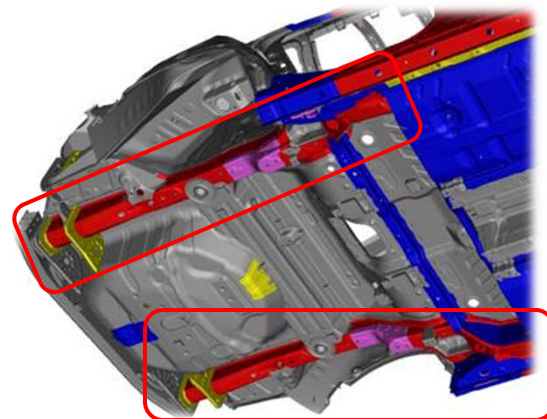
4-door models utilize weight-saving 1,500 MPa steel rear frame rails with soft zones for impact crush control.

- If rear frame damage is suspected, measure the **entire** vehicle using a three-dimensional measuring system.
- If the rear frame is damaged, replace the affected rear frame(s) as a complete assembly only.
- The traditional replacement of only the rear portion of the frame (Rear Frame B) is **not** possible because the 1,500 MPa rear frame **cannot be sectioned**.
- For further repair information, refer to the following:
 - “Repairing 1,500 MPa Steel Parts” on **page 7** of this publication.
 - “Rear Floor/Rear Frame Replacement” in the body service information.

1,500 MPa Steel Rear Frame Rails

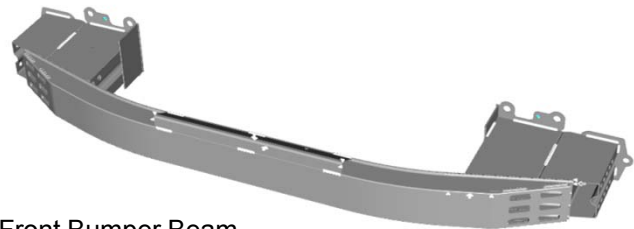
The front bumper beam uses 6000 series aluminum alloy construction.

- Do not repair damaged bumper beams.
- To help prevent galvanic corrosion, some fasteners for aluminum parts are considered one-time use and must be replaced if removed.

Front Bumper Beam

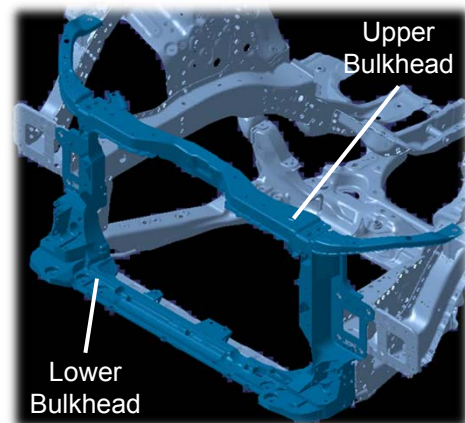
This vehicle has a lower bulkhead assembly constructed of resin composite material.

- The upper bulkhead frame is constructed of 270 MPa mild steel.
- The front upper and lower bulkheads are only sold as a complete assembly.
- The bulkhead design improves engine compartment access during factory assembly and service.
- The cooling fans, radiator, A/C condenser, hood lock, outside air temperature sensor, and related piping/components are attached to the front bulkhead.
- The bulkhead is attached to the body with 20 bolts.
- A damaged bulkhead must be replaced.
- For more information, refer to “Front Bulkhead Replacement” in the body service information.

Resin Composite Front Bulkhead

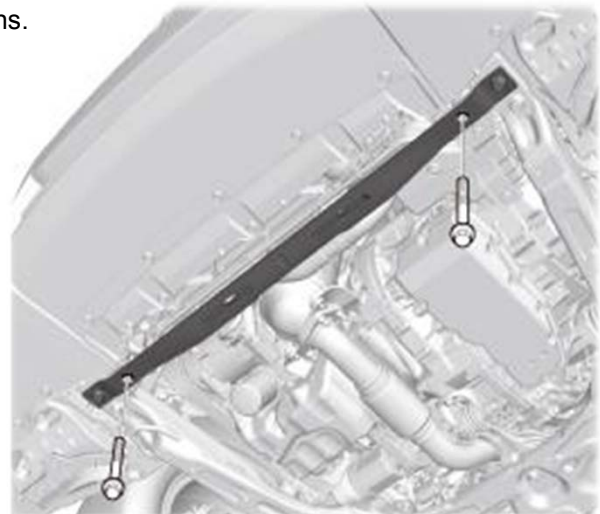
This front brace is located under the front bumper directly ahead of the front subframe.

- The front brace is attached to the body using special collar bolts that compensate for body dimensional variations.
- A special removal and installation procedure is required
- For more information, refer to “Front Brace Removal and Installation” in the service information.

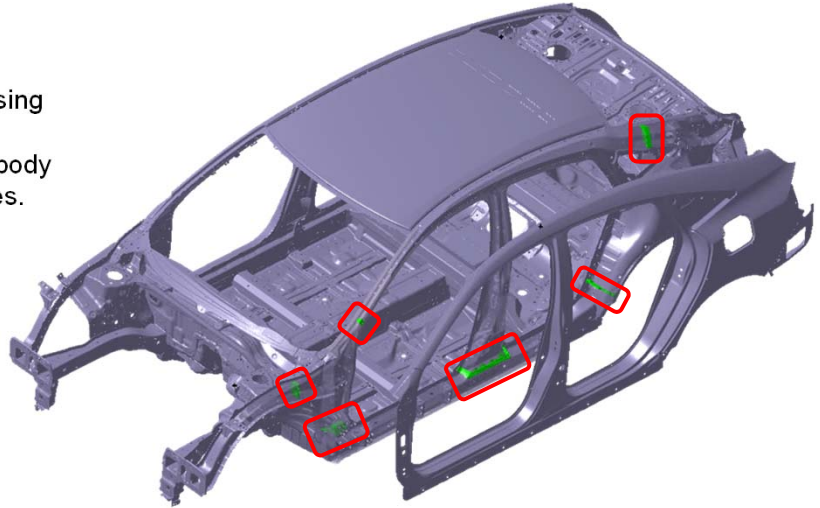
A combination of molded, extruded, and tape acoustic separators are applied in various body locations.

- Locations are shown in the diagram below.
- These are applied within the body pillars.
- They are designed to block noise paths into the cabin from hollow body cavities.
- Repairs are similar to previous models using commercially-available products.
- Refer to the Replacement section of the body service information for specific procedures.

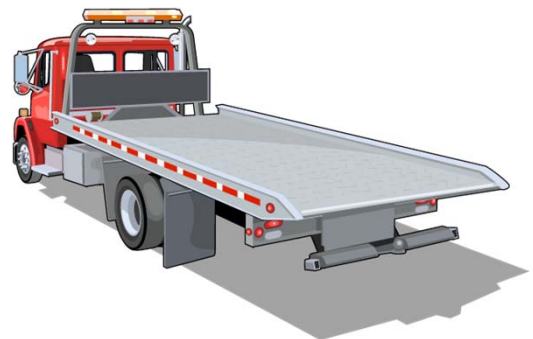
- Flat bed towing equipment is the preferred method to transport this vehicle.
- Front wheel lift towing equipment may also be used to tow this vehicle.

- Lift or jack only at the specified points to avoid damaging the vehicle.
- **Do not** lift or tow this vehicle by its bumpers, or serious damage will result.

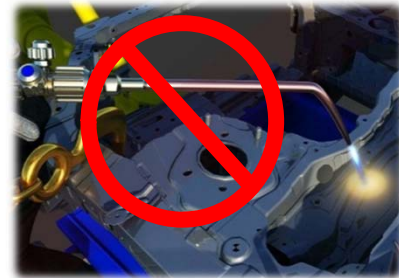
- **Do not** apply heat to any body part during straightening. This may compromise the internal structure and strength of high-strength steel parts.
- Any part that has heat applied to it during straightening **must** be replaced with new parts.
- Ignoring these instructions may significantly reduce occupant protection in any subsequent collision.

Do not heat during straightening

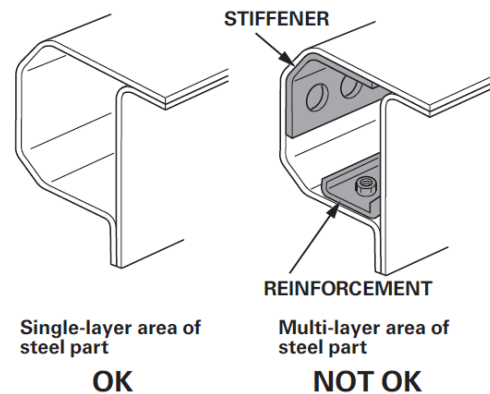
- Sectioning (cut and joint) should usually be avoided except for mild steel outer panels and floor panels unless a specific procedure is provided in the body service information.
- However, depending on the type of vehicle damage, steel parts with a tensile strength ≤ 780 MPa may be sectioned provided **all** of the following conditions are met:
 - Sectioning must be done in a single-layer area of the part.
 - Multi-layer internal steel reinforcements and stiffeners must not be cut.
 - The repair is not in a load-bearing area such as engine, transmission, or suspension mounting points.
- Replace body structural components such as stiffeners, reinforcements, and other multi-layered steel parts as assemblies that match the replacement parts configuration.
- Approved welding methods are listed in the table on the right.
- Refer to the body service information for complete information.

Sectioning Area Examples

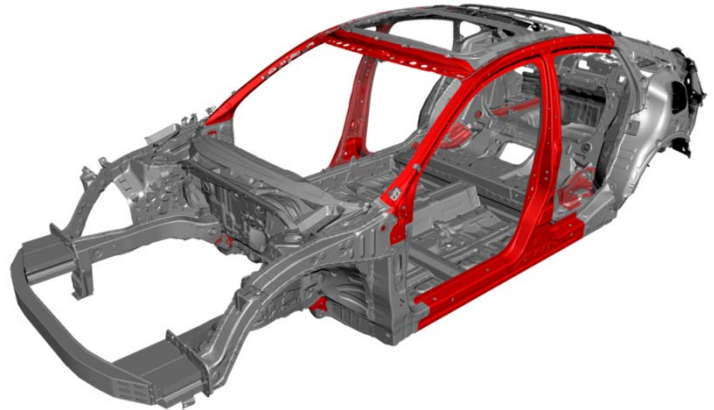
- **Never** attempt to straighten damaged 1,500 MPa steel parts; they may crack.
- 1,500 MPa steel parts **must** be replaced at factory seams using squeeze-type resistance spot welding (STRSW). **Do not section these parts!**
- MIG brazed joints should be used **only** in locations not accessible by a spot welder.
- To assure adequate weld tensile strength, always manually set the spot welder to the specifications provided in the body service information.

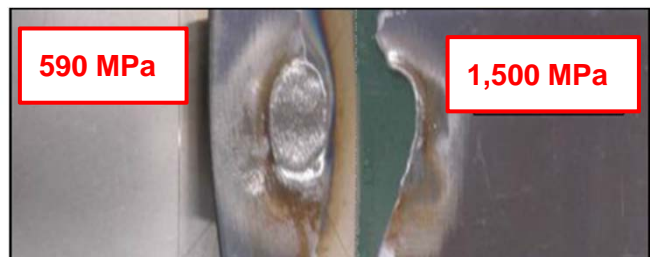
- **Never** do MAG welding on 1,500 MPa steel. The heat generated during MAG welding will significantly reduce the strength and structural integrity of 1,500 MPa steel parts.
- The photo on the right shows tensile strength test results of MAG welded 1,500 MPa steel. The 1,500 MPa steel fractured first because the welding heat reduced its strength to far below 590 MPa.
- For more details, refer to the body service information “Basic Welding Information” section.

Tensile Test Results of MAG-Welded 1,500 MPa Steel

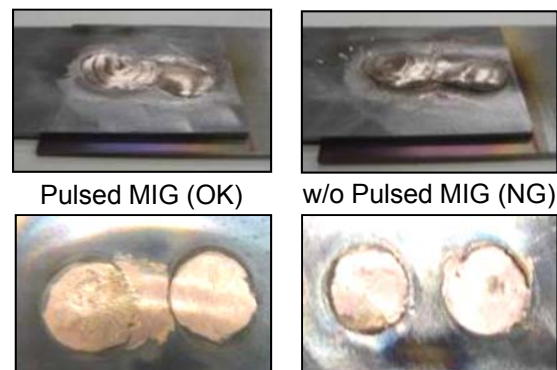
- MIG-brazed joint locations are specified in the body service information.
- A single- or double-hole MIG braze may be specified in the body service information depending on the tensile strength of the parts being joined.
- The size and number of holes are critical to achieving adequate joint strength.
- A MIG welder with pulse control **must** be used. Refer to the equipment manufacturer's instructions for welder voltage and current setup.
- The photos on the right show the difference in results between pulsed and non-pulsed MIG brazing.

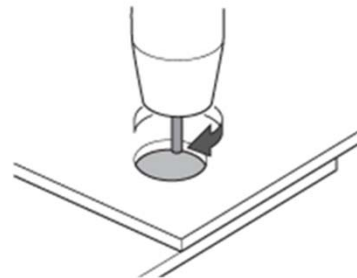
- MAG plug welding may be done when joining body components to 590–980 MPa steel parts.
- Follow the recommendations described in the body service information “Basic Welding Information” section.

MAG Plug Welding

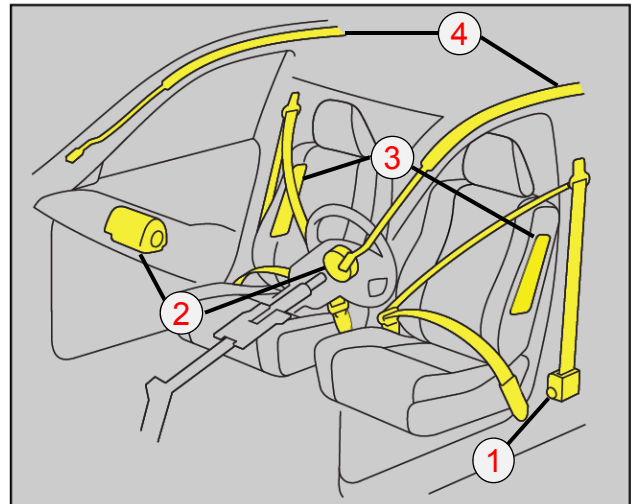
The airbag system in this vehicle includes the following components that may deploy in a collision:

1. Driver's and front passenger's seat belt tensioners (may deploy independently from any airbags).
2. Driver's and front passenger's SRS airbags.
3. Side airbags mounted in the driver's and front passenger's outer seat-backs.
4. Side curtain airbags mounted above the left and right side windows under the headliner.

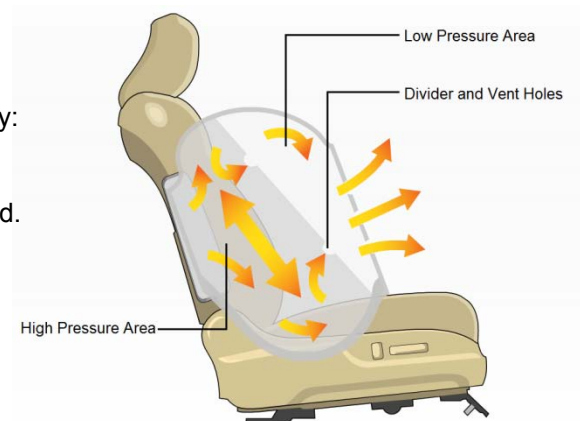
- This airbag design helps mitigate the risk of excessive airbag deployment force and risk of injury to smaller seat occupants.
- It eliminates the need for the occupant position detection system (OPDS) sensor located in the front passenger's seat-back.

- Special seat covers and/or breakaway thread are used to ensure the proper deployment path.
- Damaged front seat covers should be replaced, not repaired.
- Do not install non-factory seat covers; they may alter the airbag's intended deployment path.

SmartVent Side Airbag

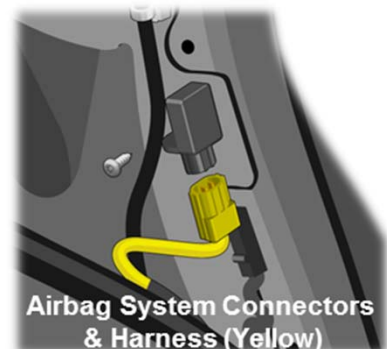
- For easier identification, electrical connectors that contain only airbag system wiring are yellow in color.
- Many harnesses that contain primarily airbag wiring are also wrapped in yellow tape.
- Airbag system wiring that runs in a common harness, such as a floor harness, is generally not marked.
- **Never** attempt to modify, splice, or repair airbag system wiring. If any part of the airbag system wiring is damaged, replace the affected wiring harness(es).

Airbag System Connectors & Harness (Yellow)

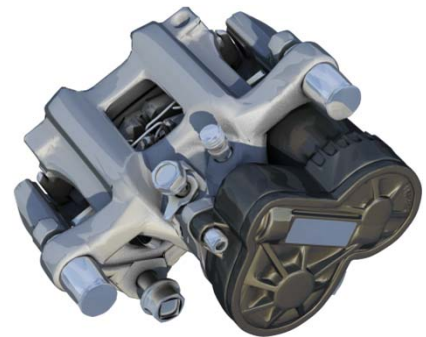
- Electric actuators on each rear brake caliper apply and release the brake pads.
- A manual procedure is provided if a malfunction prevents parking brake release.
- Refer to “Electric Parking Brake Forced Cancellation,” in the service information.

Electric Parking Brake Caliper

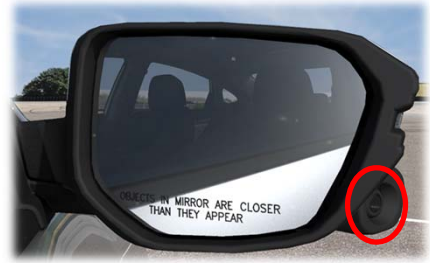
LaneWatch is an assistance system that uses a camera in the passenger's side door mirror along with the center display. It helps provide improved visibility of passenger side rear area for the driver.

LaneWatch Camera Location

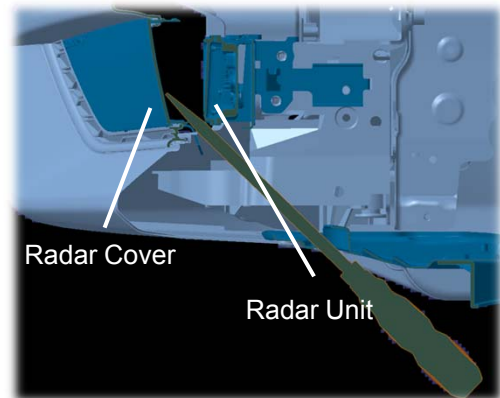
Some models are equipped with Adaptive Cruise Control and a Collision Mitigation Braking System™ (CMBS™). These systems use a millimeter wave radar unit mounted behind a plastic cover on the lower left side of the front bumper.

- This radar unit senses through a plastic cover attached to the left front fog light trim using hook-style clips.
- This part is specially designed to prevent radar interference.
- Do not paint or install any coverings over the radar cover. This may cause the Collision mitigation braking system indicator to come on and DTC P2583-97 (dust or dirt on the millimeter wave radar) to set.
- Radar cover removal requires a specific procedure and can be difficult. Refer to “Millimeter Wave Radar - Vertical Radar Aim” in the service information.

Side Cutaway View - Left Front Bumper Area

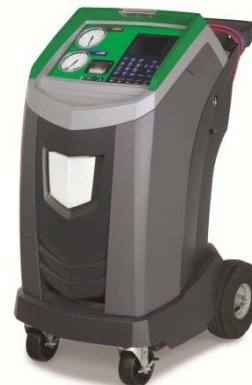
- R-1234yf refrigerant is considered “mildly flammable.” Be sure to observe all basic safety precautions for working around flammable gases. Refer to “A/C Service Tips and Precautions” in the service information.
- The system should only be serviced by qualified A/C technicians trained to handle R-1234yf refrigerant.
- Refrigerant recovery, charging, and leak detection all require dedicated tools and equipment designed and SAE approved for use with R-1234yf.
- Honda dealers have this equipment. Please contact your local dealer if you need assistance.
- RL85HM POE refrigerant oil is used in this A/C system. **Do not** use any other type of refrigerant oil.
- The receiver/dryer is integrated into the A/C condenser assembly and cannot be replaced separately.
- The receiver/dryer's desiccant bag is serviceable separately.

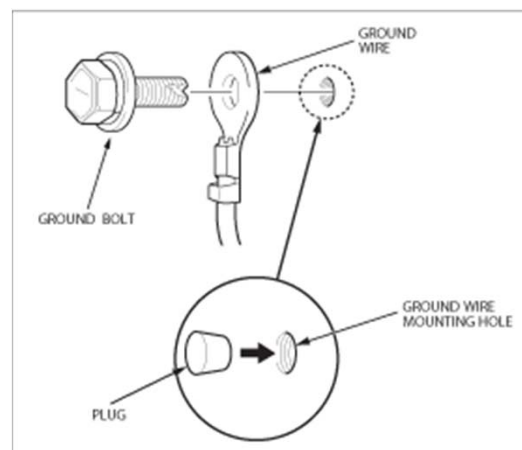
Failure to protect ground locations is the #1 cause of post-collision electrical problems on our vehicles.

- Painting over electrical ground locations may cause electrical systems, such as vehicle stability assist (VSA), to malfunction and set DTCs that may be difficult to diagnose.
- Protect the ground wire with masking tape and the ground wire mounting hole threads with a bolt or silicone plug when priming or painting.
- Honda ground bolts are almost always non-anodized, zinc plated self-cutting bolts. They can be identified by the triangular notch in the threads. Using the wrong bolt can cause ground problems.
- Do not use star or burred washers on electrical grounds.
