Vehicle as examined

Vehicle Data

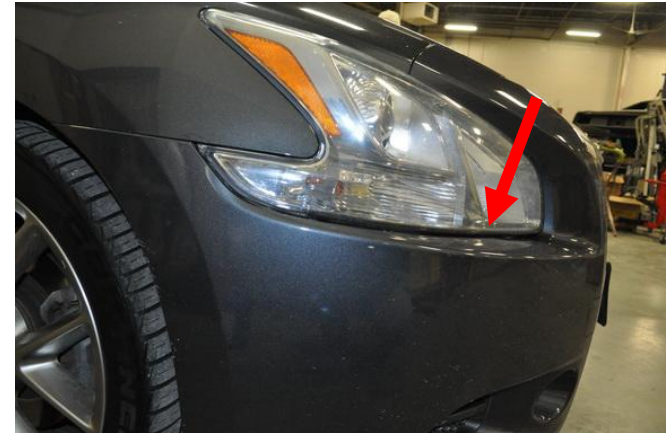
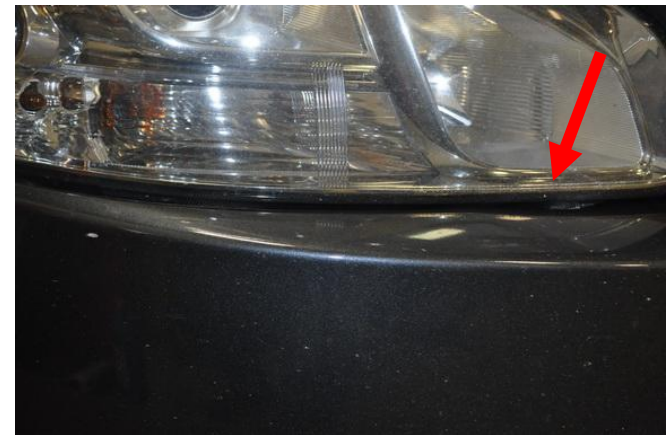
Excessive positive gap right headlamp to front fascia (red arrows).

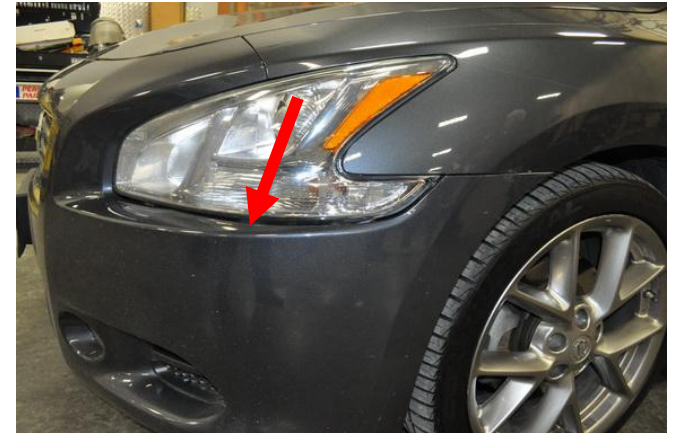
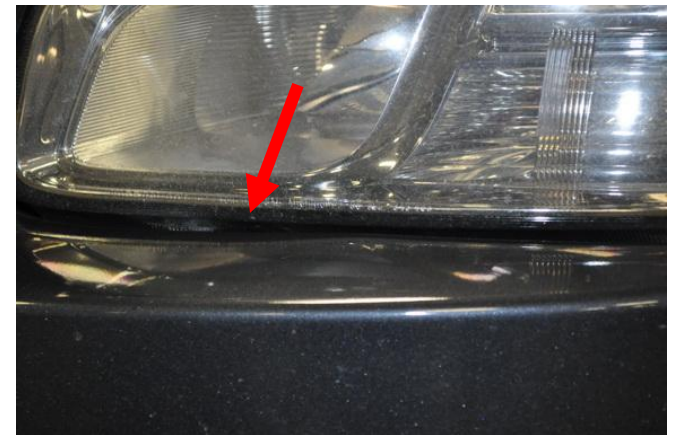
Excessive positive gap left headlamp
to front fascia (red arrows).

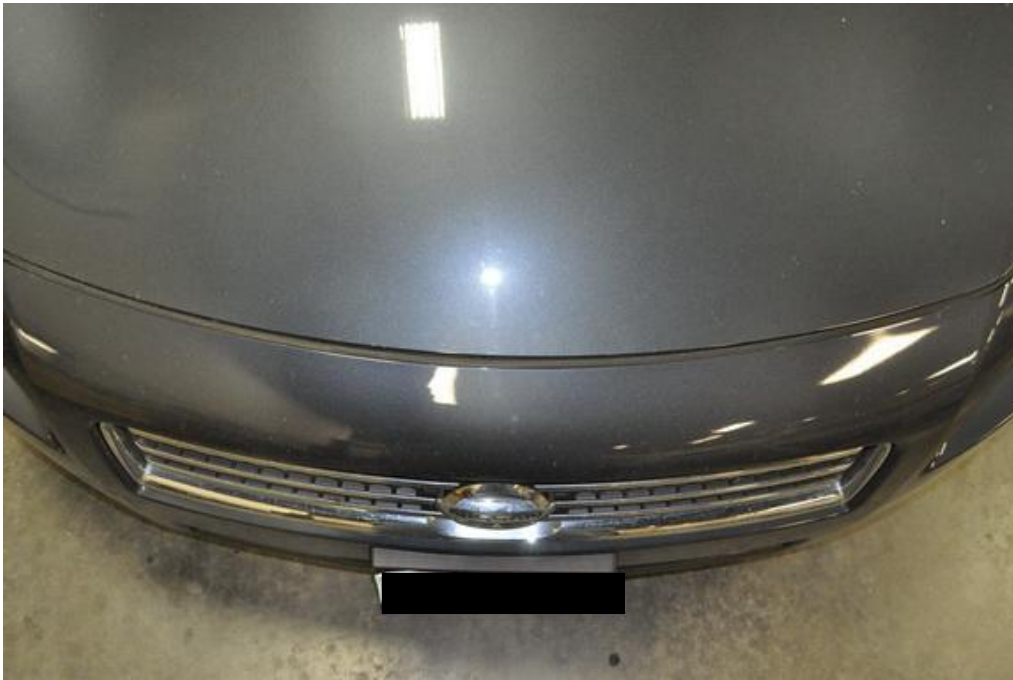
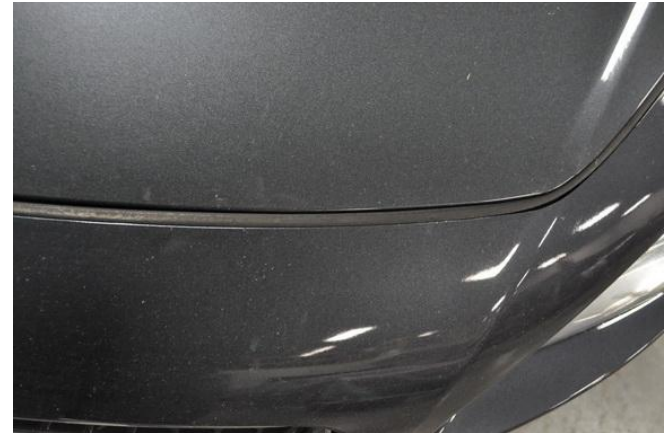
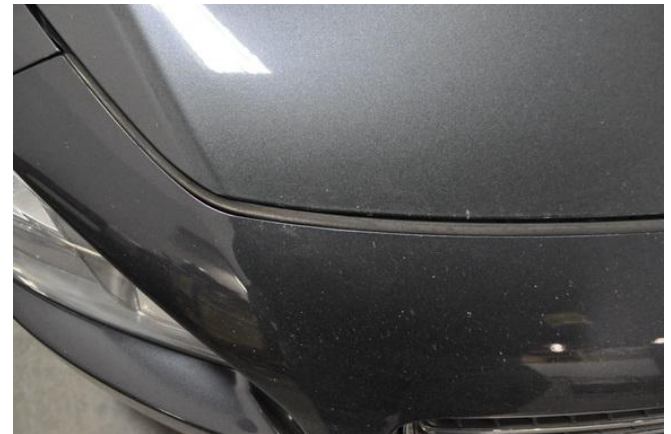
Hood to front fascia gap, excessive positive gap

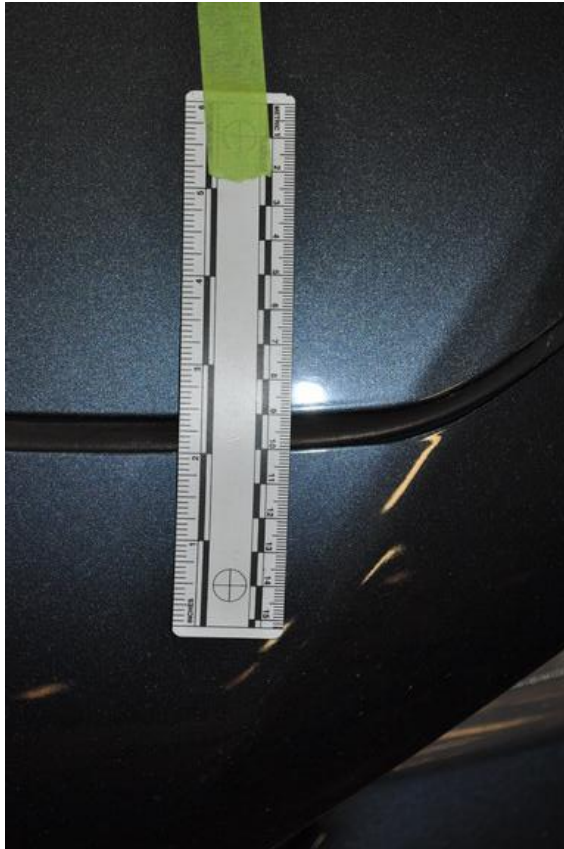
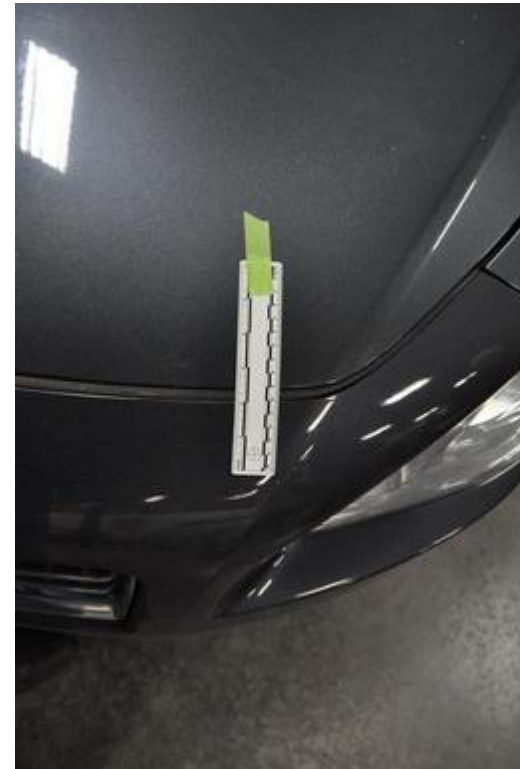
Hood to front fascia gap (left side), excessive positive gap of 11mm

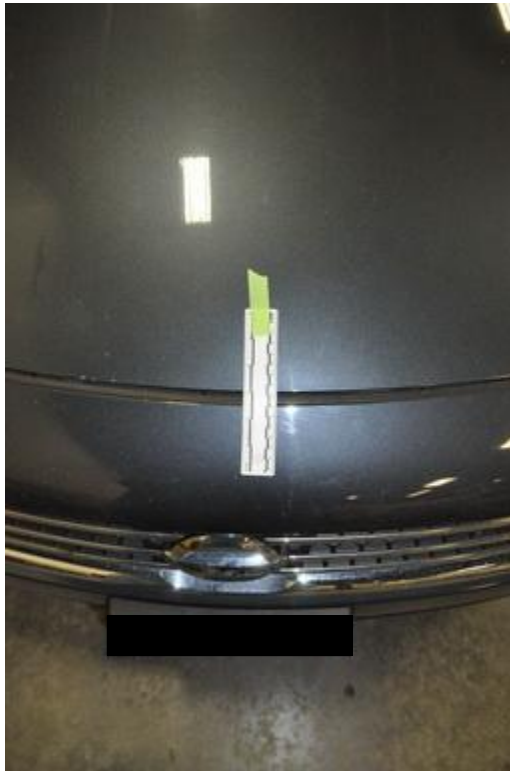
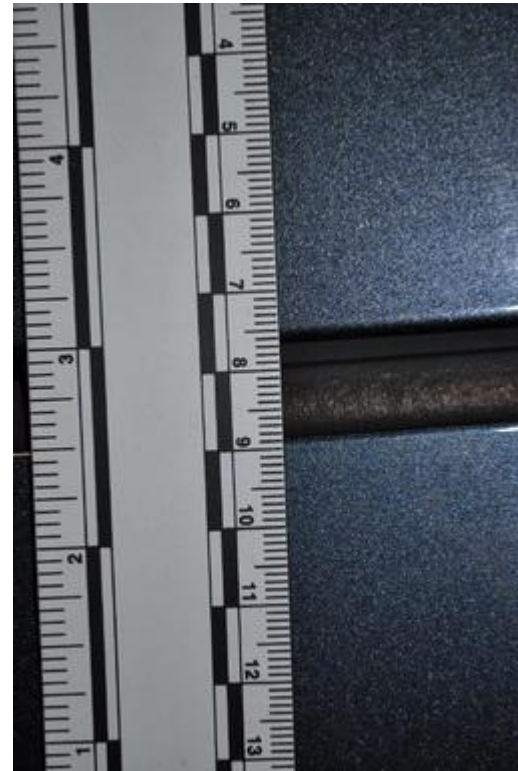
Hood to front fascia gap (center), excessive positive gap of 14mm

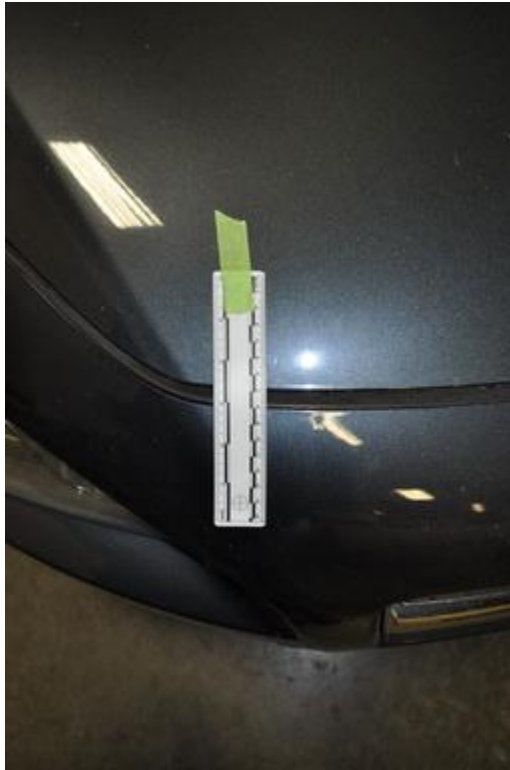
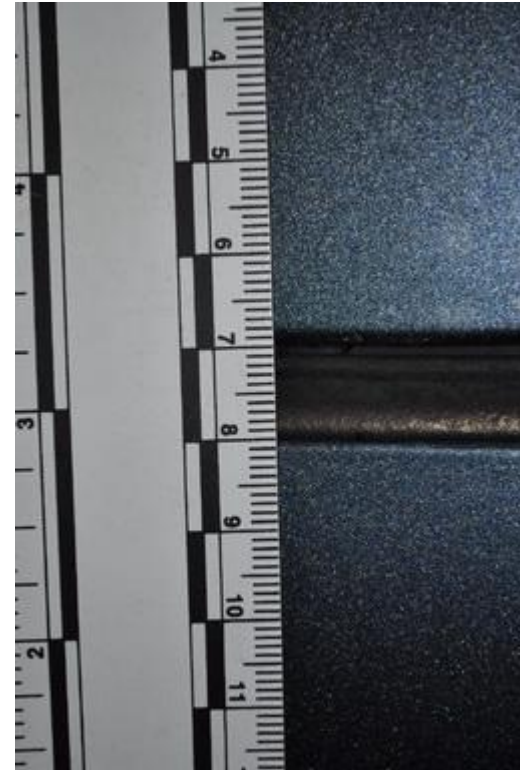
Hood to front fascia gap (right side), excessive positive gap of 7mm

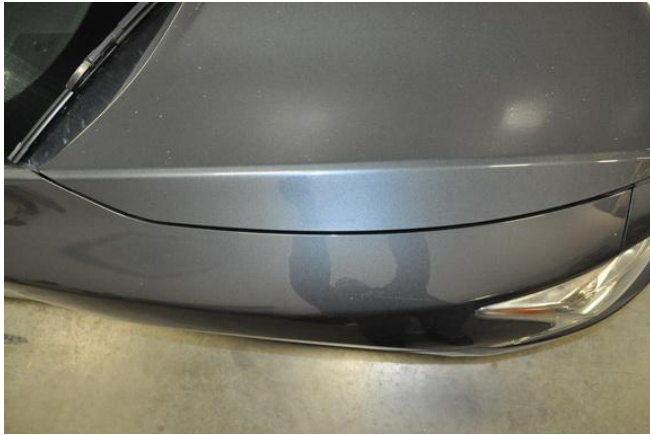
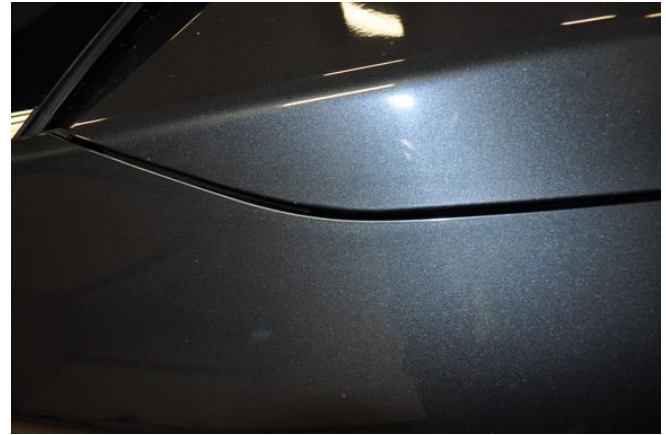
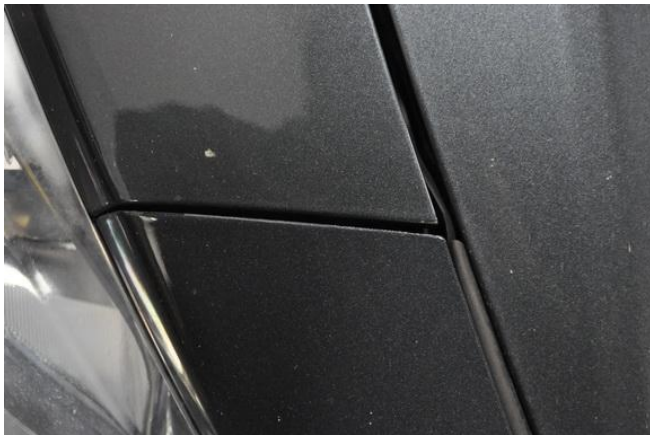
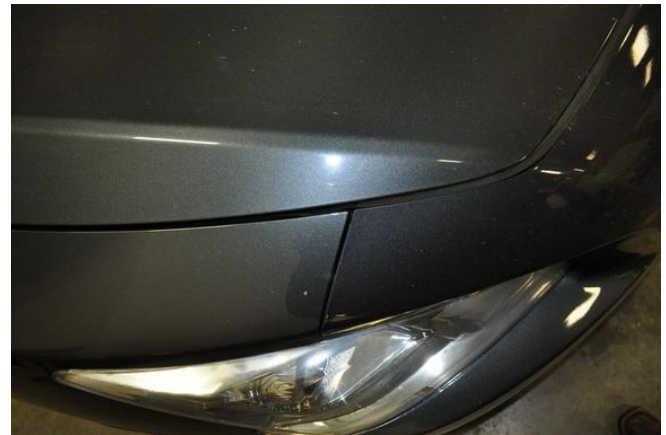
Hood to right front fender panel gap, excessive positive gap

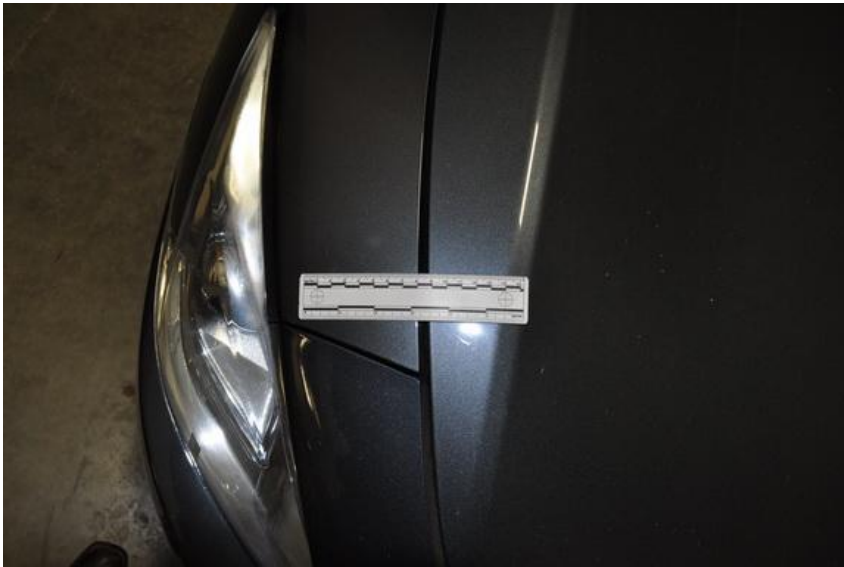
Hood to right front fender panel gap (front area), excessive positive gap of 7mm

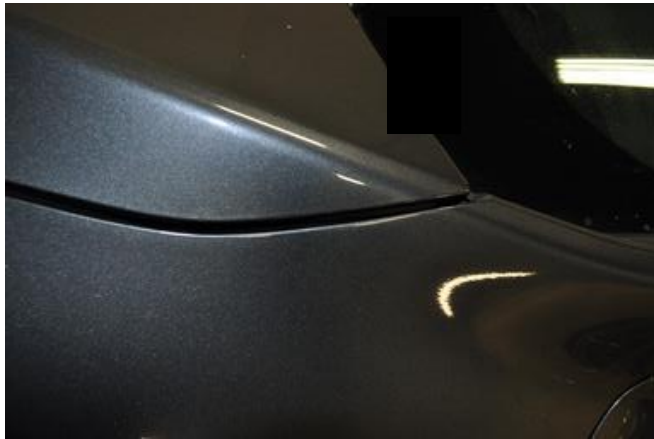
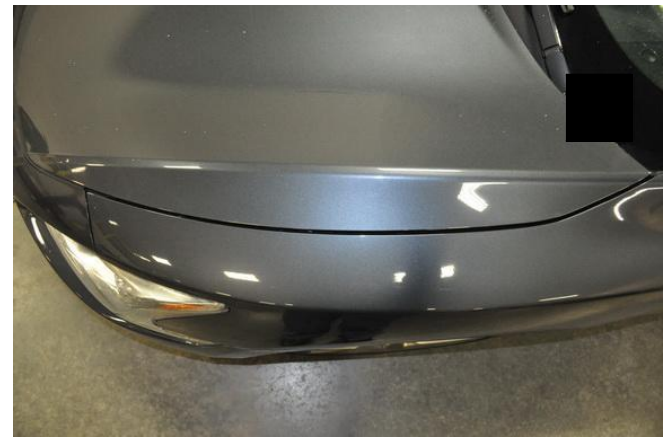
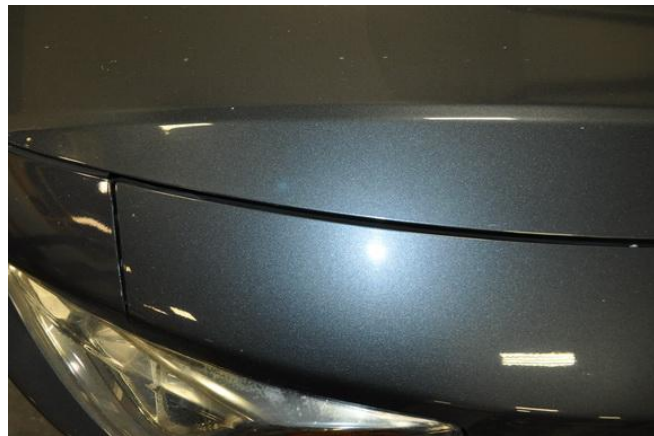
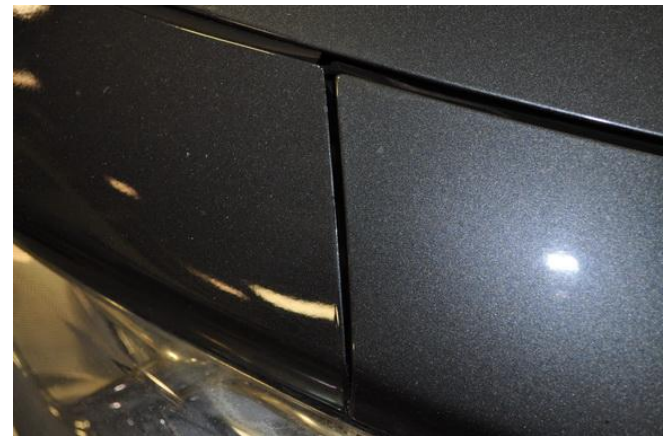
Hood to left front fender panel gap (rear area), excessive positive gap of 8mm

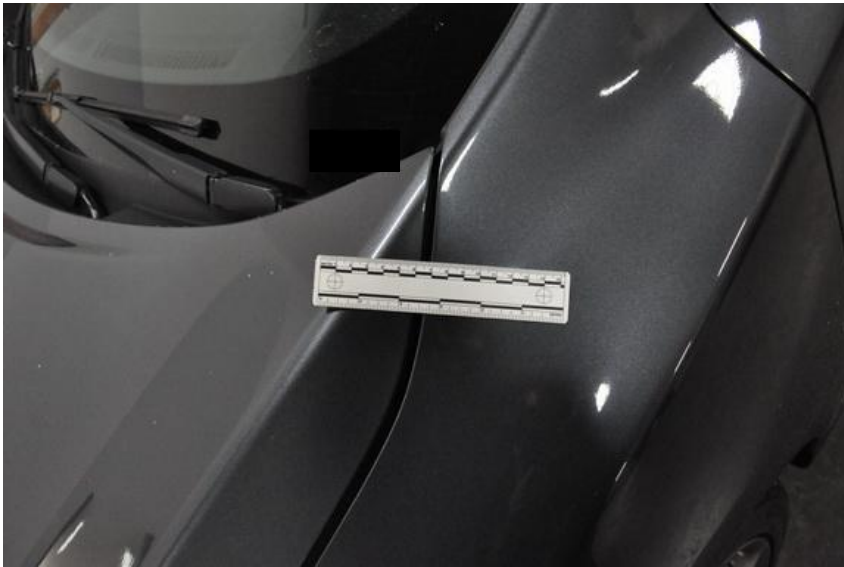
Hood to left front fender panel gap (mid area), excessive positive gap of 7mm

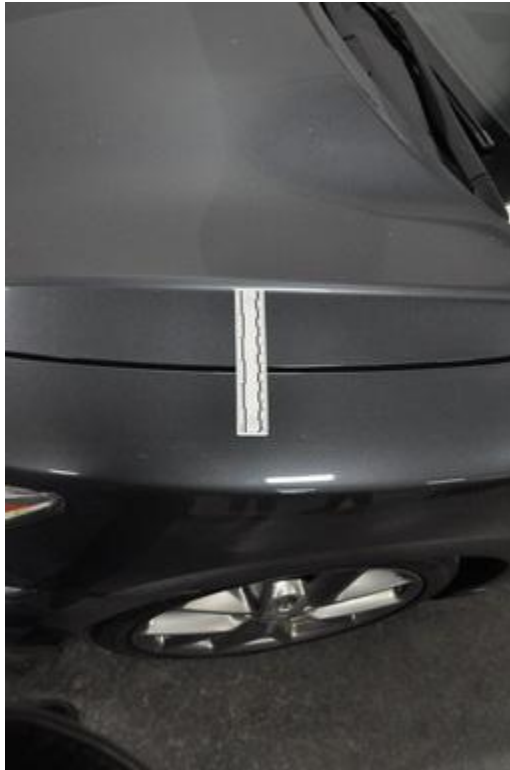
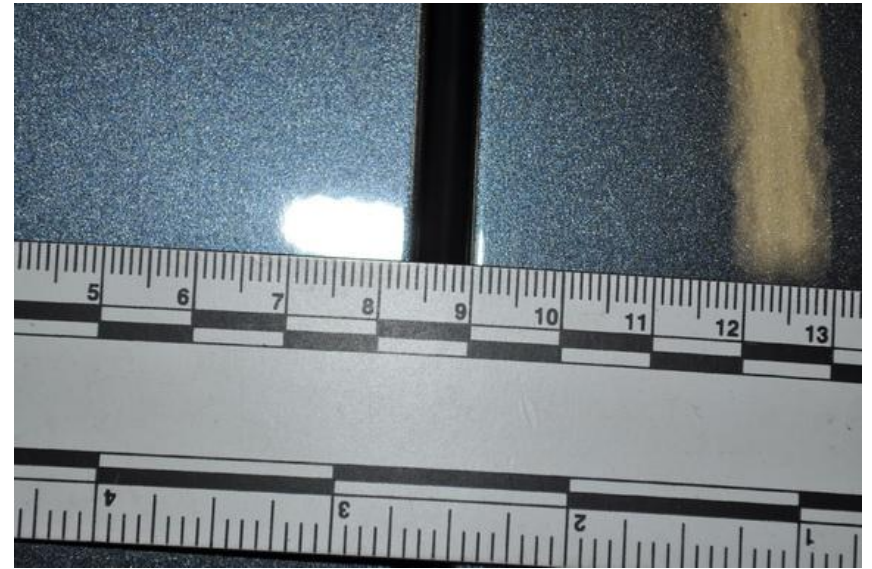
Hood to left front fender panel gap (front area), excessive positive gap of 7mm

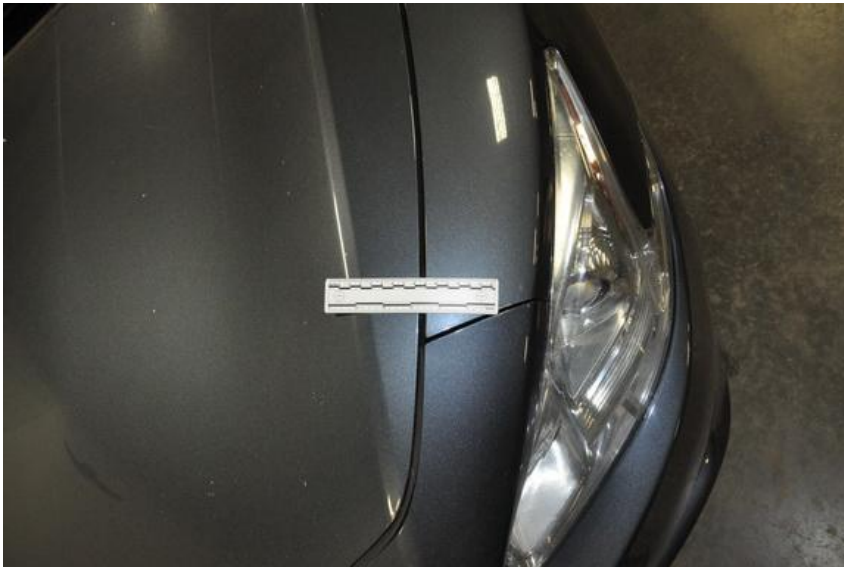
Left side of front fascia to left front fender,
excessive positive gap of 4mm

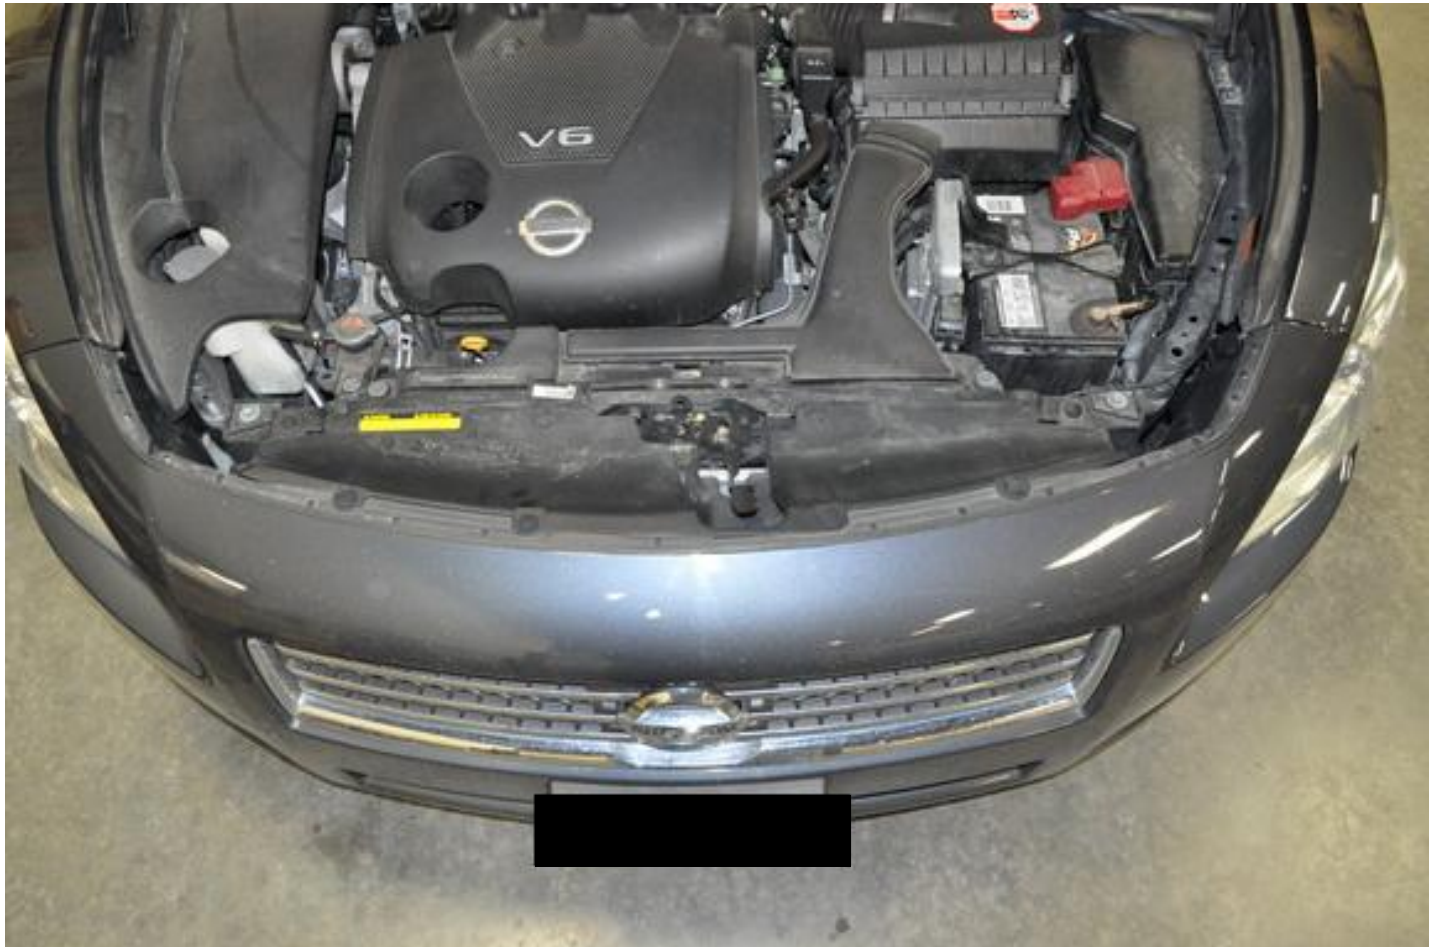
Missing mounting bolt, fiber reinforced radiator core support to air conditioning lines bracket (red boxes).

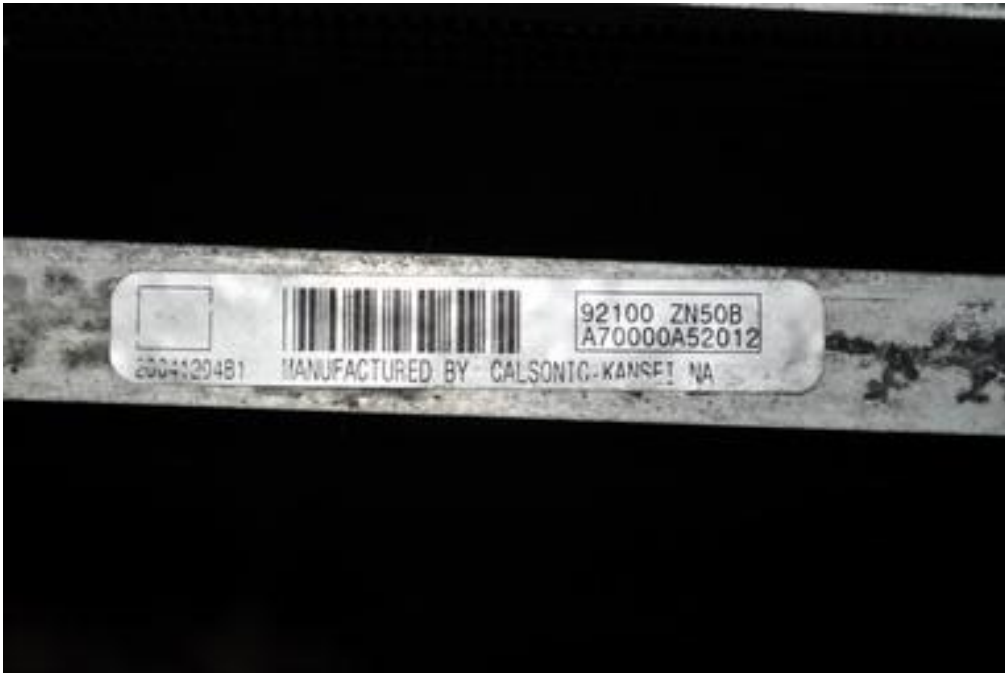
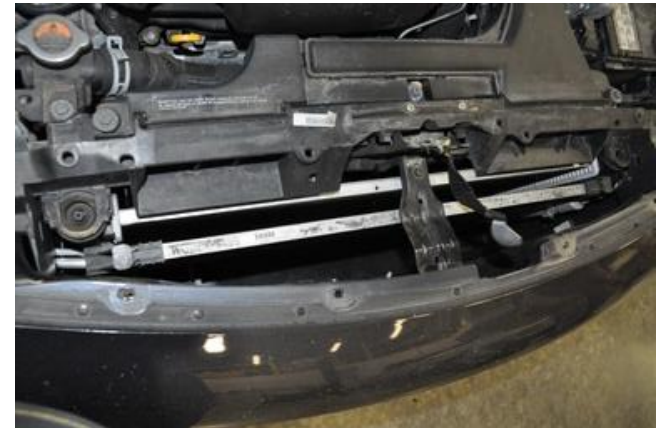
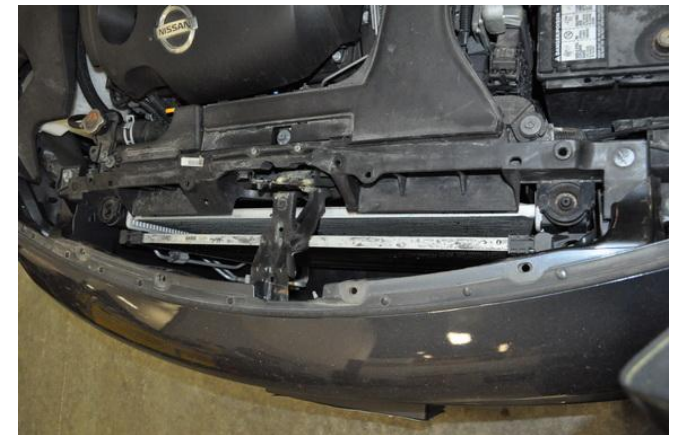
Positive and negative cable mounting nuts, no evidence of tool type impact markings.

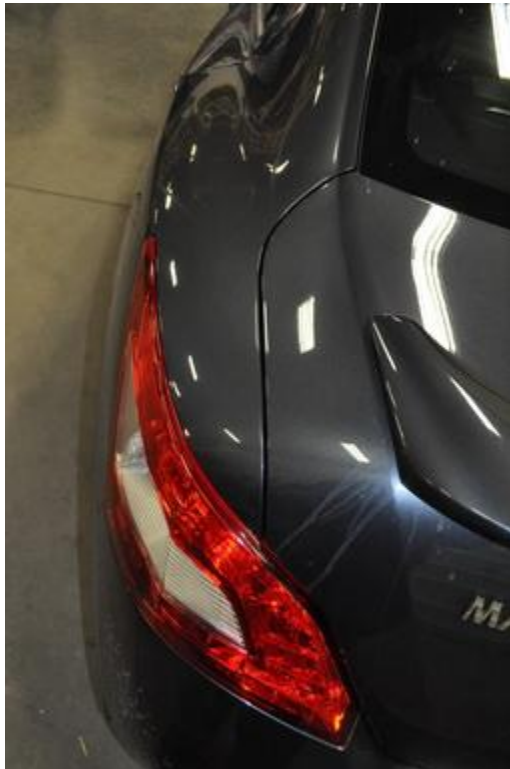
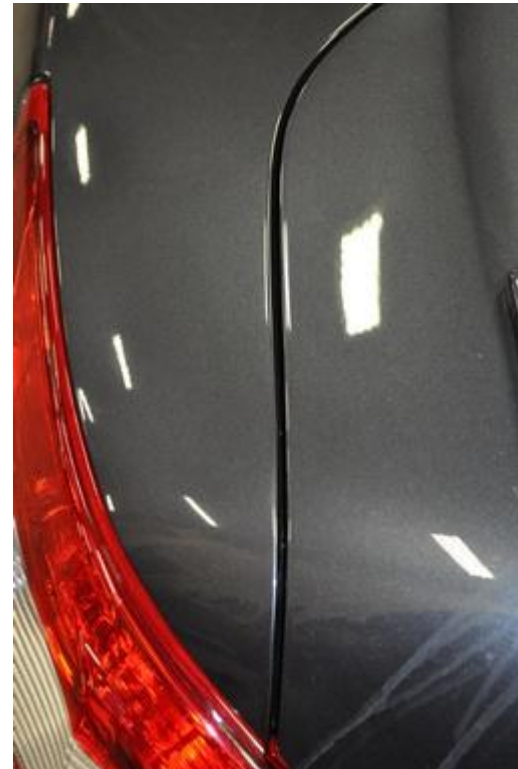
Left side deck lid to left quarter panel gap,
6mm gap acceptable.

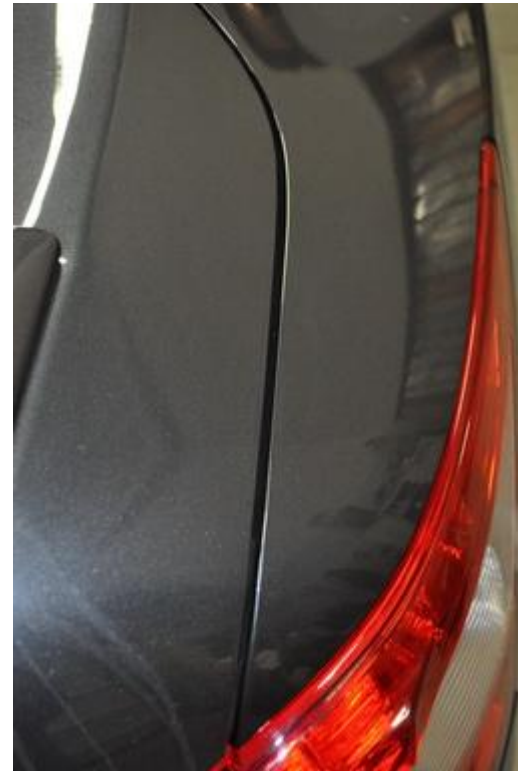
Right side deck lid to right quarter panel gap,
6mm gap acceptable.

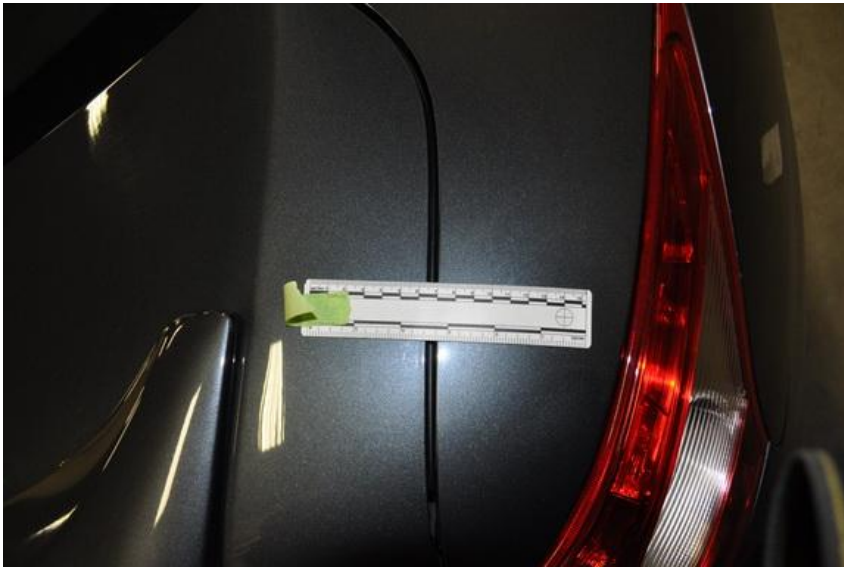
Left tail lamp to left quarter panel,
excessive positive gap of 6mm.

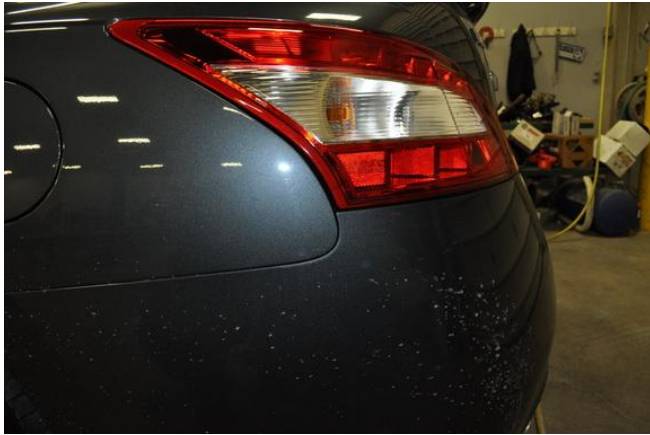
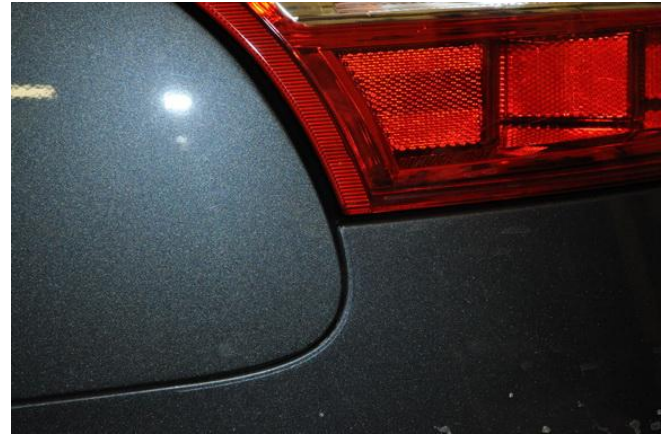
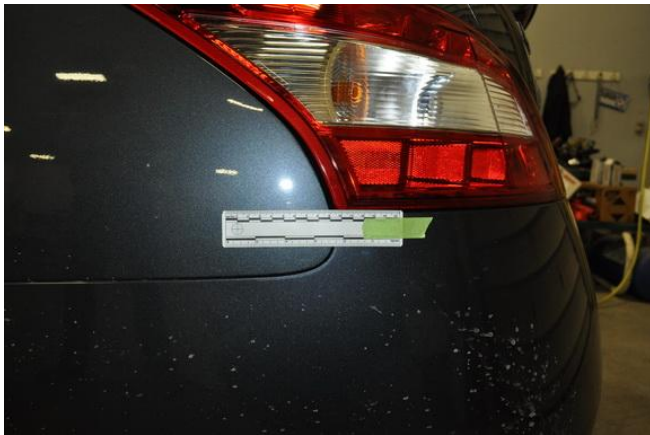
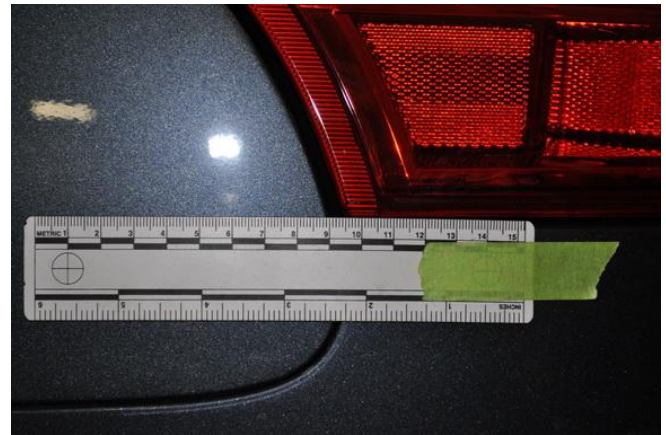
Right tail lamp to right quarter panel, excessive positive gap of 5mm.

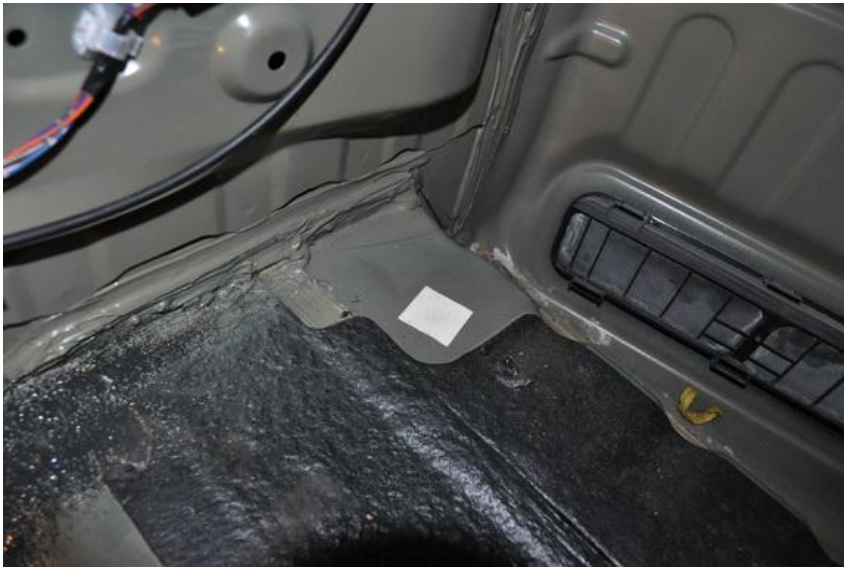
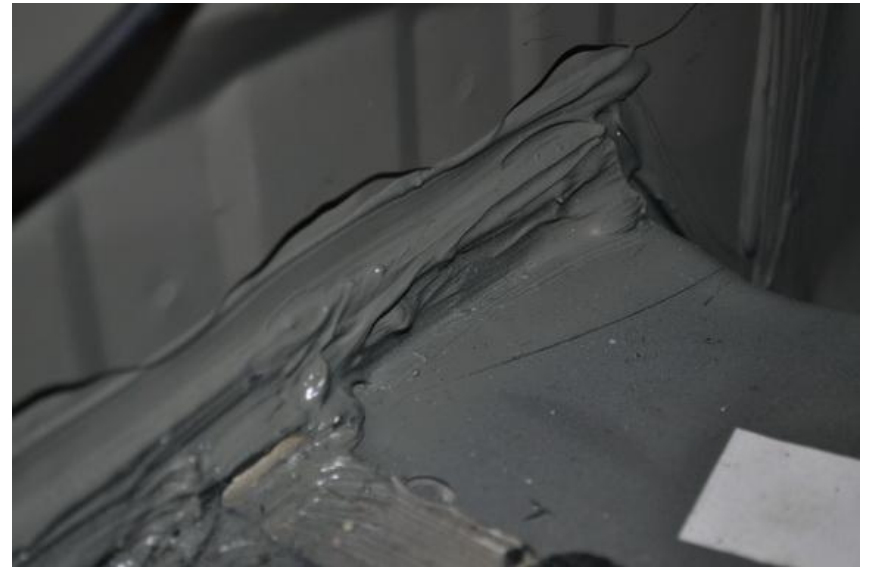
Right side of rear body panel to trunk floor panel, excessive and uneven applications of sprayable seam sealer.

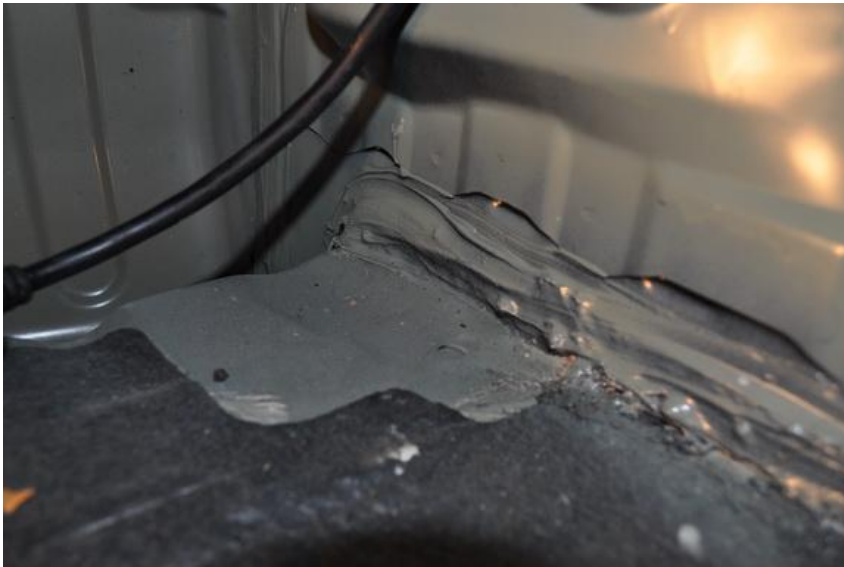
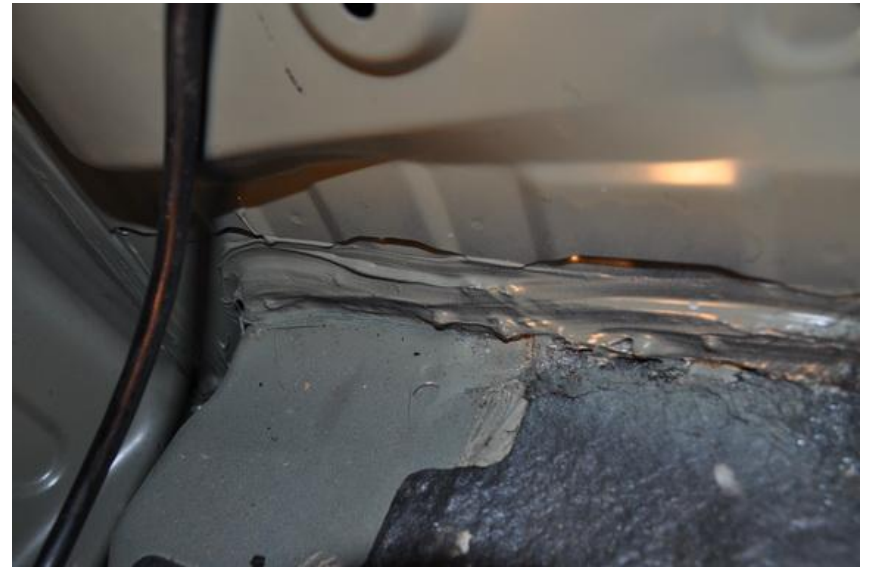
Right side of rear body panel to trunk floor,
removed seam sealer. Indications of a black
material uncured.

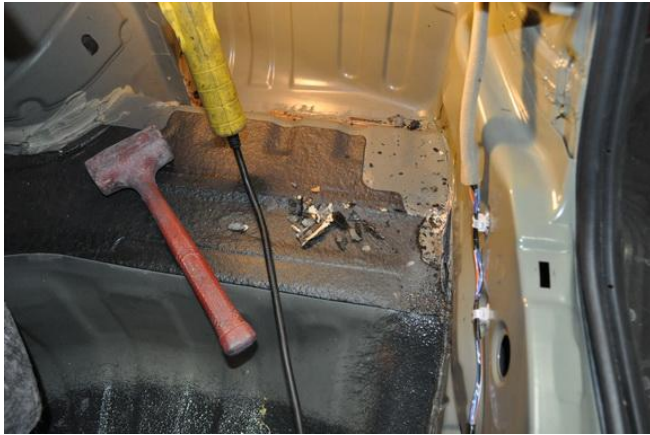
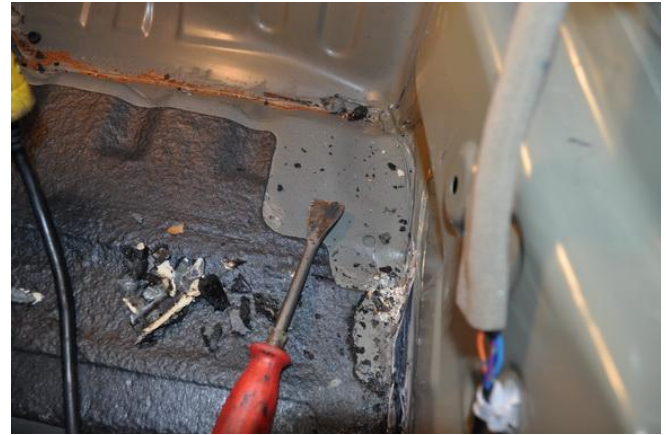
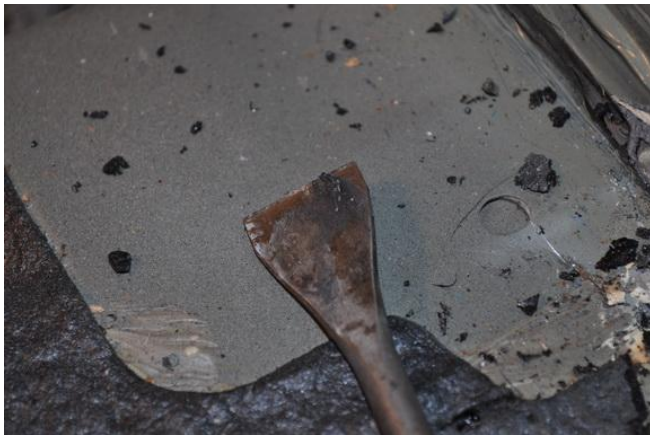
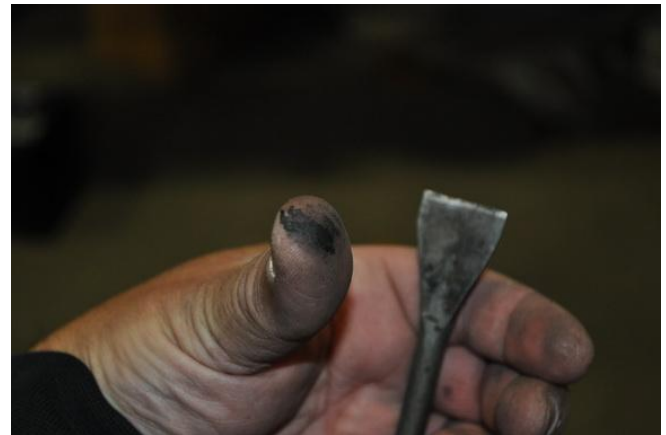
Right side of rear body panel to trunk floor,
indications of bonding adhesive applications and
no indications of resistance welds for 150mm.

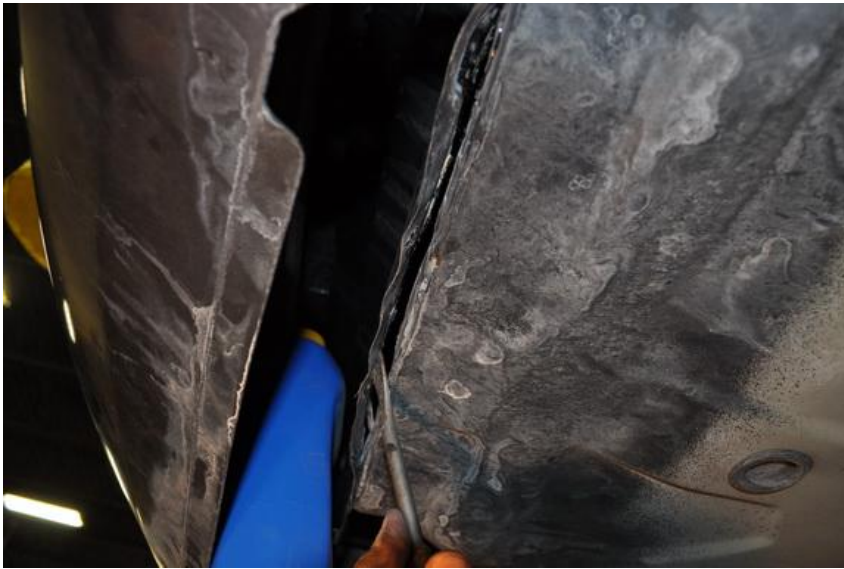
Application of a gasket scraper to the rear body panel to trunk floor mating flange. Light applications of force were applied and flange separated.

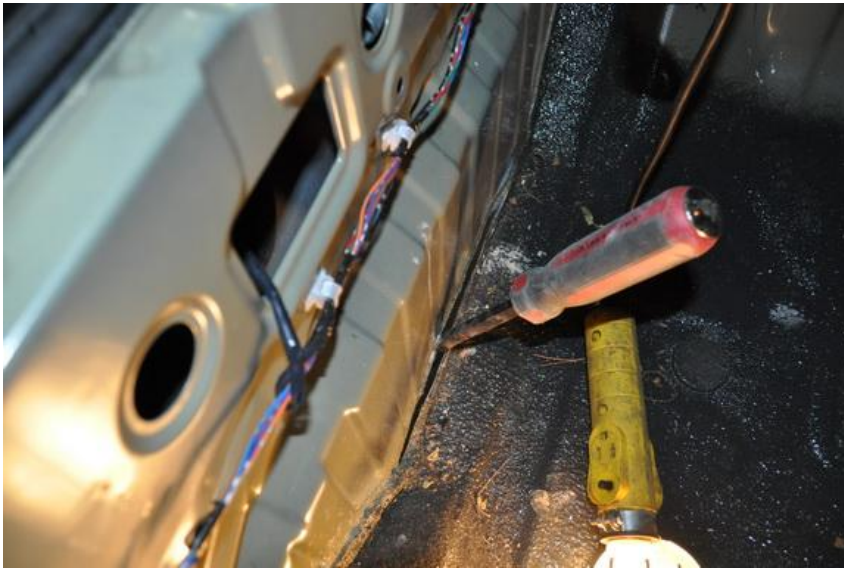
Pry bar placed in to the rear body panel to trunk floor mating flange, to show separation.
