Put Your Money Where Your Mouth is

**Todd Tracy
Dallas, Texas**

**Moderate Overlap Frontal Crashworthiness Evaluation
Crash Test Protocol (Version XVIII)**

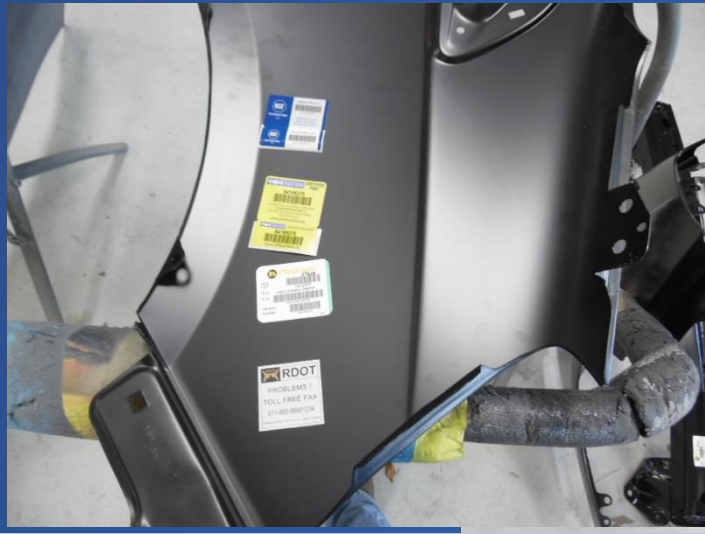
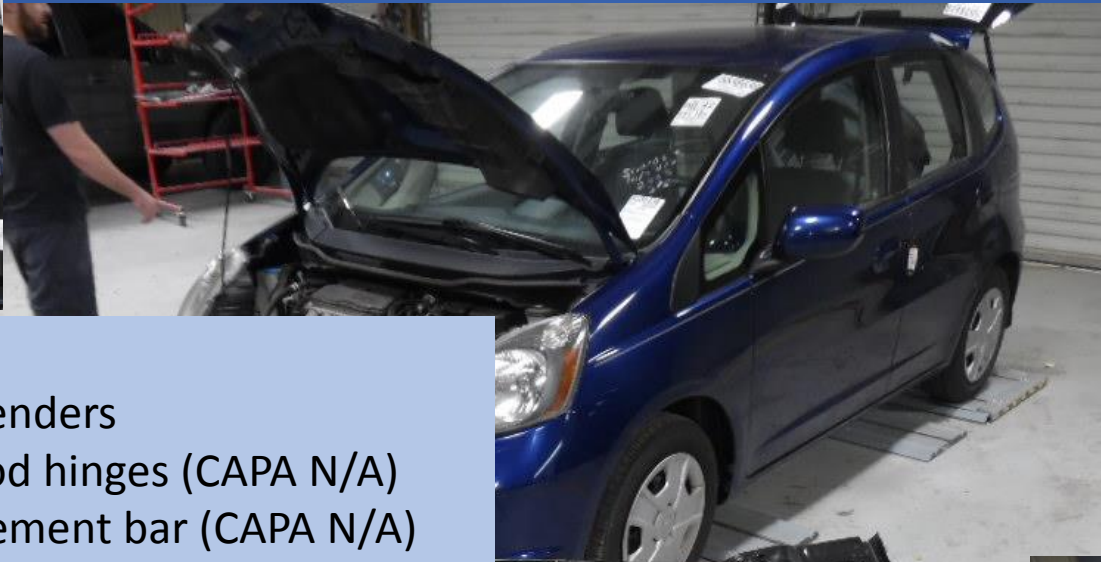
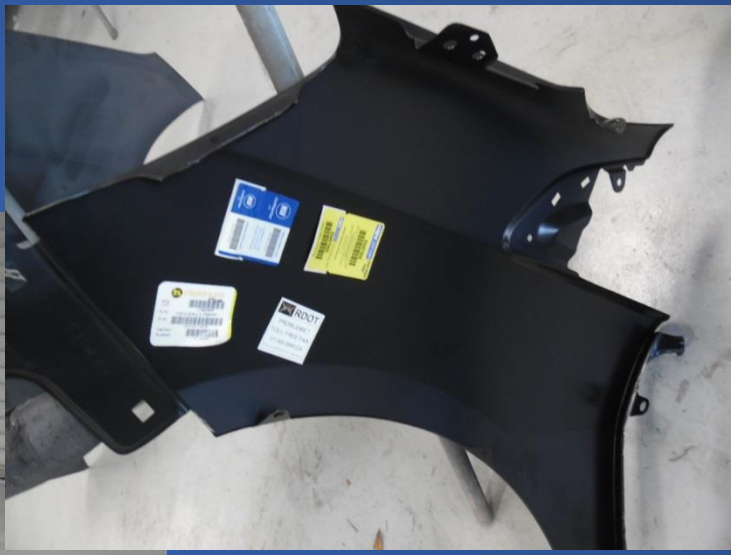
Aftermarket Parts

- 1) CAPA certified Hood
- 2) CAPA certified left and right fenders
- 3) Aftermarket left and right hood hinges (CAPA N/A)
- 4) Aftermarket bumper reinforcement bar (CAPA N/A)
- 5) Aftermarket radiator support (CAPA N/A)
- 6) Aftermarket left front wheel (CAPA N/A)
- 7) Aftermarket front windshield

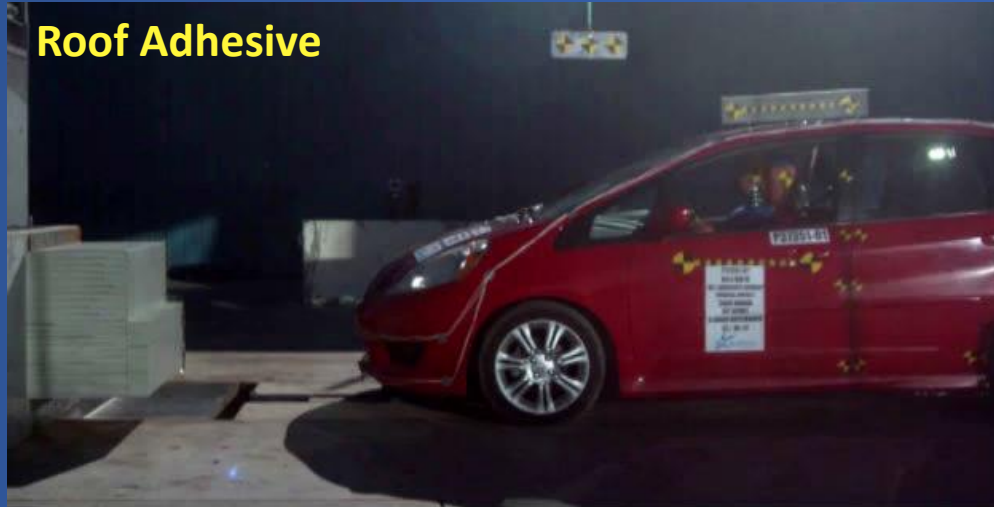
Frame # -49 ● Time -0.049

The HIC numbers for the adhesive vehicle are high because the vehicle failed to properly distribute energy

Roof Adhesive

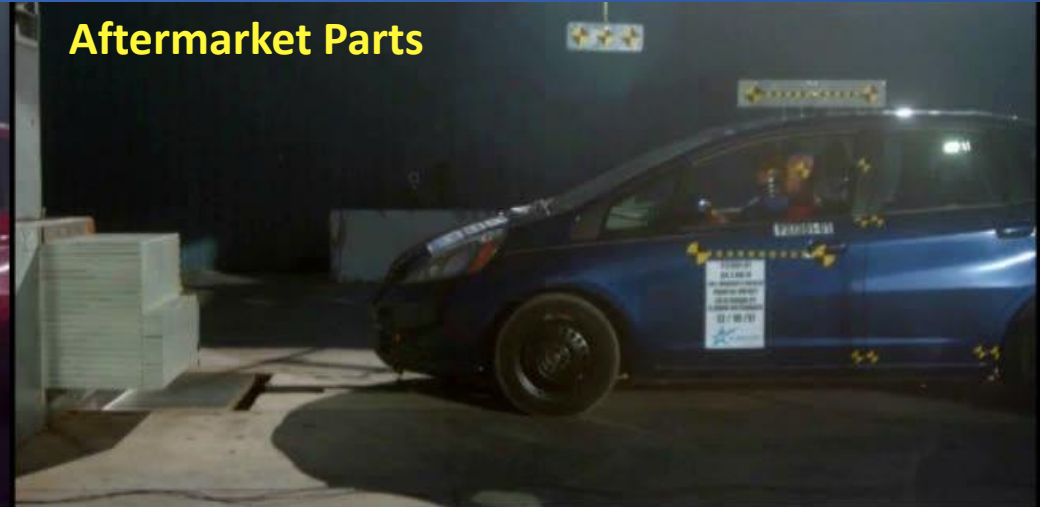
Frame # -49 ● Time -0.049

Aftermarket Parts

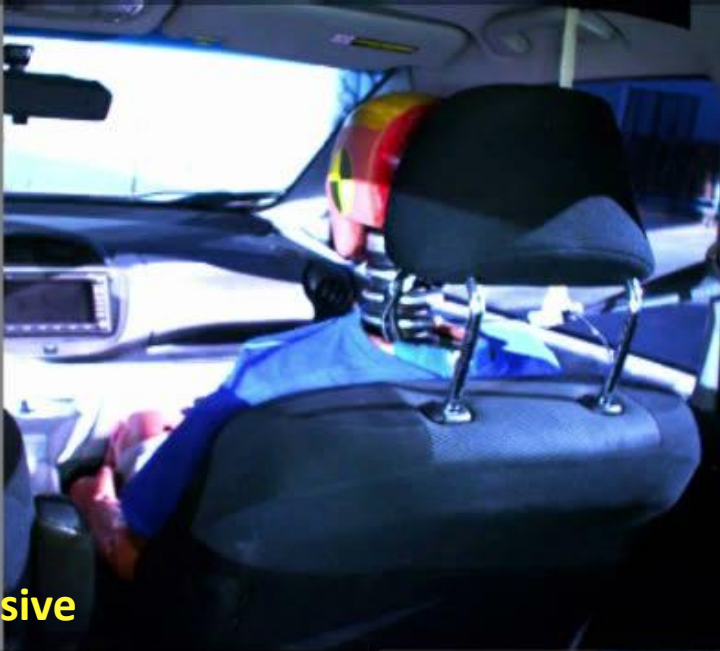
Roof Adhesive

Inadequate Repairs and Material Cause Neck Injury

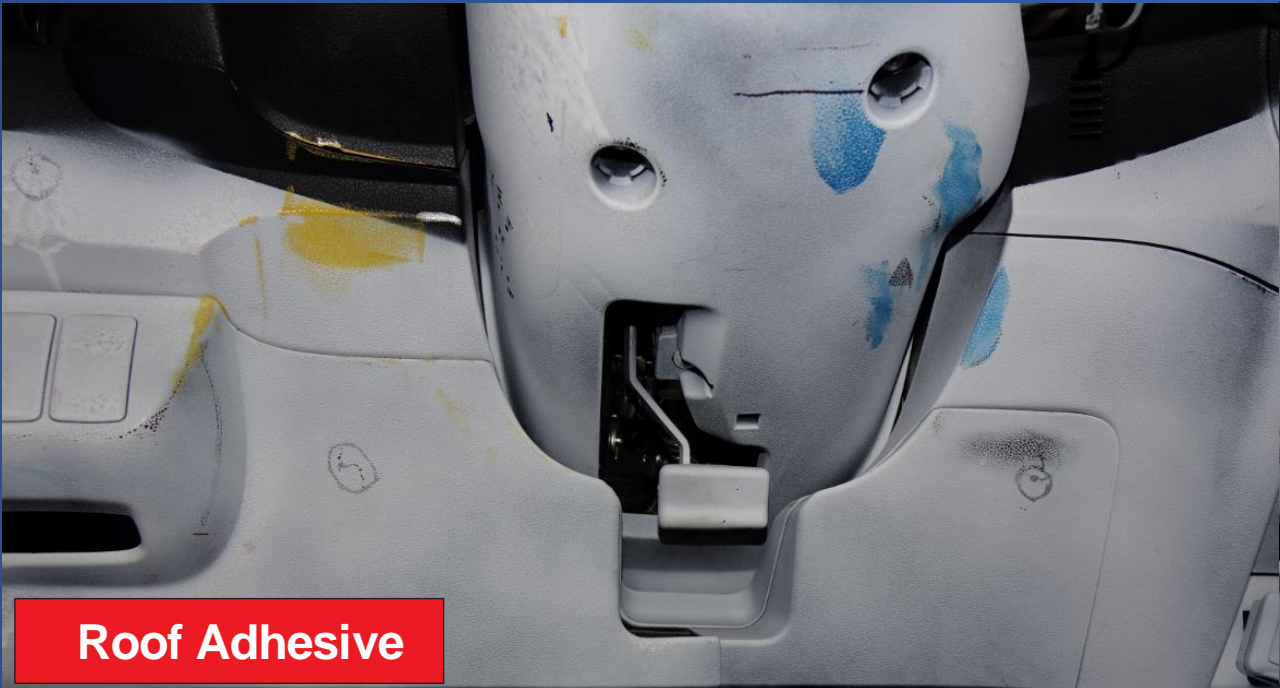
Roof Adhesive

Inadequate Repairs and Material Cause Femur Fractures
